# BUILDING SURVEY REPORT

**PROPERTY**       1 Example Street  
London  
A1 2BC

**SURVEY DATE**   6 May 2021

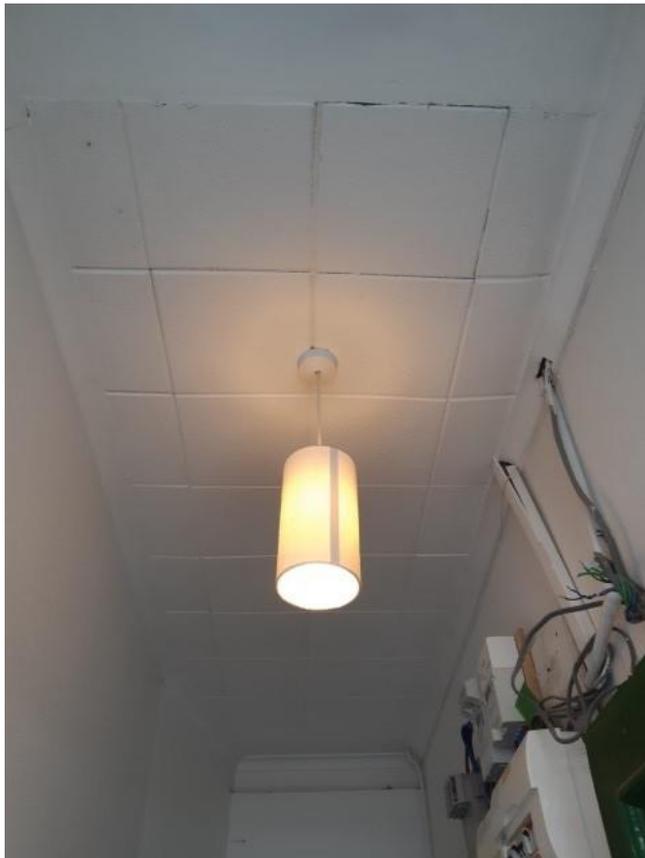
Possible flammable ceiling tiles to communal hallway

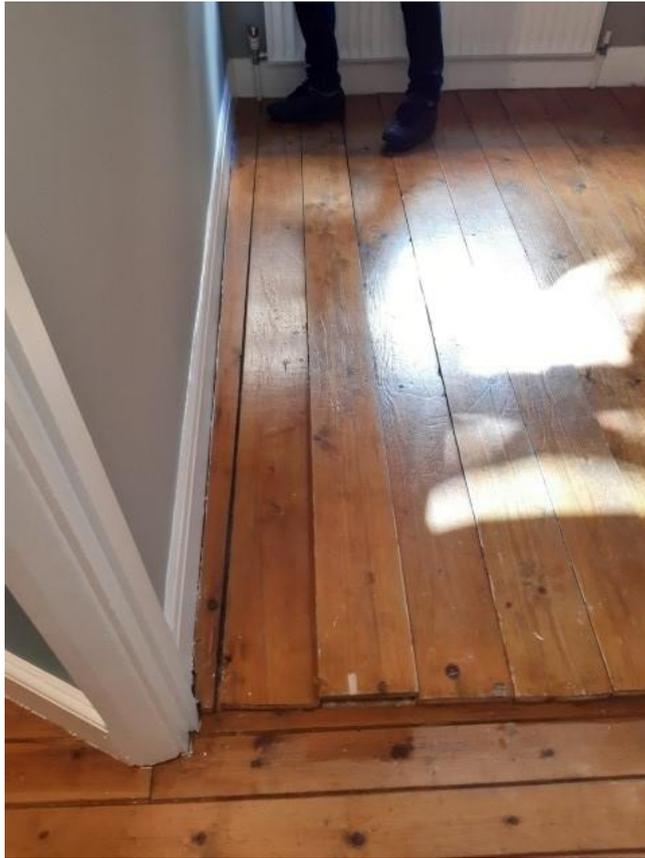
Floor covering in small bedroom not secured - pic 1

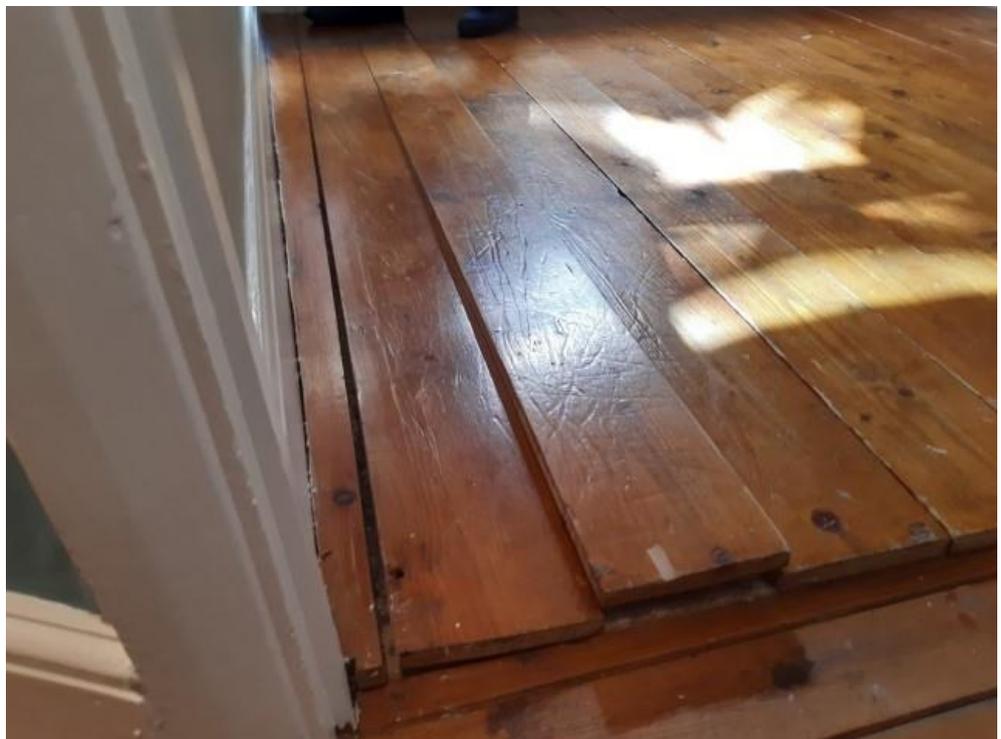
Floor covering in small bedroom not secured - pic 2

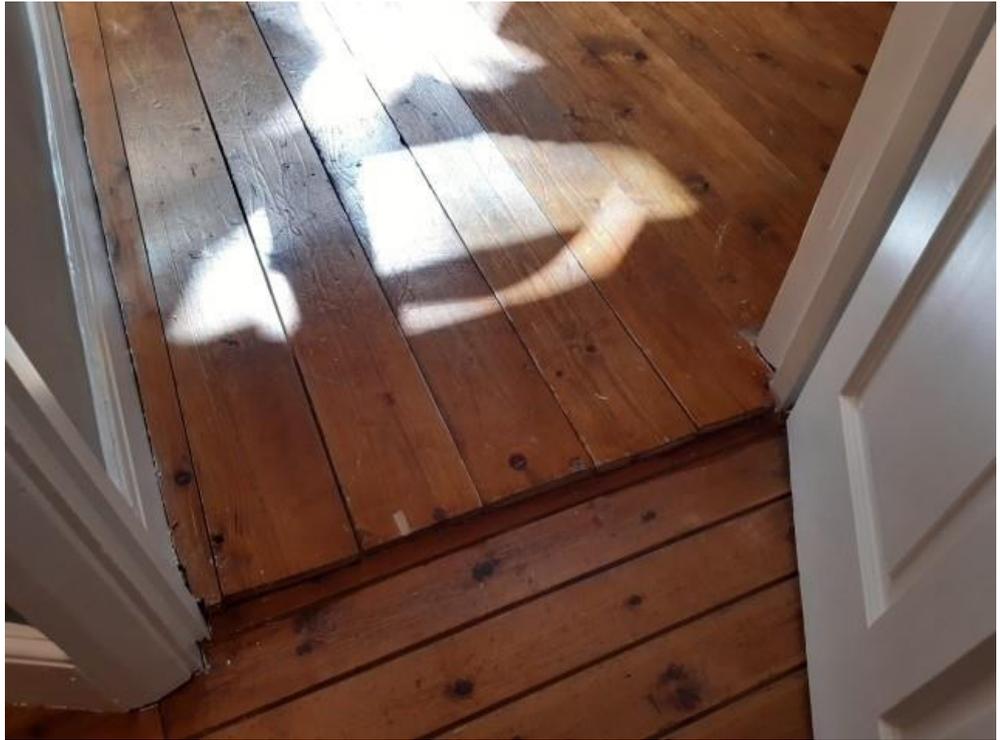
Trip hazard to small bedroom

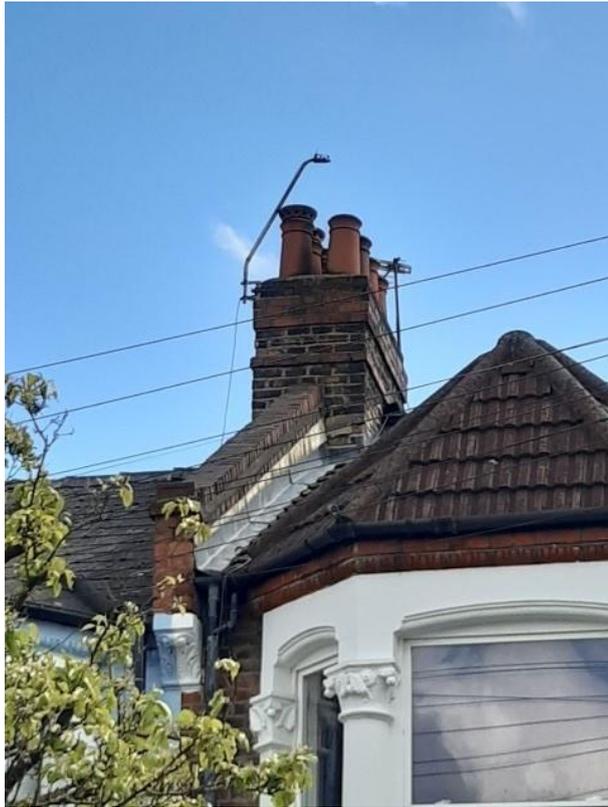
<b>Condition</b>	<p>No significant defects were noted and the chimney stack was found to be structurally stable.</p> <p>No evidence was seen of any unusual cracking or other failure, or of unusual wear of the bricks.</p> <p>It was noted that there is a gap in the mortar pointing between the bricks at the bottom right-hand corner of the front face of the chimney stack.</p> <p>The flashing at the base of the stack is, as far as can be seen, in a serviceable condition.</p> <p>The chimney pots are uncapped and open to the elements. If any pots are left uncapped then rain can penetrate the flues and damp can appear inside the property on the chimney breasts. Providing fireplaces are regularly used then any penetrating moisture will dry out, however if fireplaces are used infrequently, or blocked/sealed off as is the case in the kitchen, then it would be prudent to provide rain cowls to allow ventilation but prevent moisture ingress to the flue.</p>

Chimney stack

<b>Action Required</b>	<p>Missing, loose or defective mortar should be repointed as necessary.</p> <p>Capping of the open pots is required to prevent water penetration to the flues</p> <p>The chimney stack should be regularly monitored for any indications of damage, instability or other defects. You should carry out a thorough visual inspection at least once a year, ideally in the Spring, and ideally at roof level, to identify and repair any damage that could have been caused by winter weather.</p>

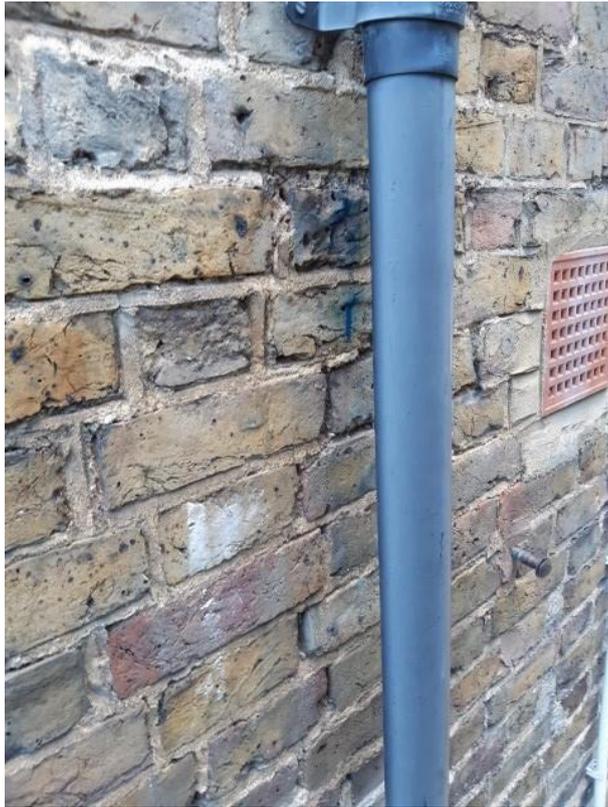
Missing mortar to rear elevation - pic 1

<p><b>Action Required</b></p>	<p>The existing mortar pointing is approaching the end of its life. It will be necessary to remove the current mortar pointing and replace/repoint with new mortar. If repointing is not carried out then this will lead to water migrating through the external walls, to the inside of the property. This in turn will lead to problems with damp and possibly other building defects.</p> <p>Walls should be examined regularly to inspect for changes in the nature of any cracking or other defects that may become apparent.</p> <p>You should carry out a thorough visual inspection at least once a year, ideally in the Spring to identify and repair any damage that could have been caused by winter weather.</p> <p>Ensure that the air bricks are kept clear to maintain adequate ventilation in the underfloor void. External paving and soil levels should not be allowed to rise above the level of the air bricks. A lack of ventilation can allow moisture levels beneath the floor to become elevated, increasing the risk of the development of moisture related defects such as rot and infestations by wood boring insects (commonly known as woodworm).</p>

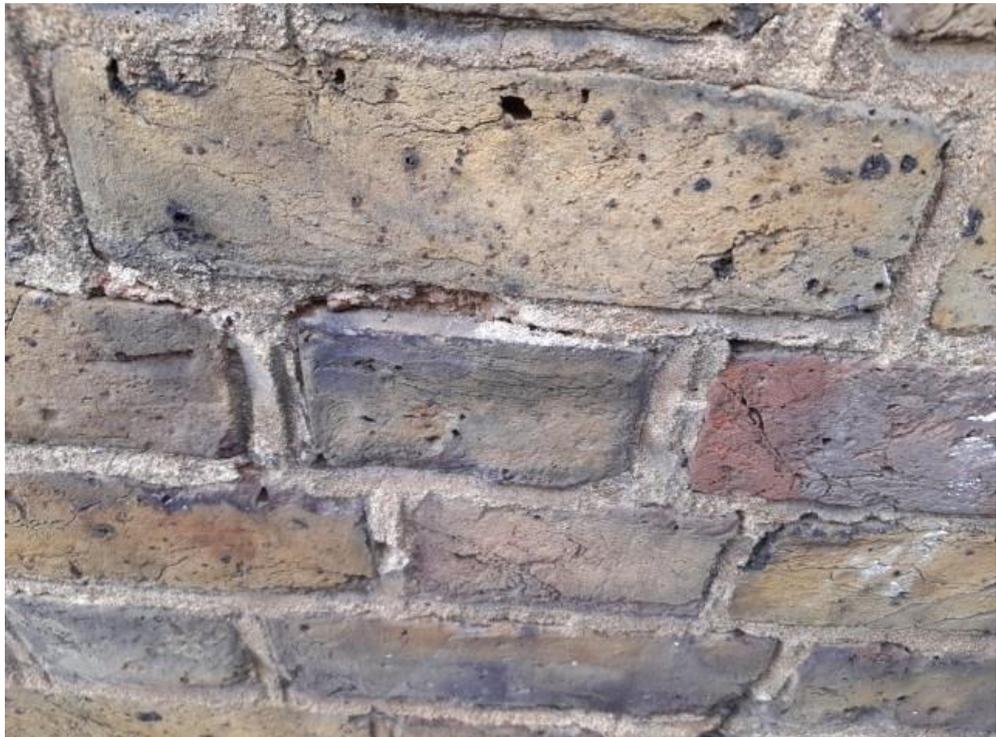
Missing mortar to rear elevation - pic 2

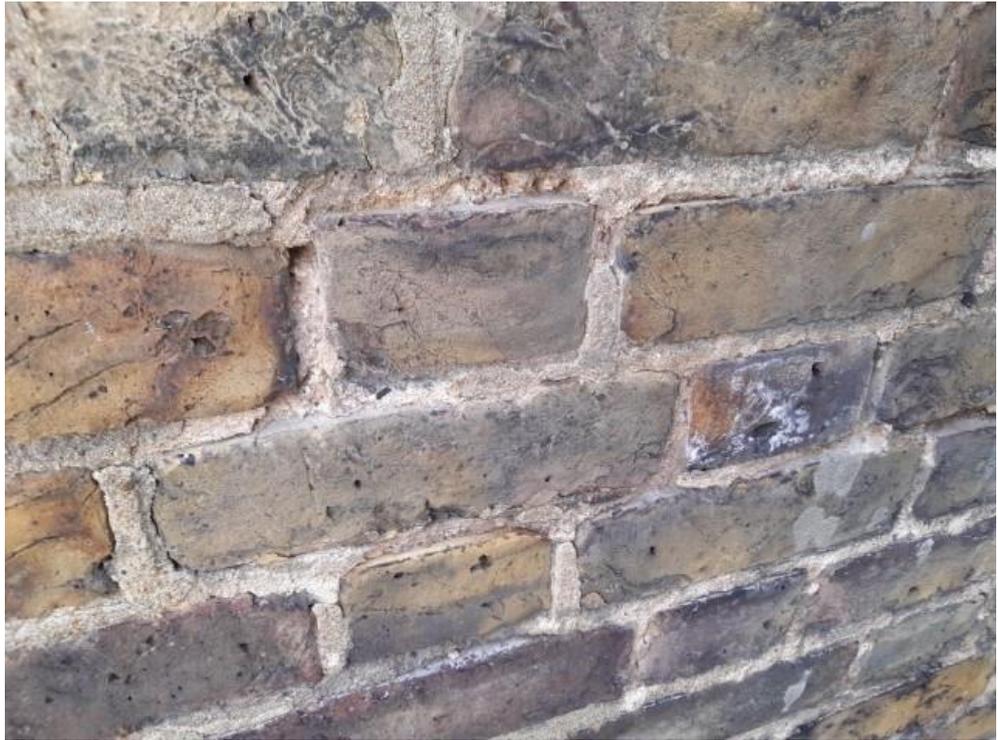
Missing mortar to rear elevation - pic 3

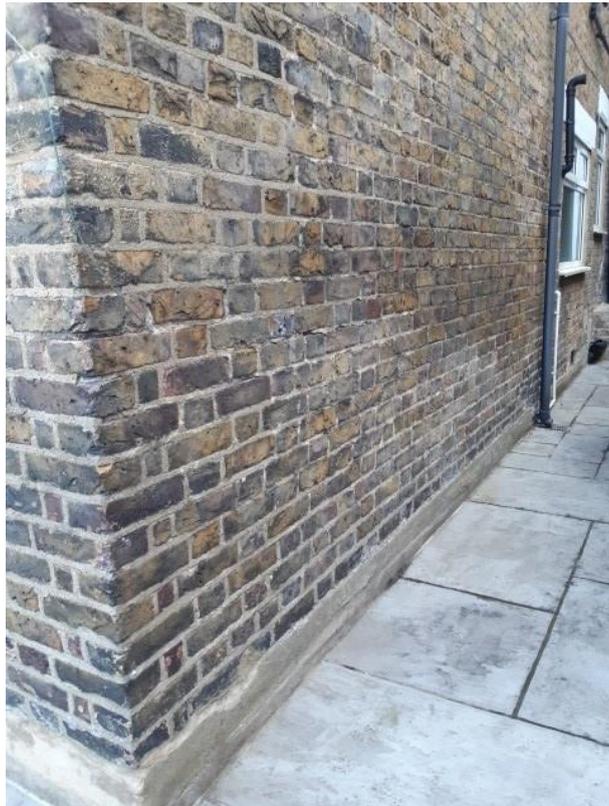
Staining due to rising damp - pic 1

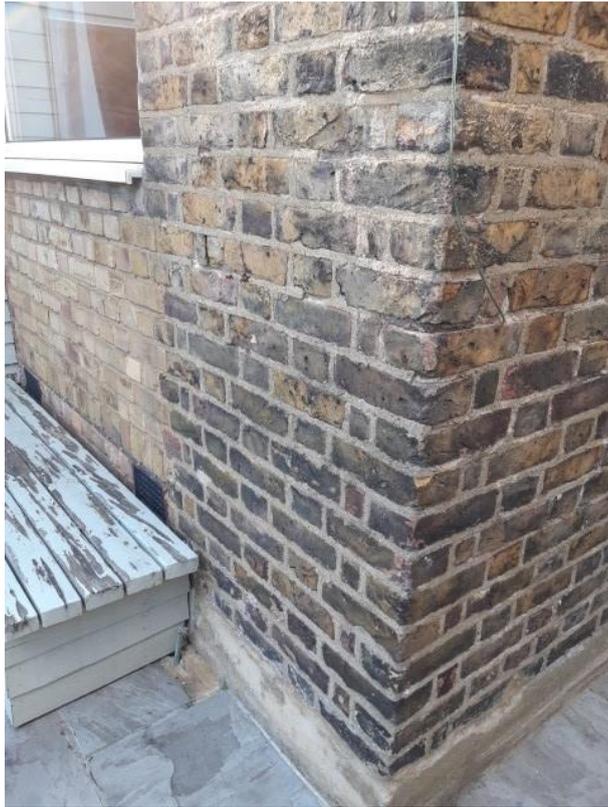
Staining due to rising damp - pic 2

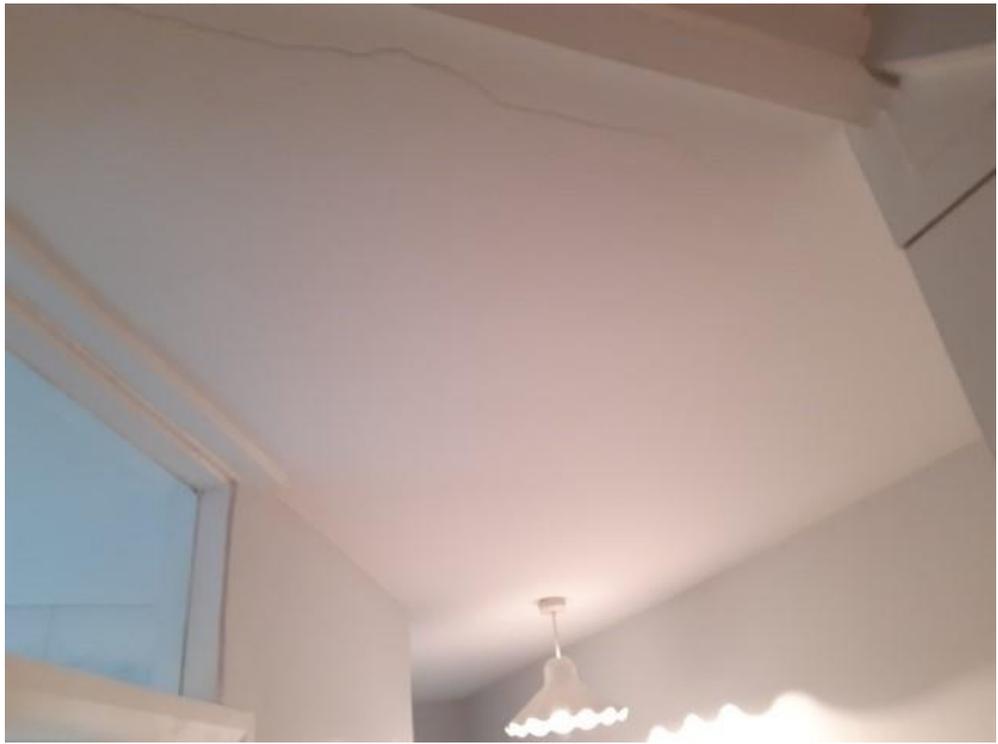
Crack to hallway ceiling

<p><b>Action Required</b></p>	<p>Normal future maintenance is required, including filling and redecorating any cracks as necessary.</p>
	<p style="text-align: center;"><b>LATH AND PLASTER CEILING</b></p>

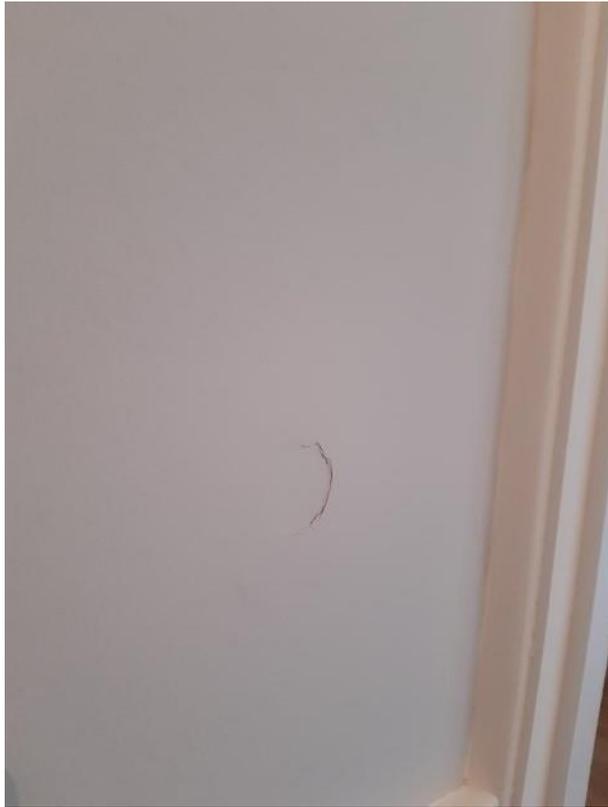
Damage to hallway wall from front door impact

<b>Action Required</b>	Normal maintenance is required, including filling and redecorating cracks as necessary.

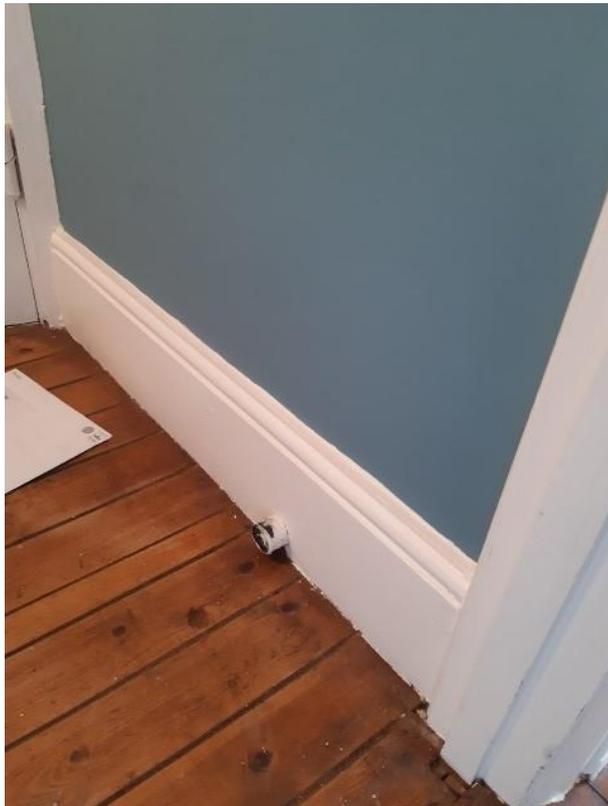
Front door stop not long enough to prevent impact

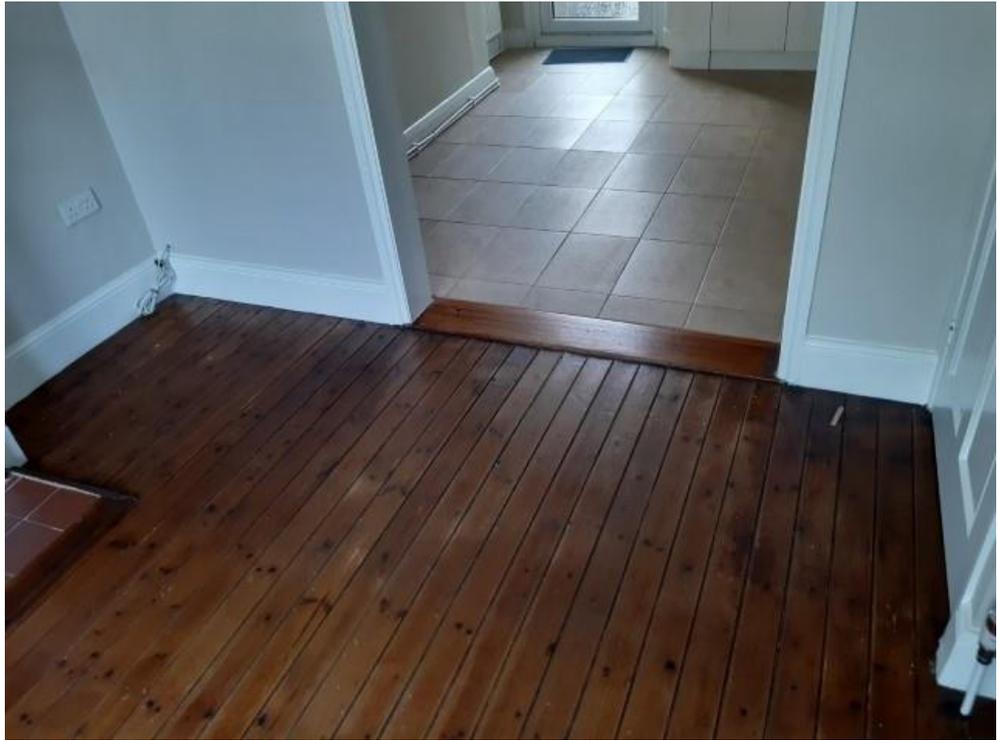
Sloping floor in living room

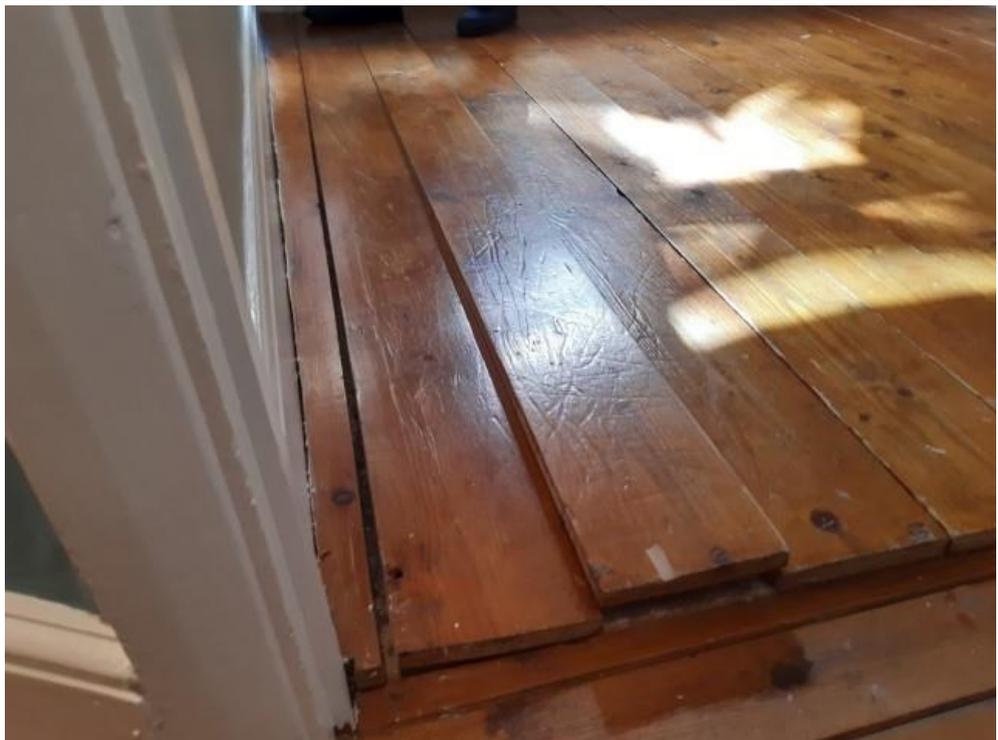
Floor covering in small bedroom not secured

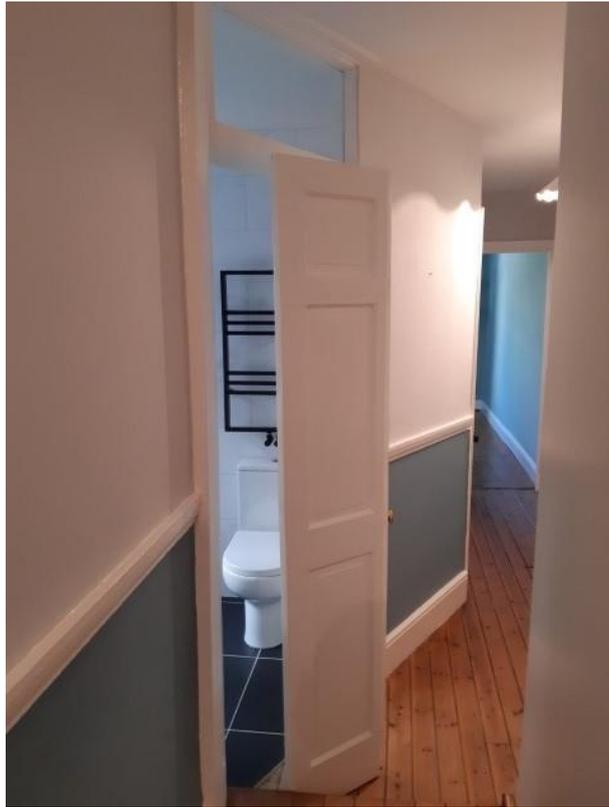
Door to bathroom does not open fully

<b>Action Required</b>	Door hinges and locks should be regularly lubricated. Internal timbers should be inspected regularly for evidence of bowing or distortion, woodworm and other defects.

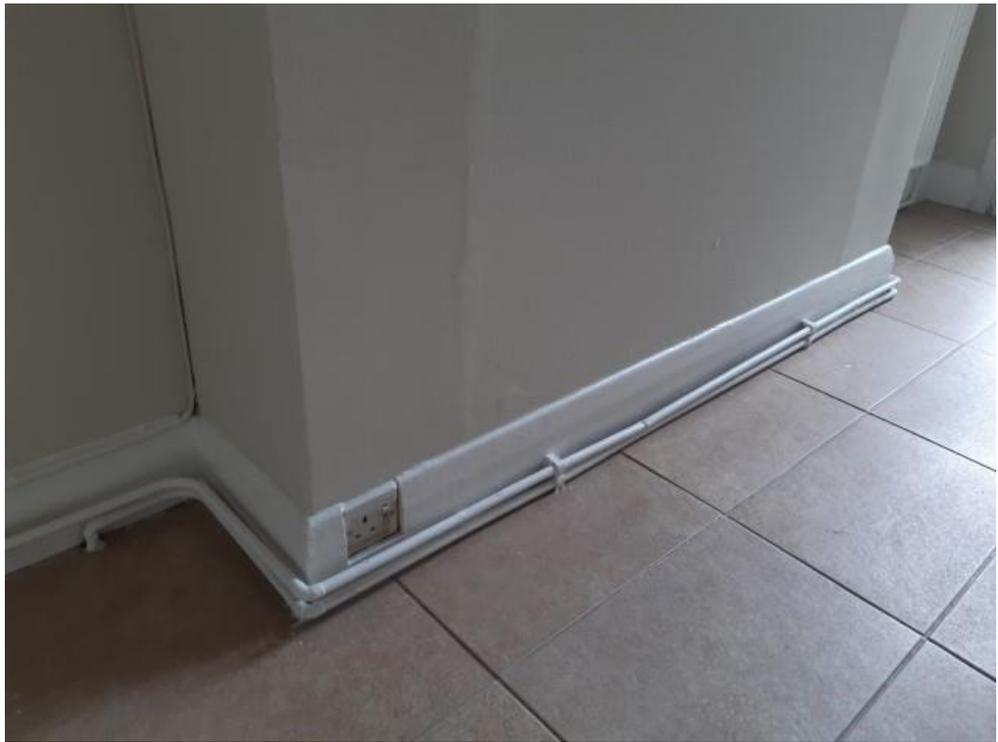
Low level socket in kitchen

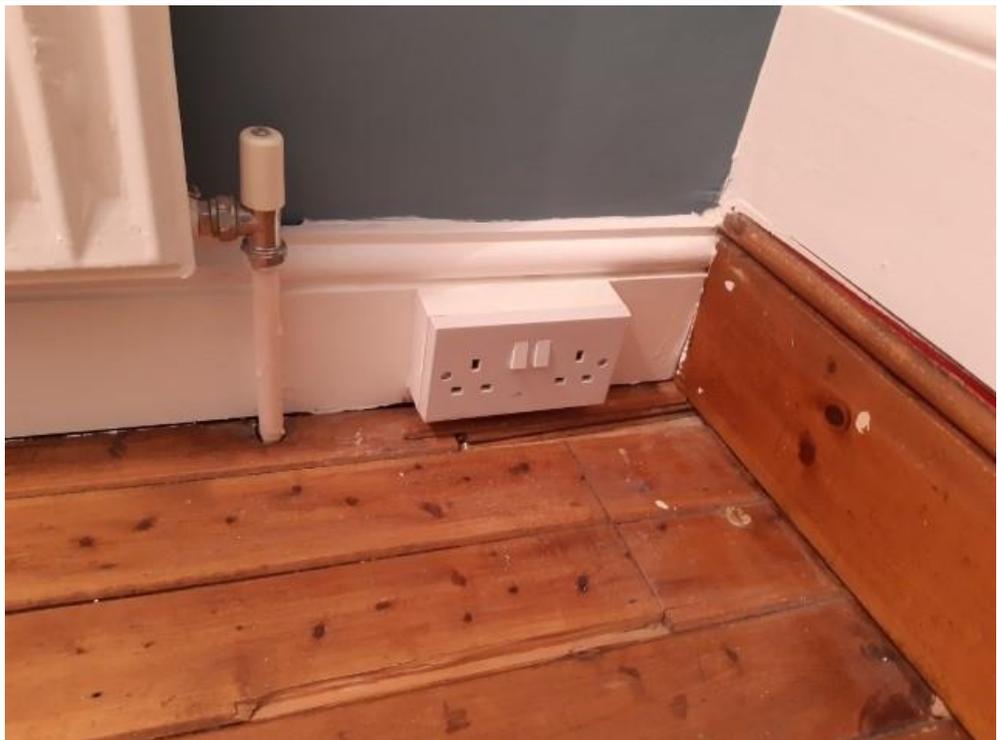
Low level socket in hallway

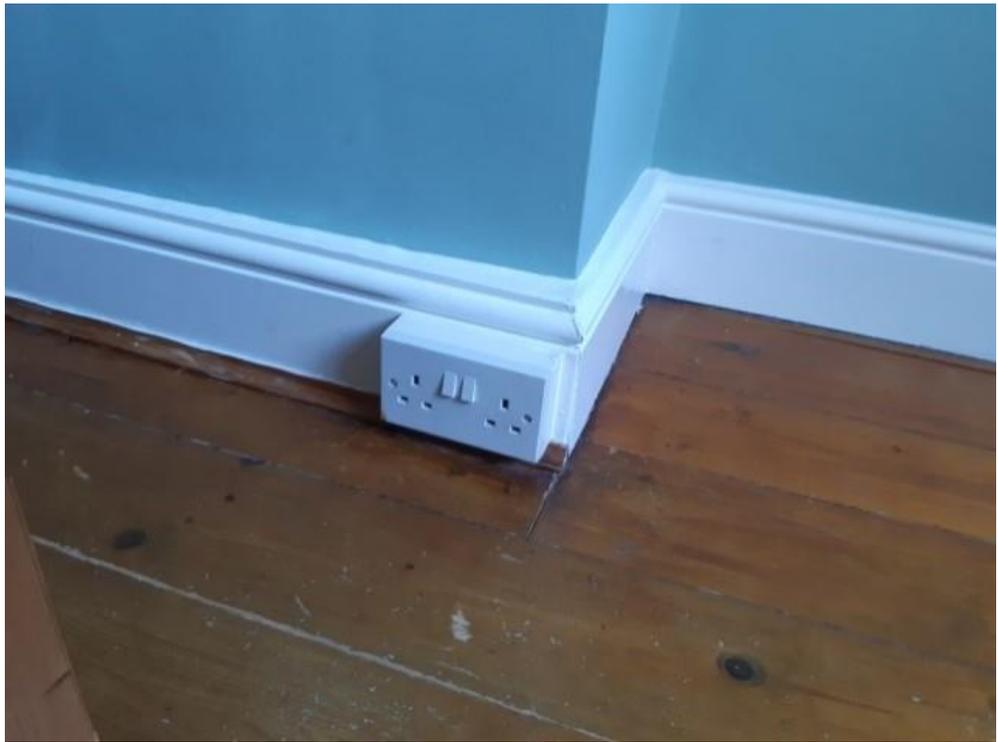
Low level socket in master bedroom

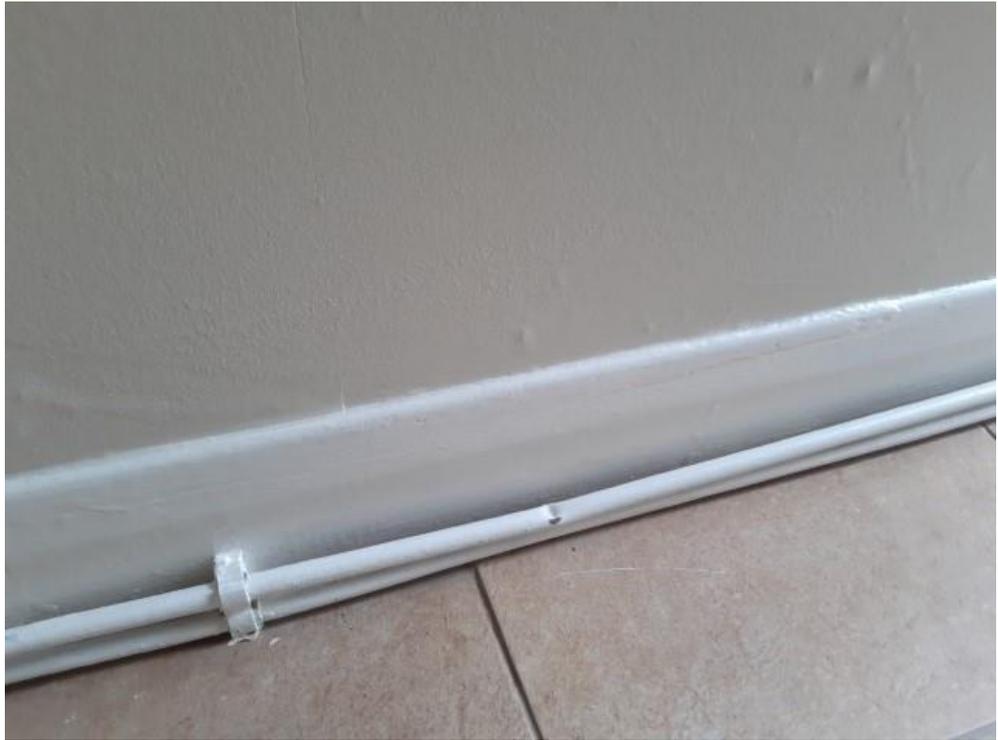
Damaged radiator pipe in kitchen

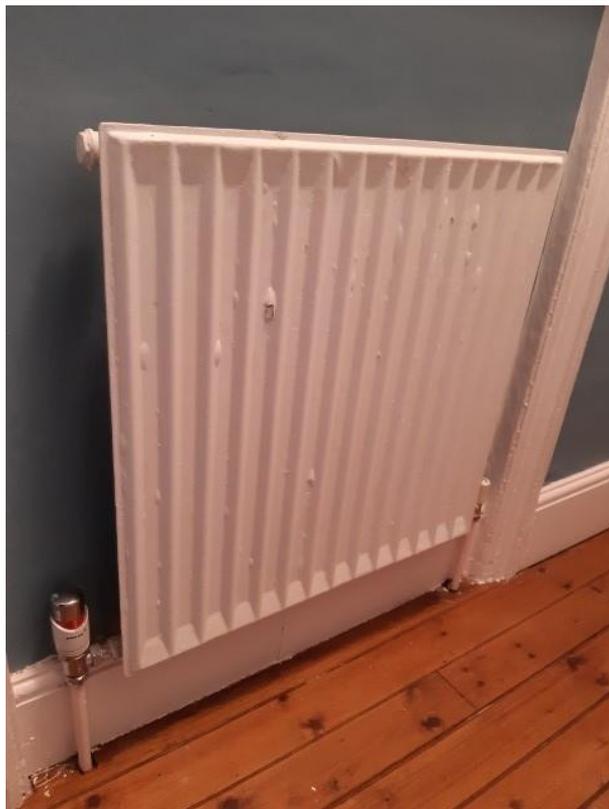
Blistering paint to radiator in hallway - pic 1

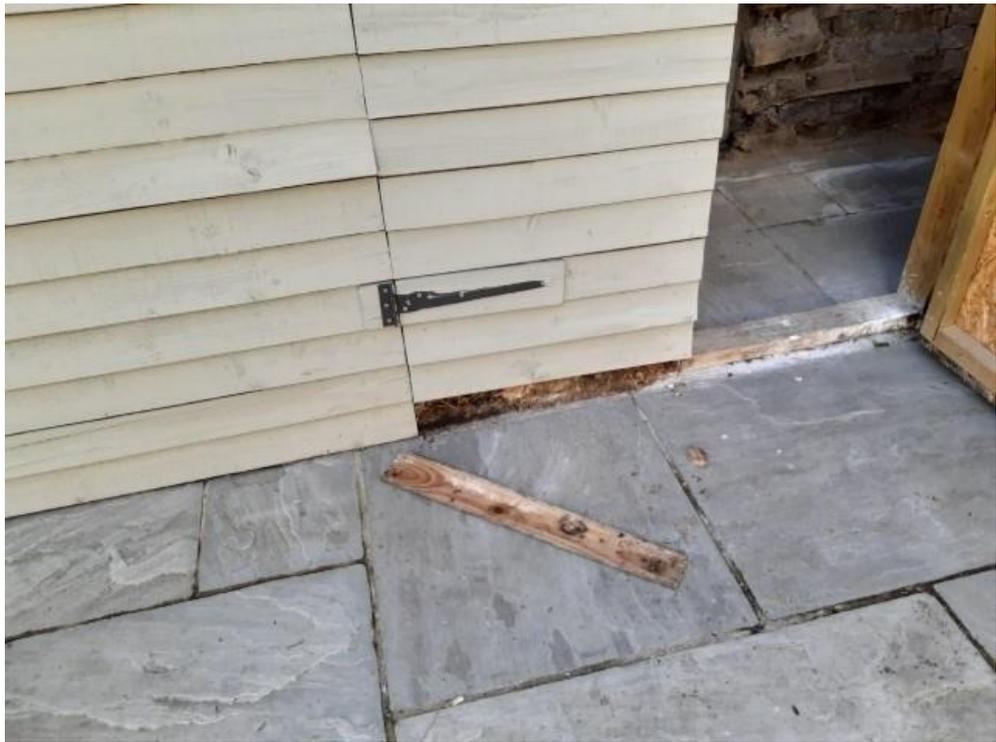
Large shed - detached timber slat

<b>Action Required</b>	<p>Reattach the timber slat which has become detached from the timber door on the large shed.</p> <p>Carry out repairs to internal brick wall/boundary wall of the large shed located alongside the property.</p> <p>Normal maintenance, including regular retreatment of the timber walls, is required.</p> <p>Any accumulating foliage and debris should be removed from the outside walls.</p> <p>Compared to traditional coverings such as tiles and slates, most felt roofs have a typical life of 10-25 years. They are also prone to sudden failure and leakage. Periodic re-covering will therefore be necessary. When this is undertaken, the supporting structure may also need some attention.</p>

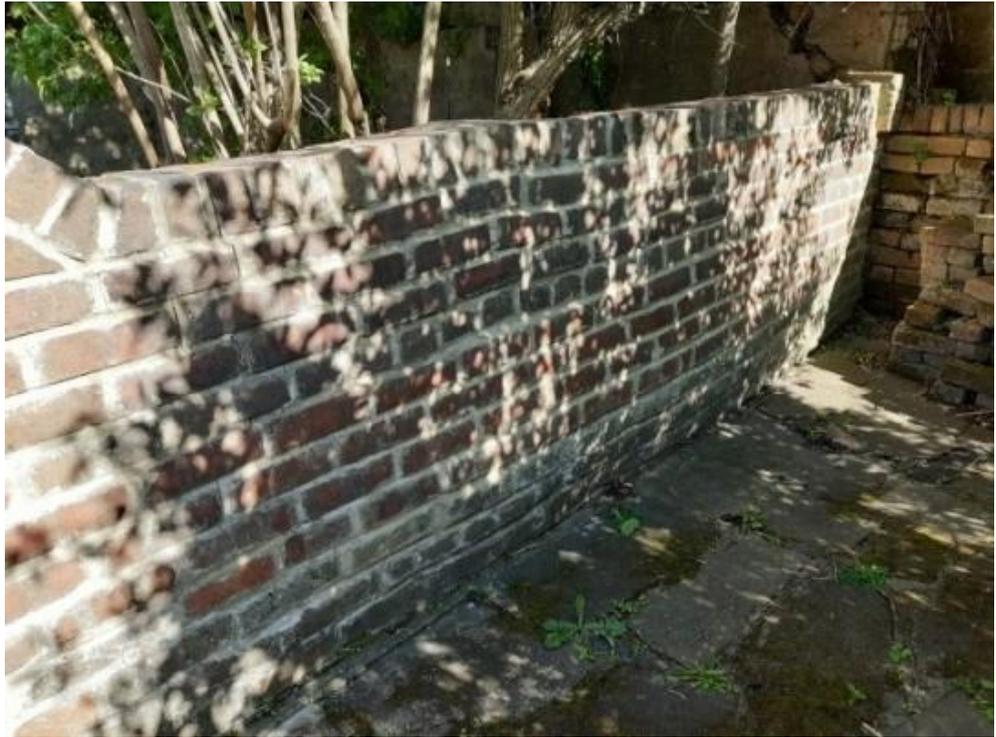
Bulge to boundary wall from tree roots

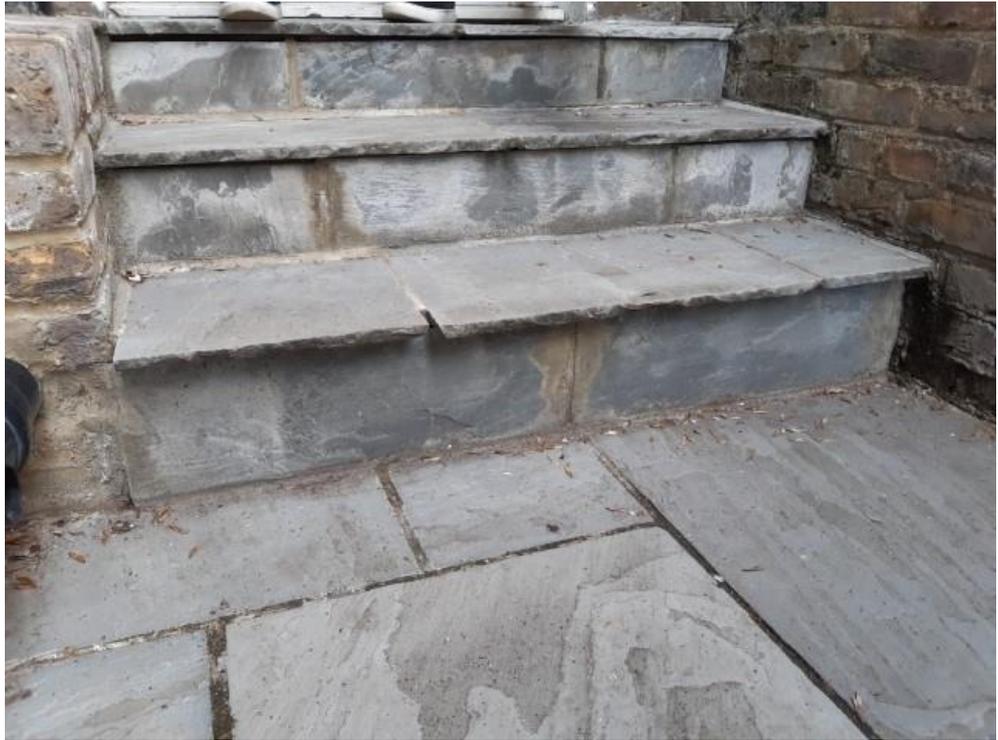
Overhang to flagstone paving forming steps

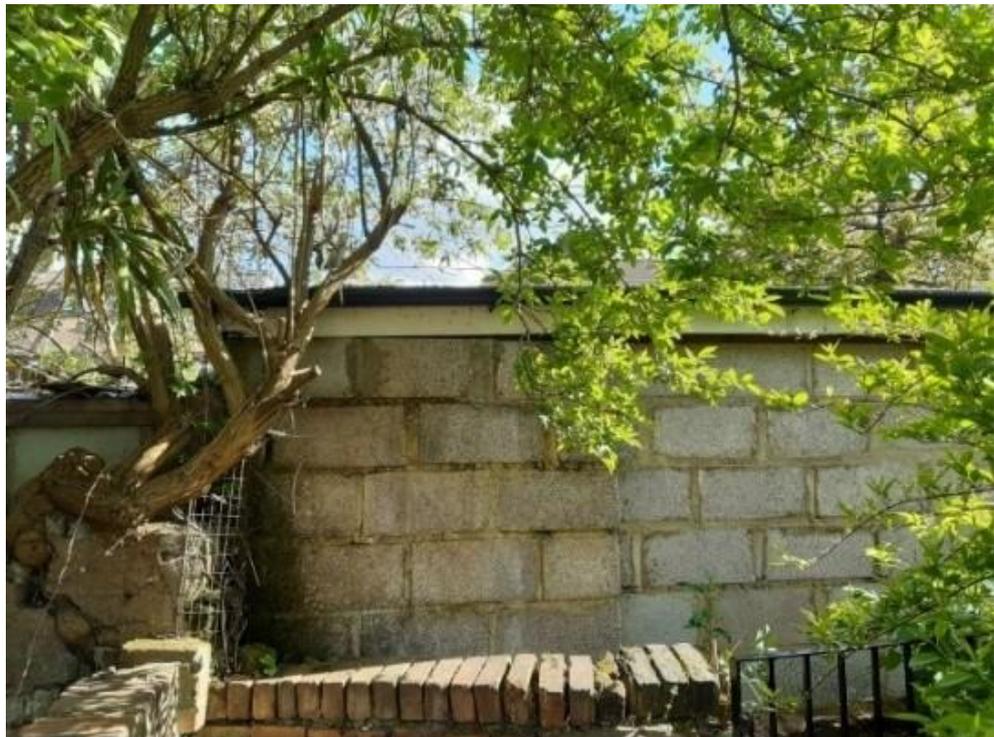
Neighbours rainwater drainage discharging onto boundary wall - pic 1
