# HOME BUYER SURVEY

**PROPERTY** Ground floor flat,  
123 Street,  
London  
A1 2BC

**SURVEY DATE** 3 Feb 2021

**REF** 12477

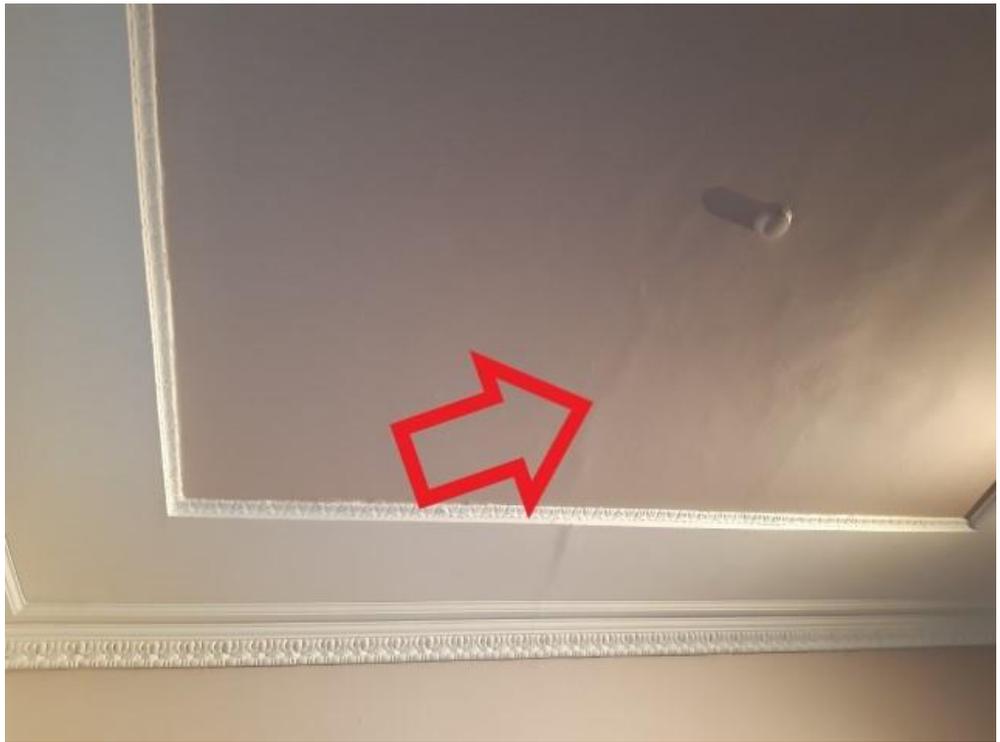
Lounge ceiling, undulation noted

Normal future maintenance is required, including filling and redecorating any cracks as necessary.

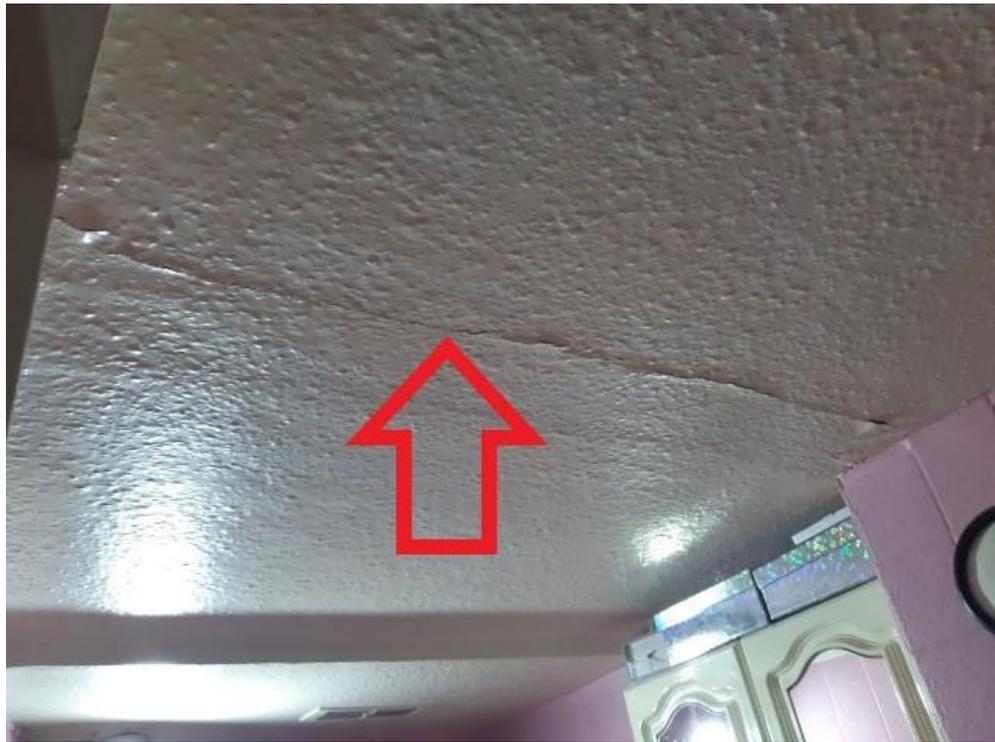
Hairline crack to bathroom ceiling

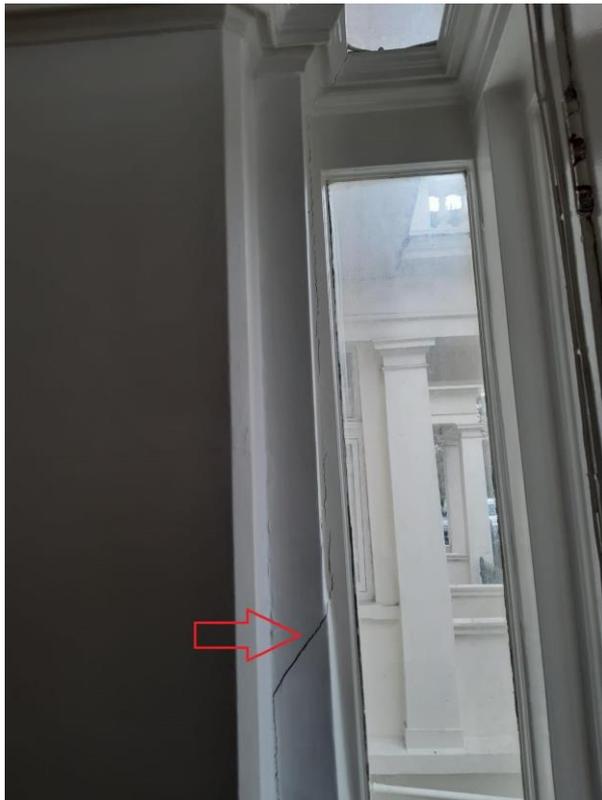
Crack to communal internal wall

Normal maintenance is required, including filling and redecorating cracks as necessary.

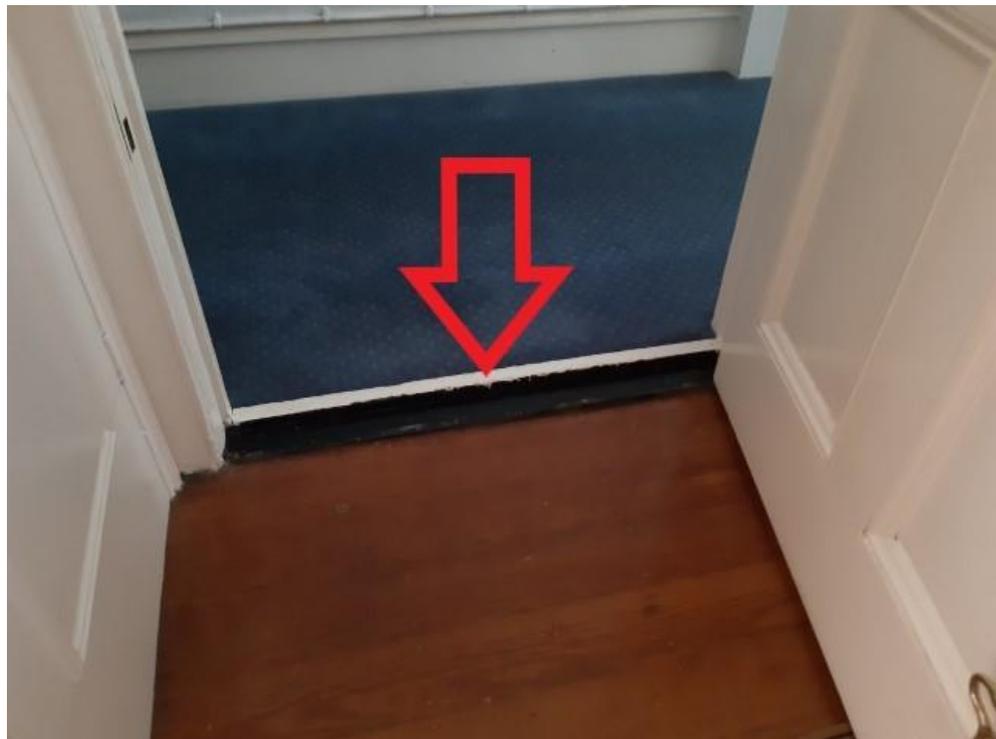
Level change / trip hazard lounge room

Floors should be monitored for any changes that occur in their level or springiness or noise, and further investigations carried out should any such changes become apparent.

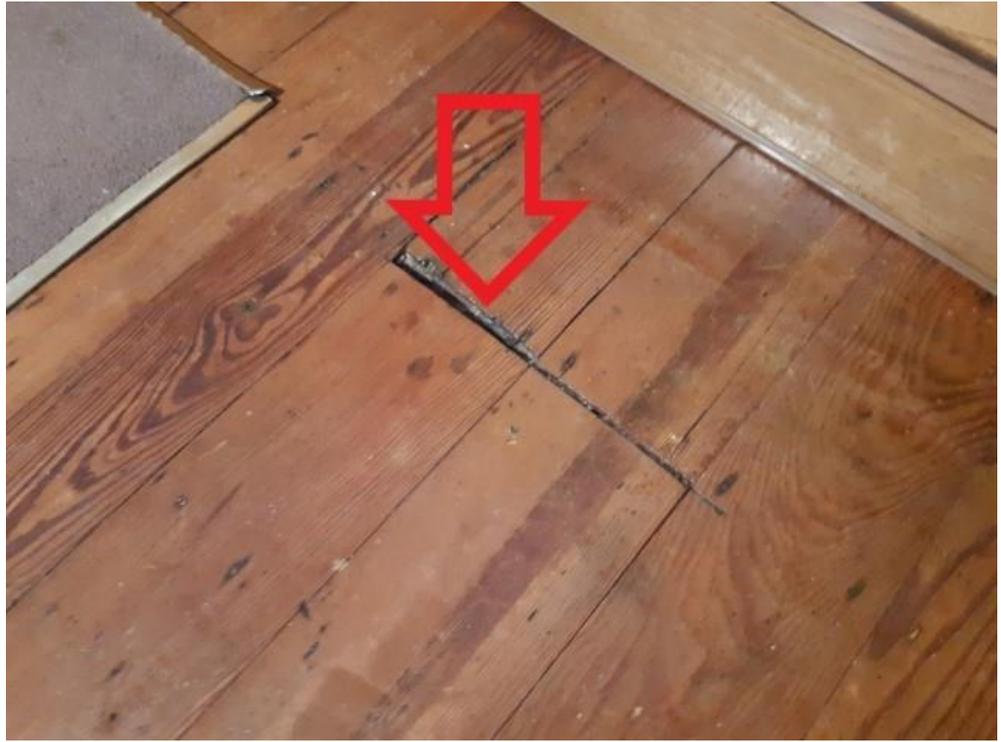
Historic repair to timber floor

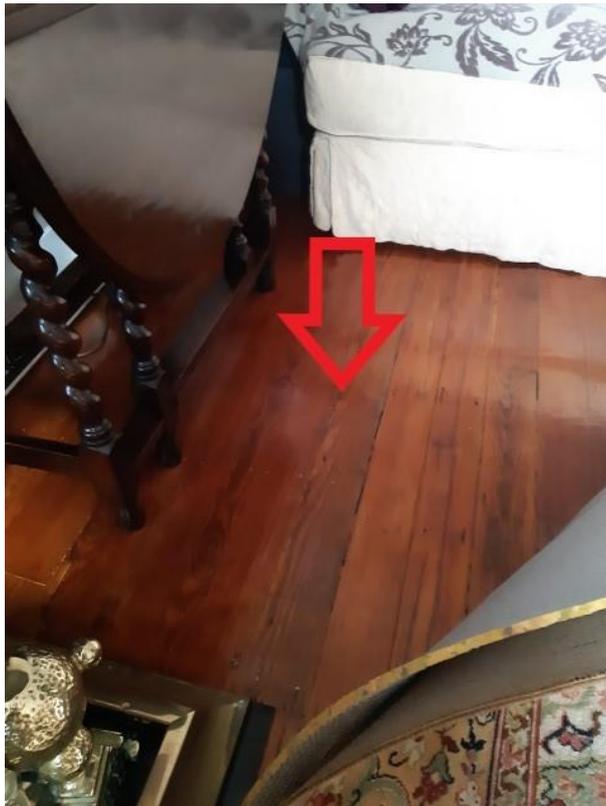
Timber floorboard uplifting

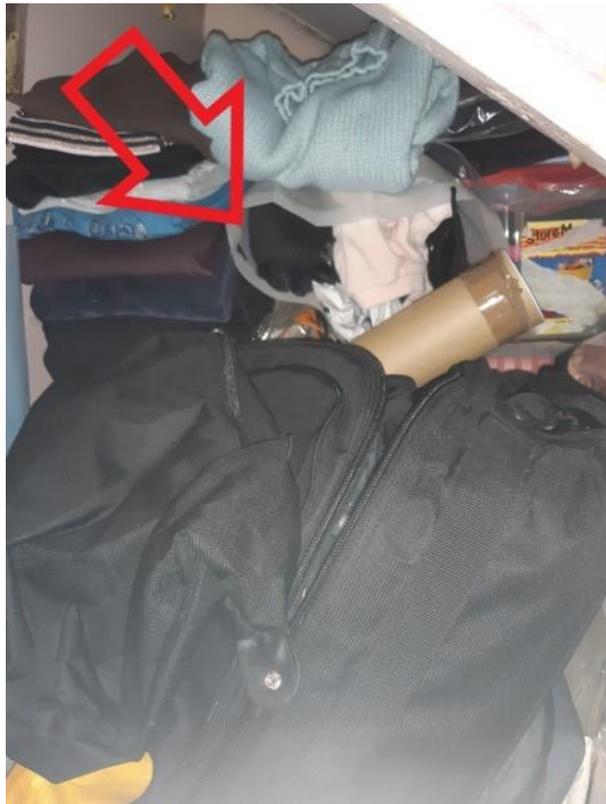
No access to consumer unit

An electrical installation can look to be in a safe condition, but serious defects may be hidden within the walls or under floors. It is therefore considered to be essential that you commission an inspection and testing of the electrical installation prior to purchase of the property, unless you are provided with verifiable evidence that such an inspection has recently been carried out by a registered competent person (electrical).

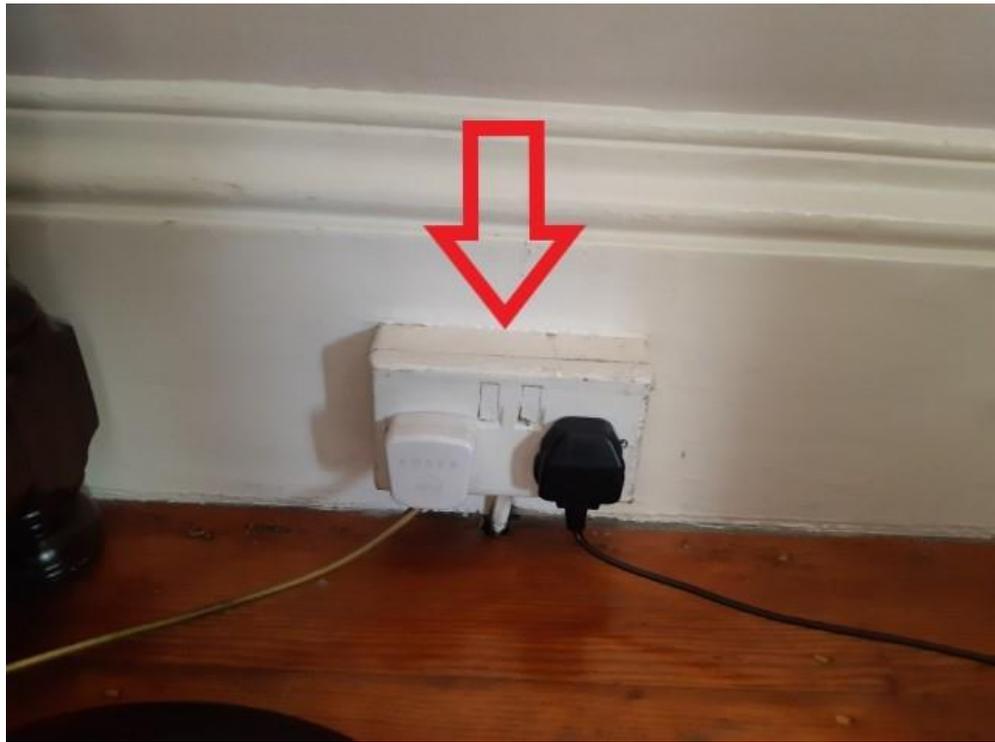
Old double plug socket

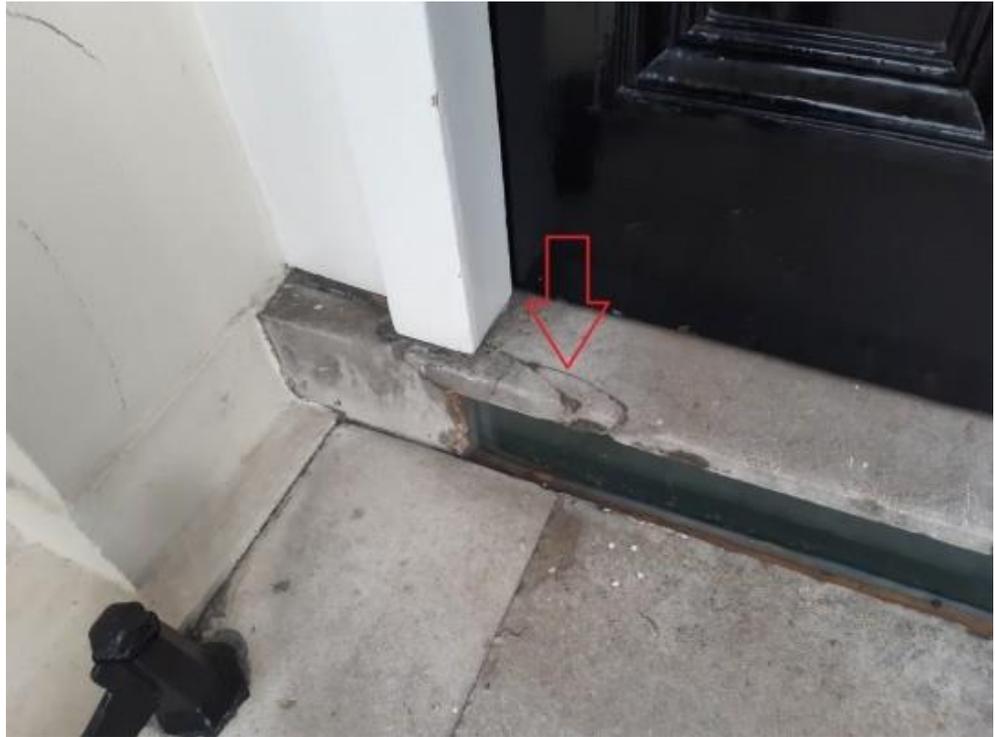
Crack to concrete step

Normal maintenance is required.
