Your survey report

Flat 7,
Example Road,
London,
WC1X 7DR

16th March 2022

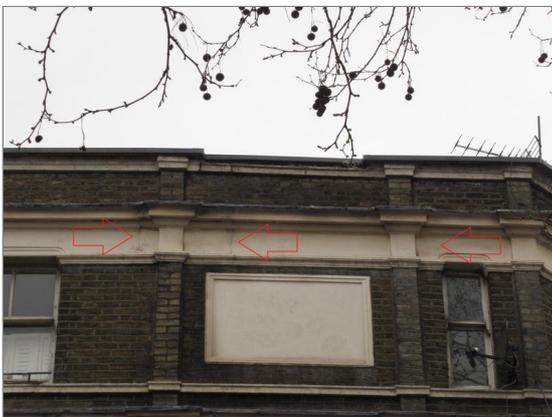
There are a number of cracks present to the front elevation and cracks above the main living room window and the kitchen window (see photos below). These types of cracks are not unusually for a buildings of this type and age. As mentioned, most properties are subject to slight settling down over the years as sub-soil consolidates and adjusts to changes in ground condition. This will frequently result in limited differential movement, which is often expressed as minor cracking, as displayed here, and is not of structural significance. It should be noted that these cracks are not limited to the subject property, but are present externally to most window openings in the building.

Photo - 6 Cracks to left elevation

The cracks present to the front elevation, above the main living room window and the kitchen window should be repaired and made good. The areas will also require repainting on completion of the repairs.

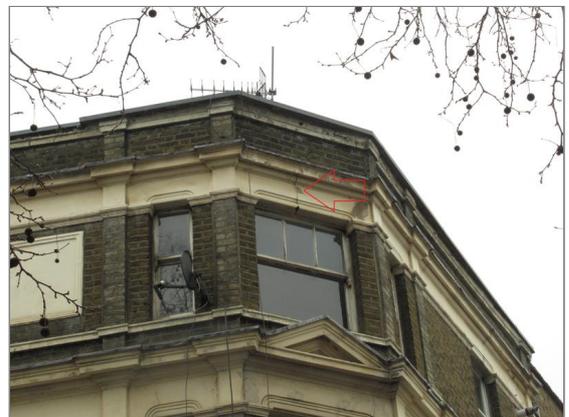
Photo - 7 Crack above main living room window - pic 1

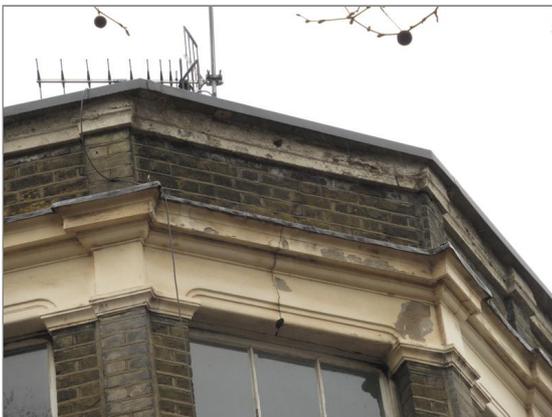
Photo - 8 Crack above main living room window - pic 2

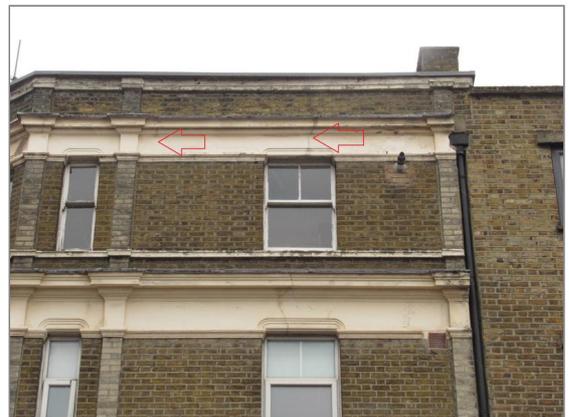
Photo - 9 Cracks to right elevation and above kitchen window

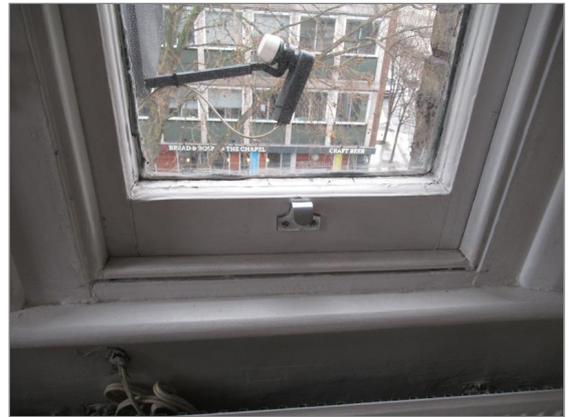
As expected the window frames are affected by minor splitting and isolated softening. Shrinkage cracks are also present to the joints of most windows (see photos below). The frames are in an overall serviceable condition, although would benefit from re-painting and attentive repair to extend the life of the windows.

Photo - 15 Damage to interior of window in living room

Immediate re-painting and attentive repair of all window frames in order to extend their life.

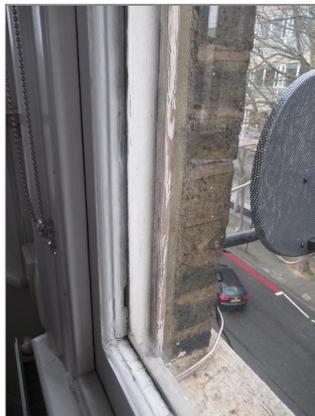
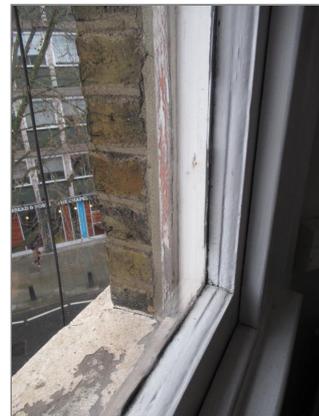
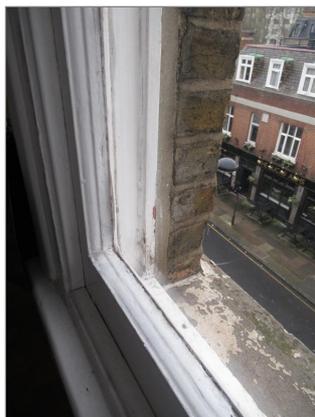
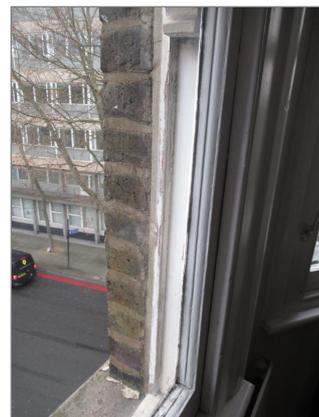
Photo - 16 Water damage to external frame of windows in living room - pic 1

Photo - 17 Water damage to external frame of windows in living room - pic 2

Photo - 18 Water damage to external frame of windows in living room - pic 3

Photo - 19 Water damage to external frame of windows in living room - pic 4

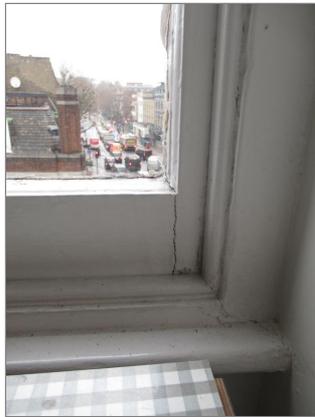
Photo - 20 Shrinkage cracks to joints of windows

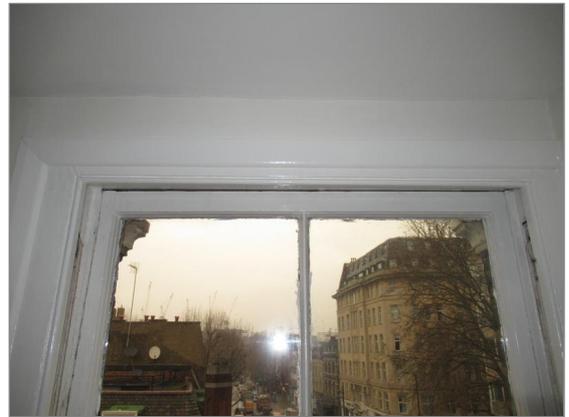
It was noted that the top section of the sliding sash window in the kitchen does not close fully (see photo below).

Photo - 21 Gap to top section of sliding sash window in kitchen

Repair of sliding sash window in kitchen, so that window closes fully.

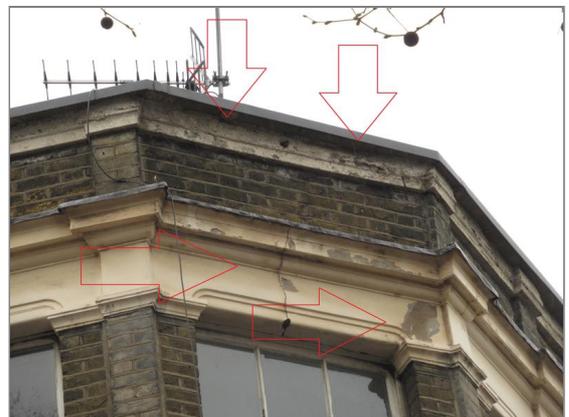
The majority of these decorations are visibly sound, have been maintained and are in a serviceable condition. However there are areas that are suffering from weather damage and require attention (see photos below).

Photo - 24 Weather damaged area to parapet wall and above main living room window

Repaint areas suffering from weather damage.

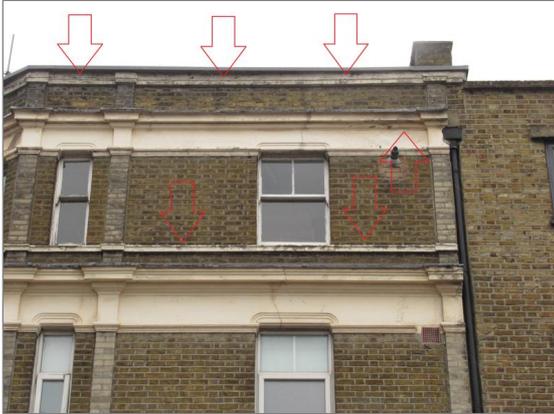
Photo - 25 Weather damage to decorations

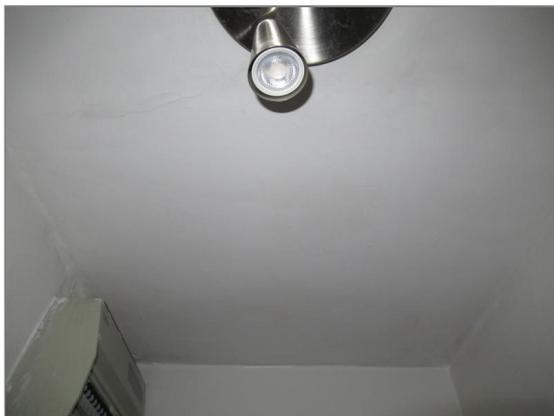
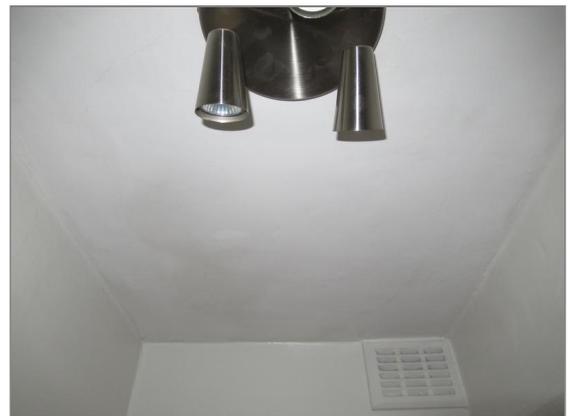
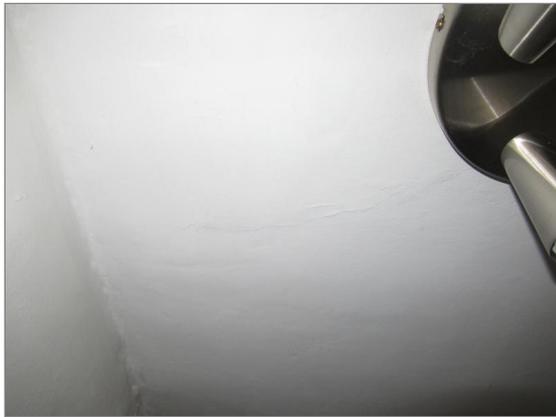
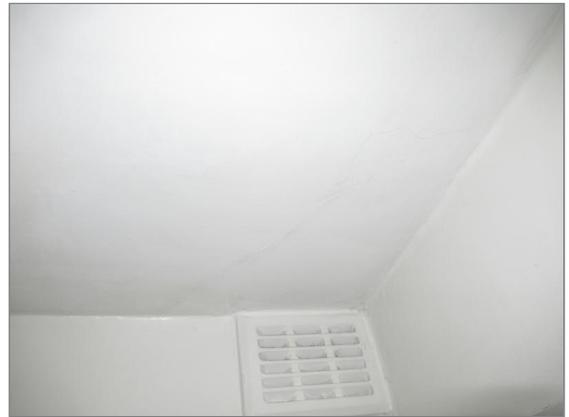
Hairline cracking is visible to the plaster-boarded ceiling in the hallway (see photos below). This is

not of structural concern. It is caused by normal thermal and mechanical movement of the building materials and is within acceptable tolerance levels.

Photo - 26 Sporadic cracking to hallway ceiling - pic 1

Photo - 27 Sporadic cracking to hallway ceiling - pic 2

Photo - 28 Hairline crack to hallway ceiling

Photo - 29 Hairline crack to hallway ceiling

Repair hairline cracking to the plaster-boarded ceiling in the hallway as necessary. It may be more cost effective in the long term to replaster the ceiling by applying a plaster skim and repainting. The ceiling would then have a cleaner appearance and would theoretically last another 60 years.

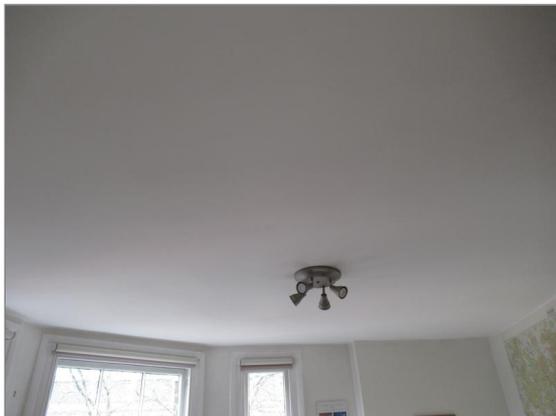
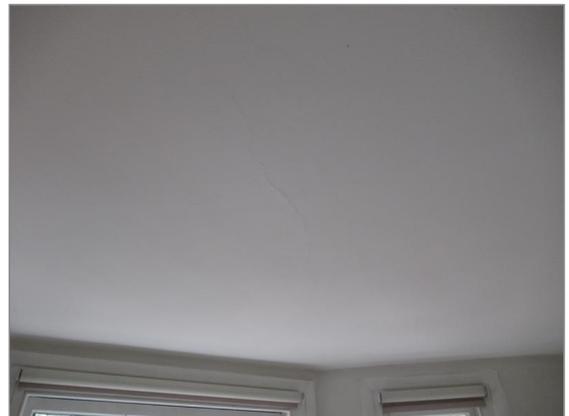
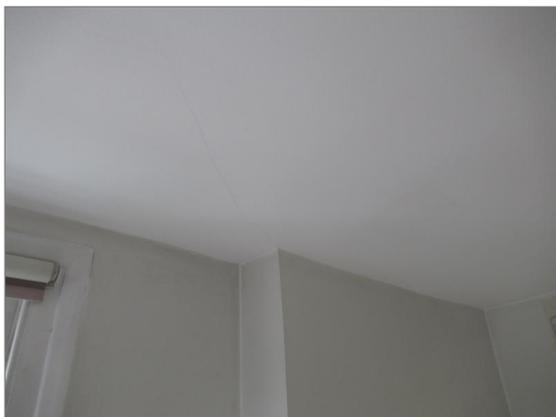
Hairline cracking is also visible to the plaster-boarded ceiling in the living room (see photos below). This is not of structural concern. It is caused by normal thermal and mechanical movement of the building materials and is within acceptable tolerance levels.

Photo - 30 Hairline crack to living room ceiling - pic 1

Photo - 31 Hairline crack to living room ceiling - pic 2

Photo - 32 Hairline crack to living room ceiling - pic 3

Fill and paint hairline cracking to the plaster-boarded ceiling in the living room as necessary.

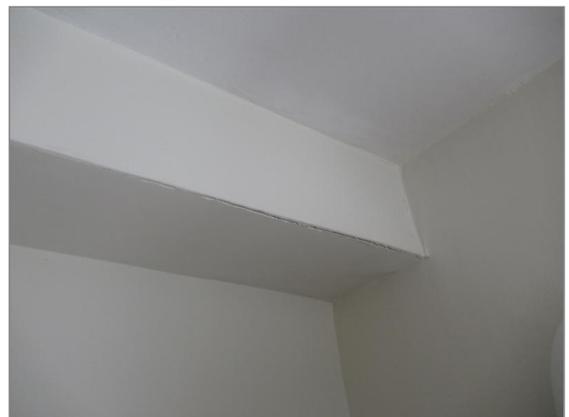
There is perimeter junction cracking to the timber boxing in the kitchen and to the bathroom ceiling(see photos below). This is not of structural concern. It is caused by normal thermal and mechanical movement of the building materials and is within acceptable tolerance levels.

Photo - 33 Perimeter junction cracking to timber boxing in kitchen

Fill and paint perimeter junction cracking to the timber boxing in the kitchen as necessary.

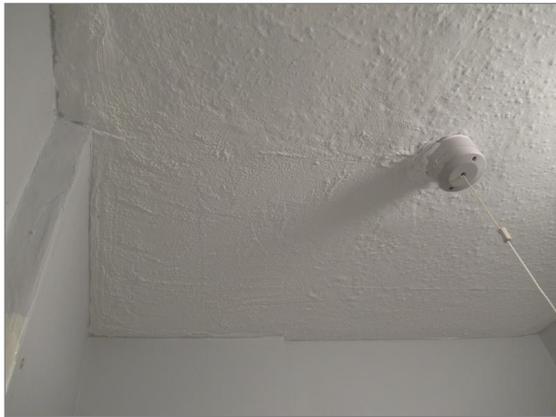
During my inspection I noted a crude repair that has been carried out to the bathroom ceiling (see photos below). This appears to be an indication of a previous leak that could have possibly occurred in the roof. It would be prudent to understand the history of the repair and if there are any ongoing problems. Due to access restrictions, it was not possible to inspect either the roof void or the roof surface and so I was unable to carryout any further investigation.

Photo - 34 Repair to bathroom ceiling, possibly from previous leak

Further investigation of the crude repair that has been carried out to the bathroom ceiling, in order to confirm that there are no ongoing problems. However, there does not appear to be any immediate issue.

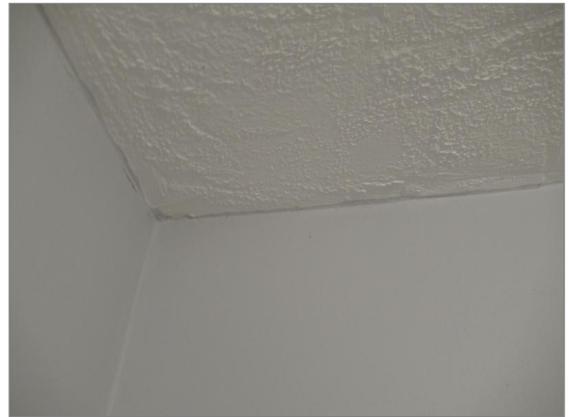
Photo - 35 Perimeter cracking to bathroom ceiling

Fill and paint perimeter junction cracking to the bathroom ceiling as necessary.

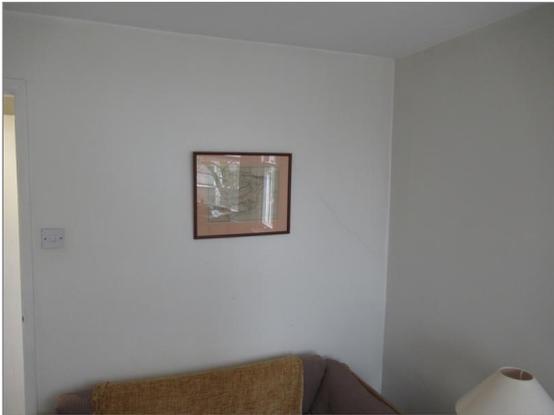
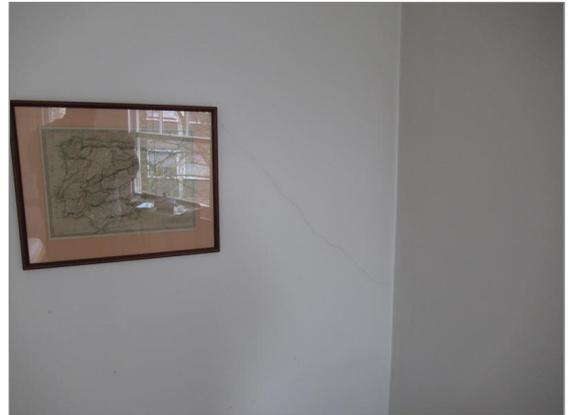
Some minor evidence of cracking was noted in the living room, to the wall that separates the living room and the kitchen (see photos below). However, no evidence was seen in the apartment of any cracking which might indicate that the property is subject to subsidence or unusual settlement.

Photo - 36 Hairline crack to wall separating living room from kitchen - pic 1

Photo - 37 Hairline crack to wall separating living room from kitchen - pic 2

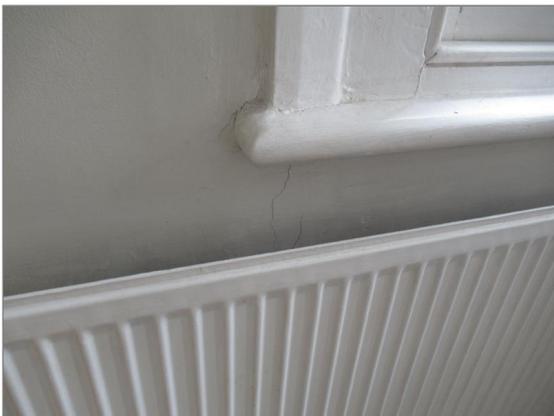
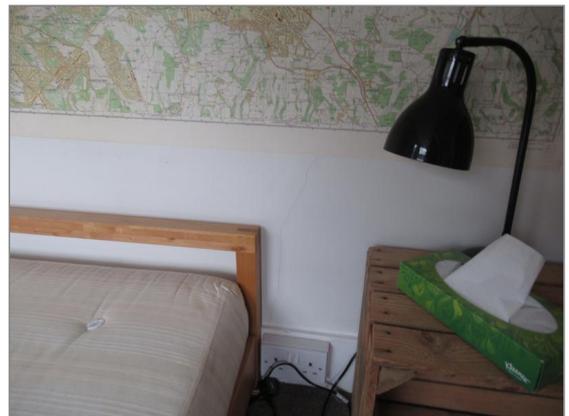
There was evidence of shrinkage cracks to the plaster board on the inside faces of external walls in the living room and kitchen. This is not of structural concern. It is caused by normal thermal and mechanical movement of the building materials and is within acceptable tolerance levels.

Photo - 38 Hairline crack to wall in living room

Photo - 39 Hairline crack to wall in living room, extends under map on wall

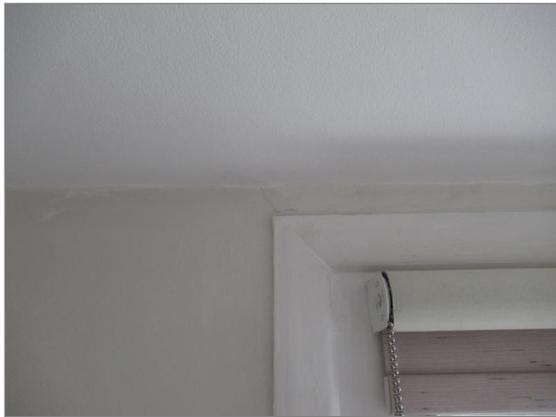
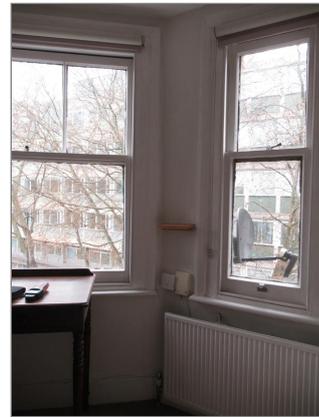
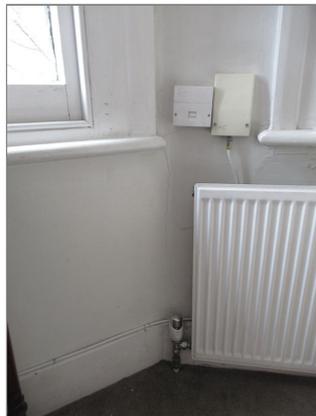
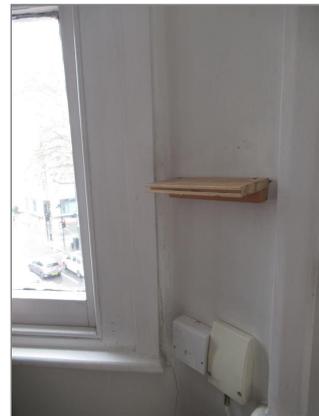
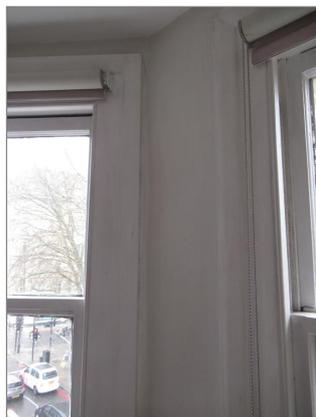
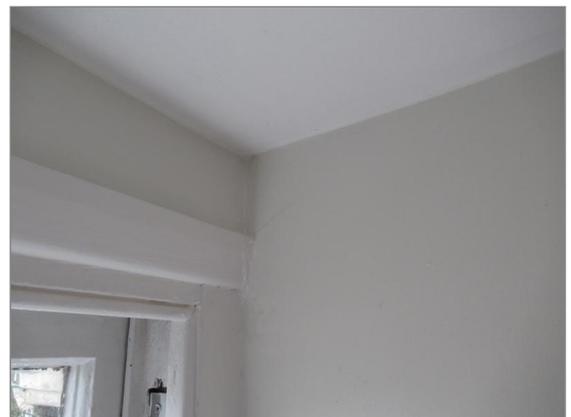
Photo - 40 Hairline crack to wall in kitchen

Photo - 41 Hairline crack to wall in corner of kitchen - pic 1

Photo - 42 Hairline crack to wall in corner of kitchen - pic 2

Photo - 43 Hairline crack to wall in corner of kitchen - pic 3

Photo - 44 Hairline crack to wall in corner of kitchen - pic 4

Photo - 45 Hairline crack to wall in kitchen

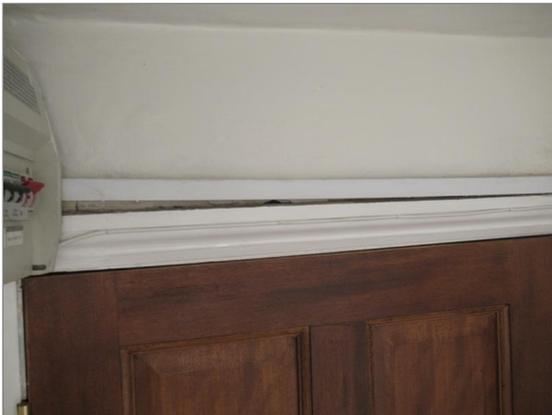
Photo - 46 Gap to wall above front door in hallway

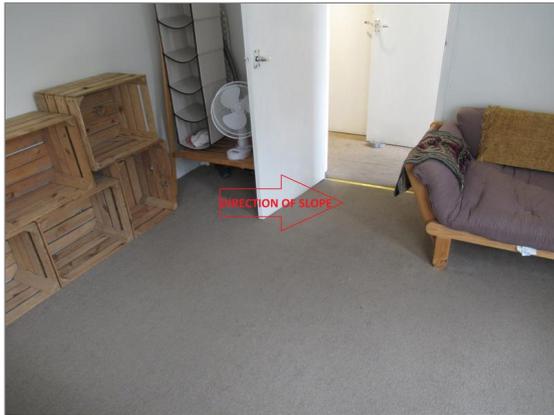
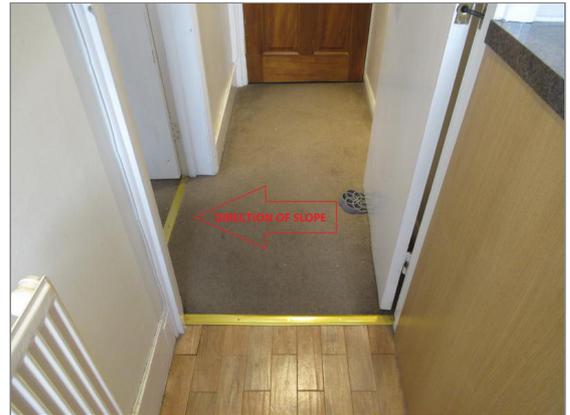
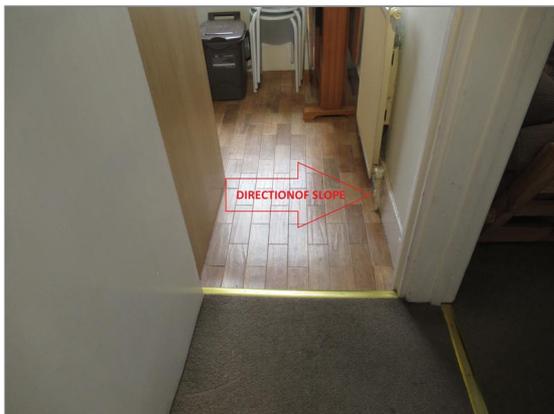
Photo - 47 Sloping timber floor - photo taken from living room

Photo - 48 Sloping timber floor - photo taken from kitchen

Photo - 49 Sloping timber floor - photo taken from hallway

Enquiries should be made with the company the manages the building, as to what plans are in place to rectify the sloping stairs in the communal area.

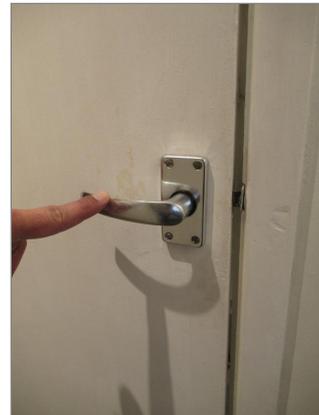
Photo - 55 Latch to bathroom door does not engage when door is closed

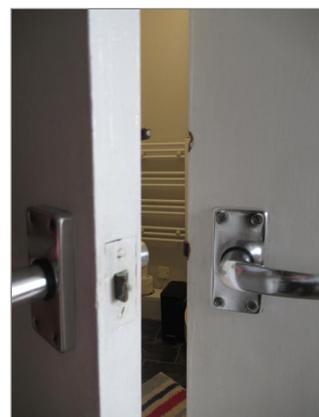
Photo - 59 Impact damage to kitchen door from bathroom door when opened

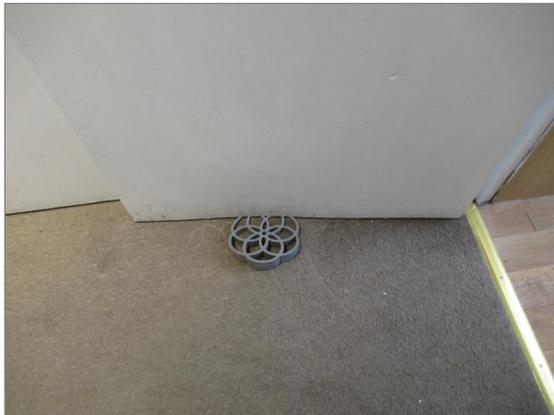
Photo - 60 Bottom of kitchen door indents when door stop inserted beneath the door

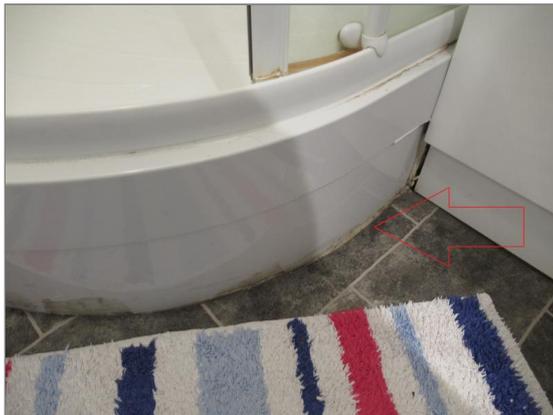
Photo - 63 Worn seal to bathroom shower tray

Regular maintenance of all seals to the shower in order to prevent water displacement.

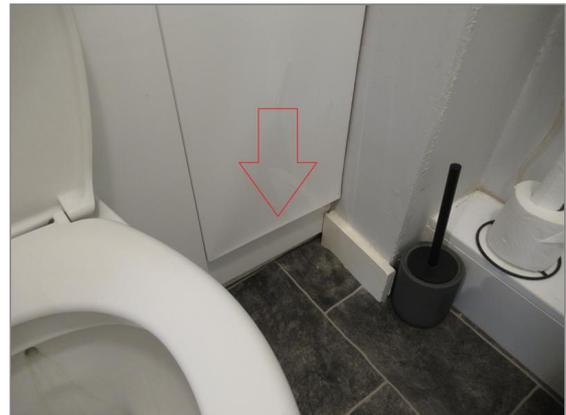
Photo - 64 Water damage to bathroom cupboard door located next to the toilet

Replace and repair bathroom units and cupboard doors as necessary.

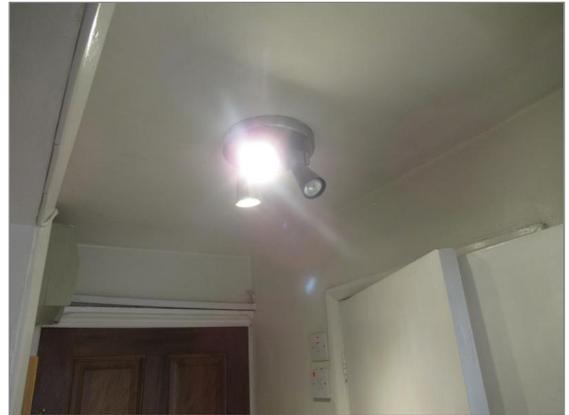
Photo - 66 Light in hallway light fitting not working

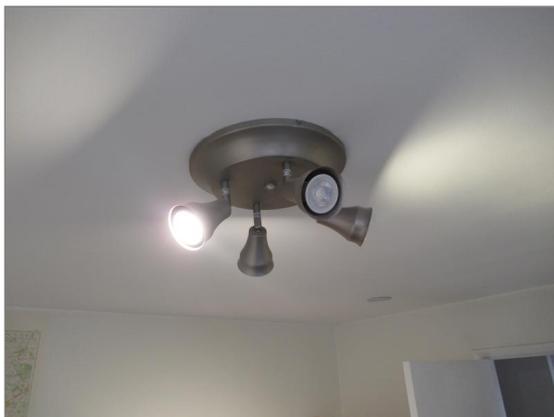
Photo - 67 Light in living room light fitting not working
