Your survey report

52 Example Avenue,
London,
W9 7DF.

12th April 2022

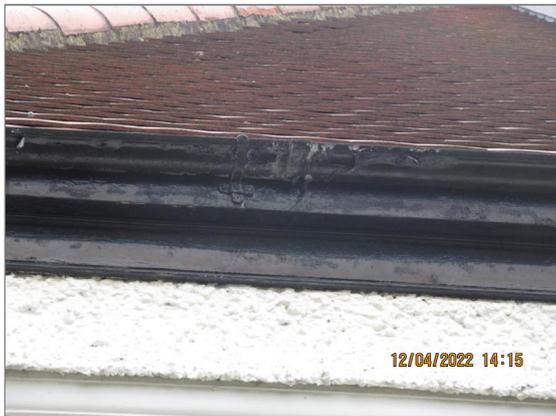
The cast iron gutters and downpipes to the property are currently in a poor condition. There is staining apparent to both the guttering and downpipes (see photos below). This is an indication that there are leaks at the joints. If not rectified this could cause damage to the external walls, leading to possible water penetration and damp to the internal faces of the walls. Prolonged leakages may also cause damage to foundations. I would recommend replacing all cast iron guttering and downpipes with uPVC rainwater fittings.

Photo - 21 Leaking joint to cast iron guttering on rear elevation

Replace cast iron guttering and downpipes with uPVC rainwater fittings to prevent water penetration to the property and possible damage to the foundations.

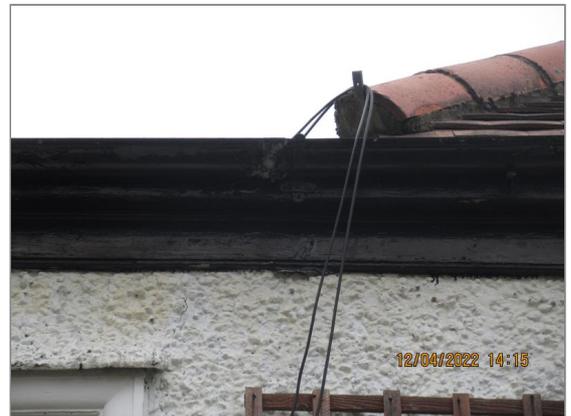
Photo - 22 Leaking joint to cast iron guttering on rear elevation

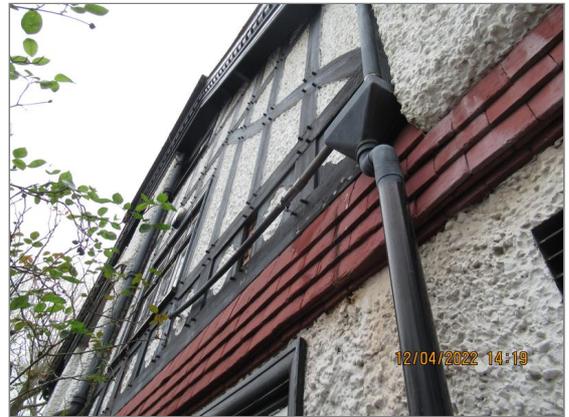
Photo - 26 Leaking joint to downpipe on side elevation

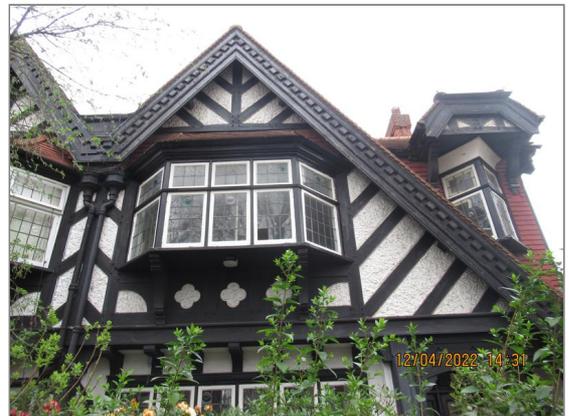
A broken fixing was noted to the wastepipe on the side elevation (see photos below).

Photo - 28 Broken fixing to wastepipe on side elevation

Replace broken fixing to the wastepipe on the side elevation.

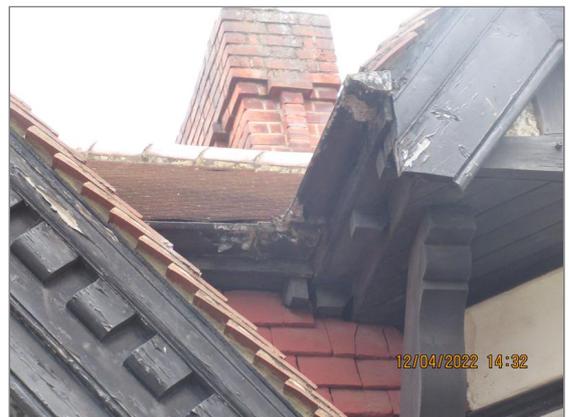
Photo - 30 Cast iron guttering to front elevation

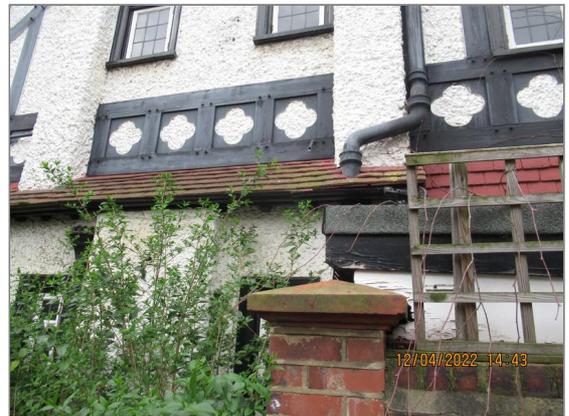
Photo - 34 Leaking joint to cast iron downpipe on front elevation

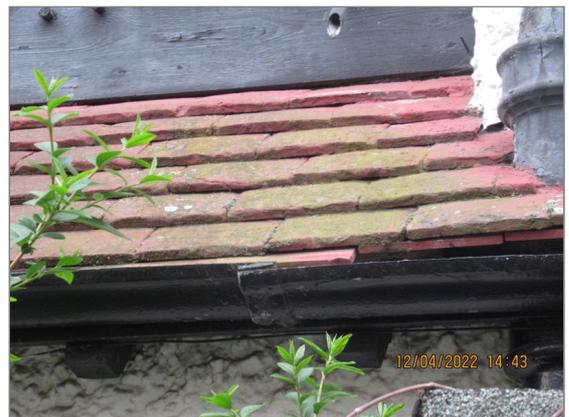
Photo - 36 Damaged guttering and missing downpipe on side elevation

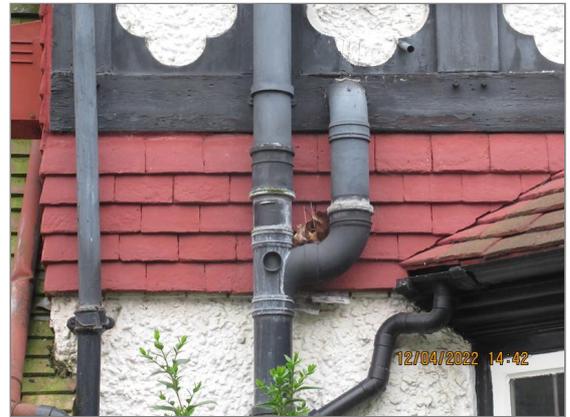
Photo - 38 uPVC soil & vent pipe to side elevation

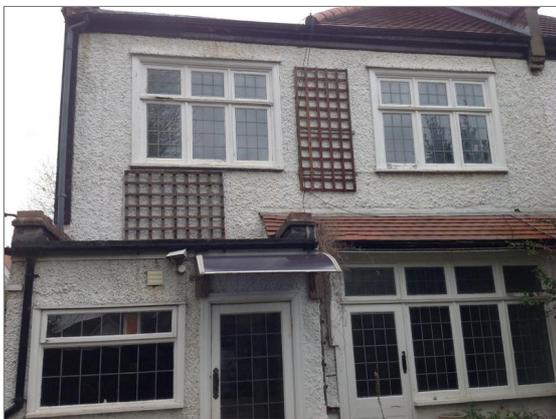
Photo - 41 Staining to rear elevation due to leaking gutters

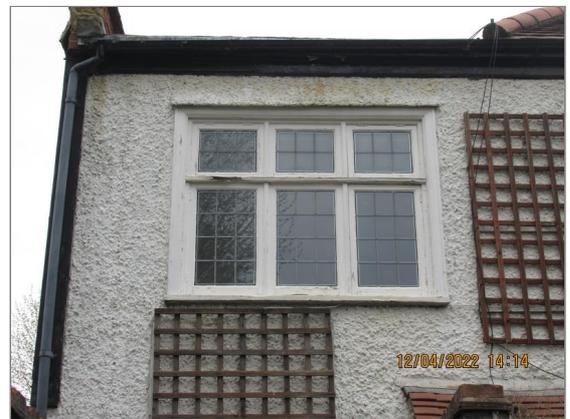
Photo - 42 Staining to rear elevation due to leaking gutters

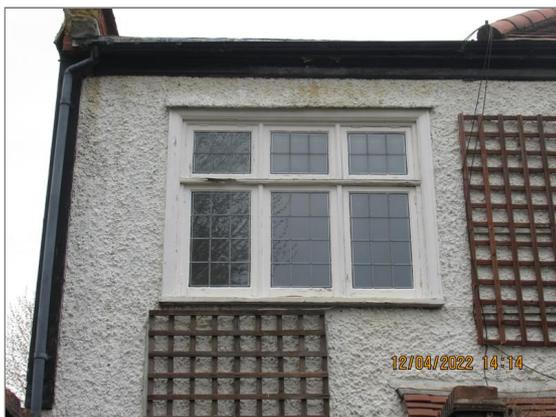
Photo - 43 Hairline cracks to lintel of rear bedroom window

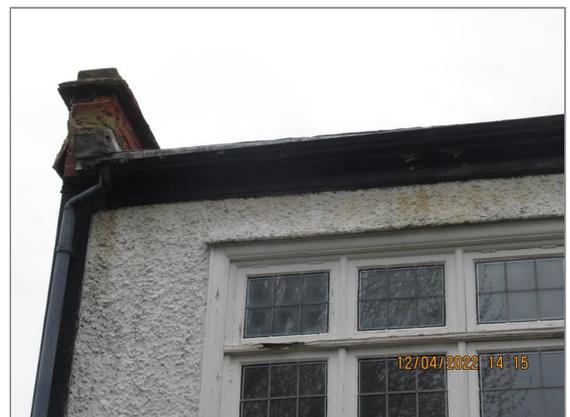
Photo - 44 Hairline crack to lintel of rear bedroom window

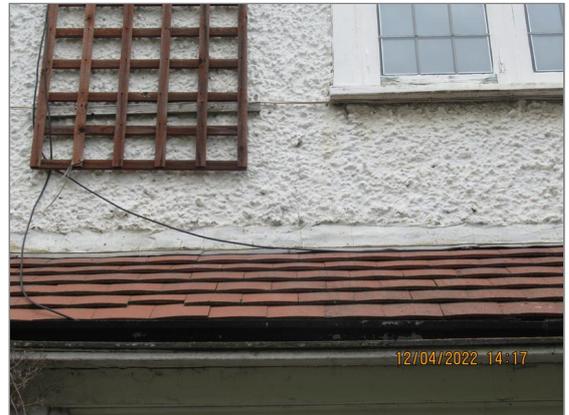
Photo - 46 Hairline cracks to render below rear bedroom window

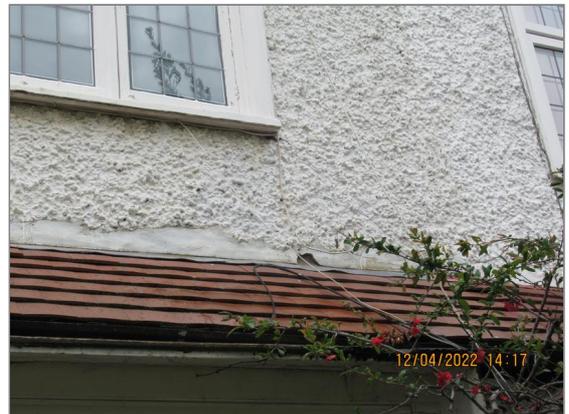
Photo - 48 Missing render below rear bedroom window

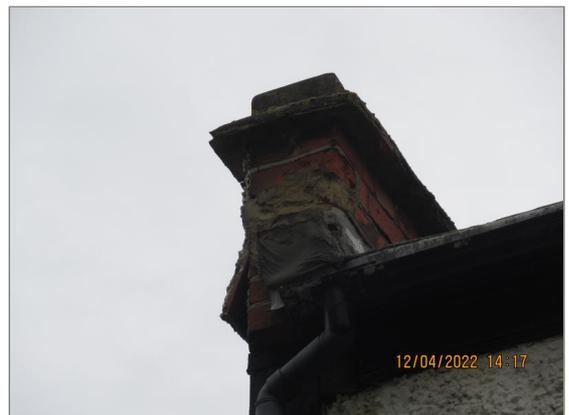
Photo - 50 Damaged brickwork to parapet wall on flat roof of 1st floor rear elevation

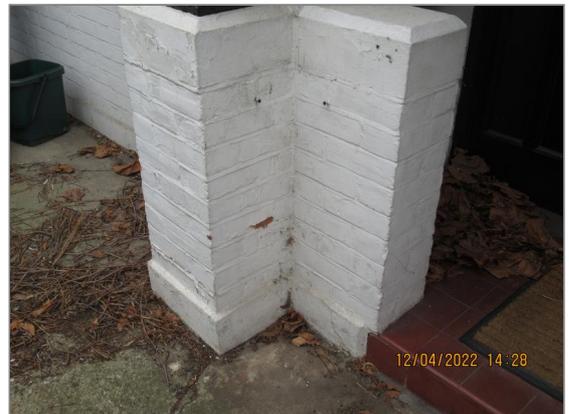
Photo - 54 Damaged/spalling brickwork next to front door entrance

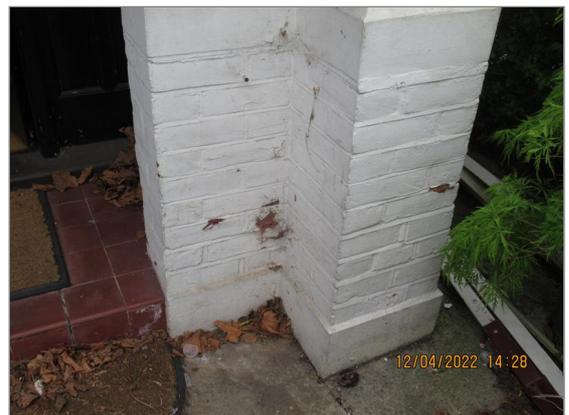
Photo - 56 Damaged/spalling brickwork next to front door entrance

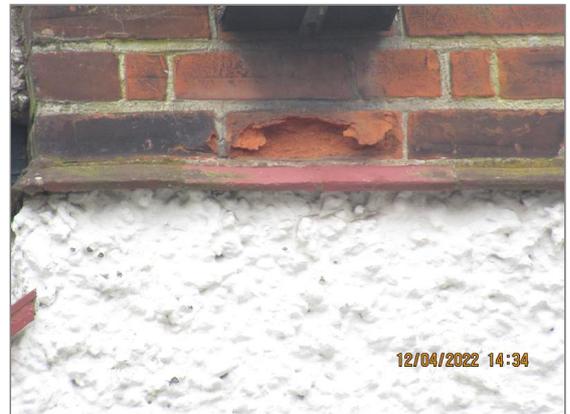
Photo - 60 Damaged/spalling brickwork below bird house on side elevation

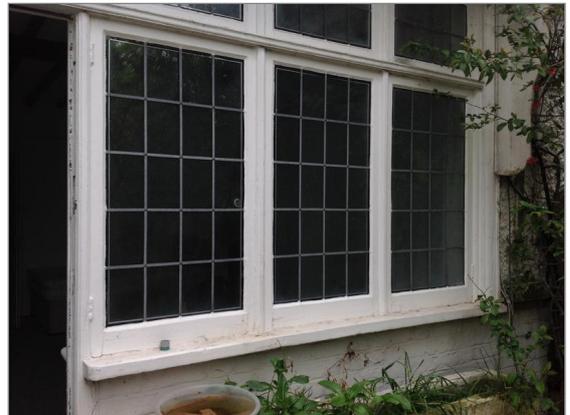
Photo - 63 Windows in an overall serviceable condition externally

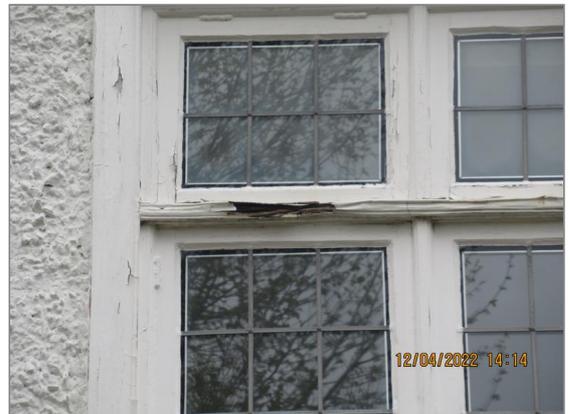
Photo - 65 Wood rot to rear bedroom window

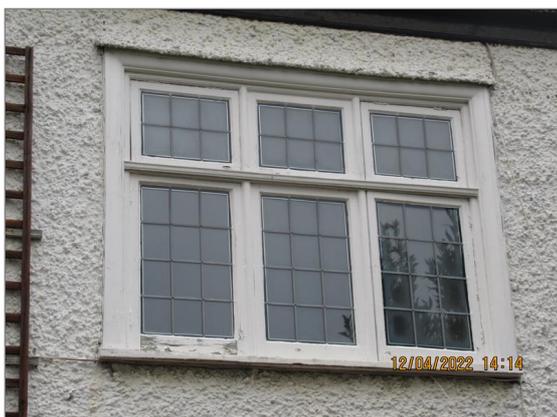
Photo - 66 Peeling paint to rear bedroom window

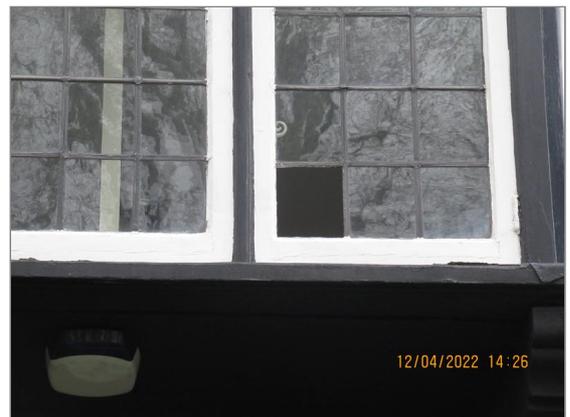
Photo - 73 Missing glass window pane to front bedroom window

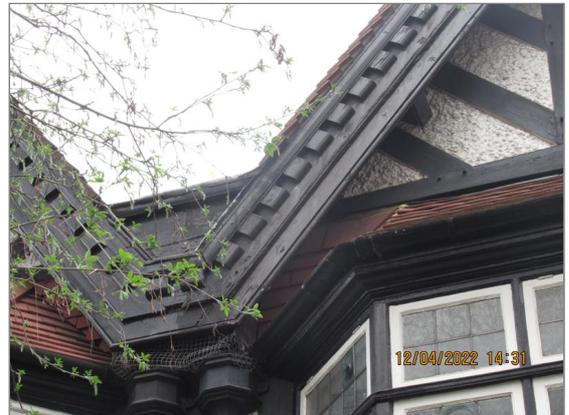
Photo - 91 Minor timber damage to bargeboard on front elevation

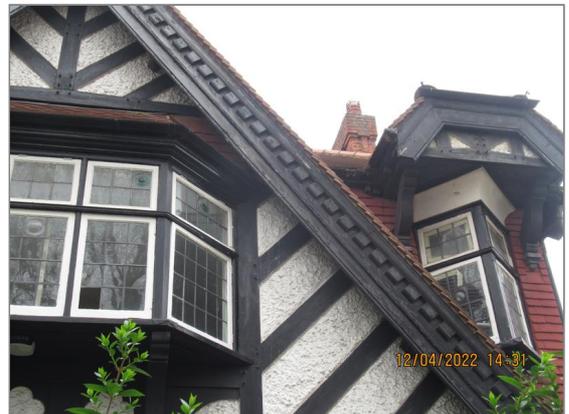
Photo - 93 Minor timber damage to bargeboard on front elevation

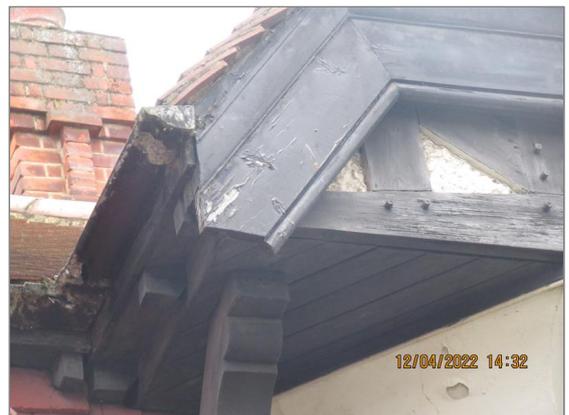
Photo - 95 Minor timber damage to bargeboard on front elevation

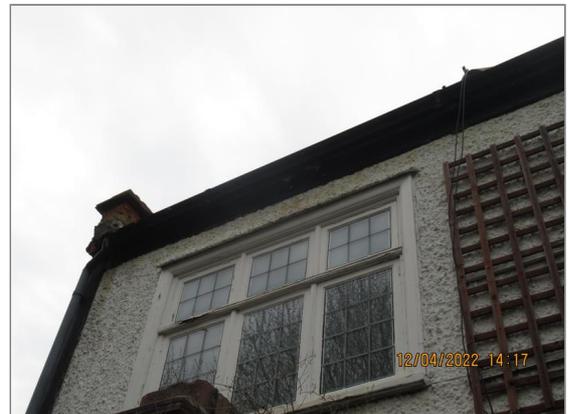
Photo - 99 Timber bargeboard to rear elevation damaged where gutters are leaking

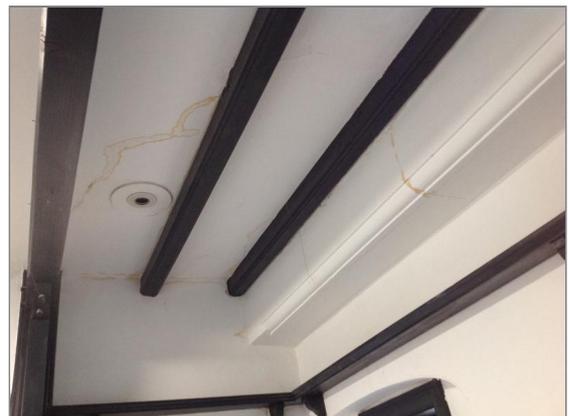
Photo - 102 Hairline cracks and staining to hallway ceiling caused by water damage

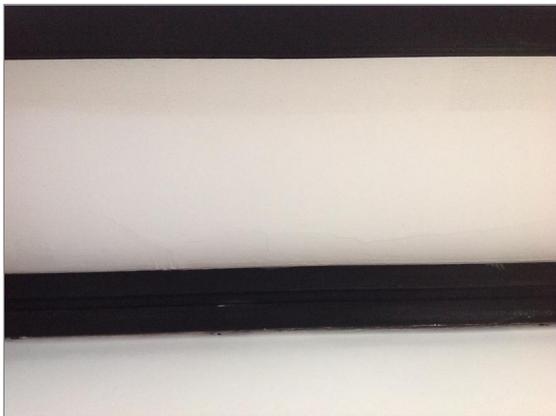
Photo - 105 Hairline cracks to hallway ceiling

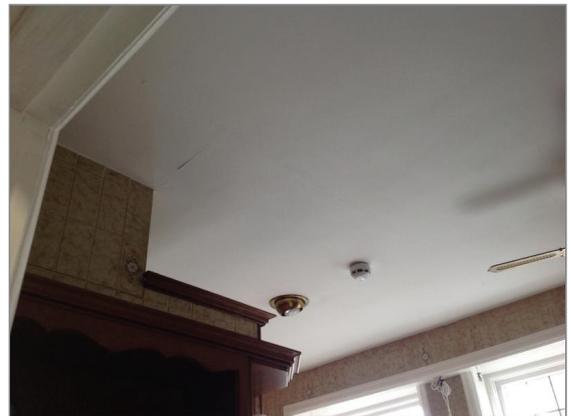
Photo - 106 Hairline cracking to joints of plasterboard of kitchen ceiling

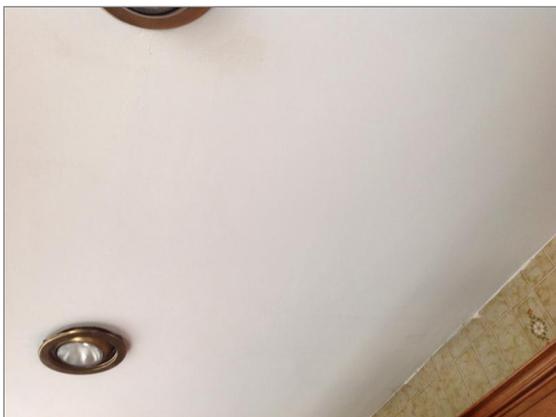
Photo - 107 Hairline cracking to joints of plasterboard of kitchen ceiling

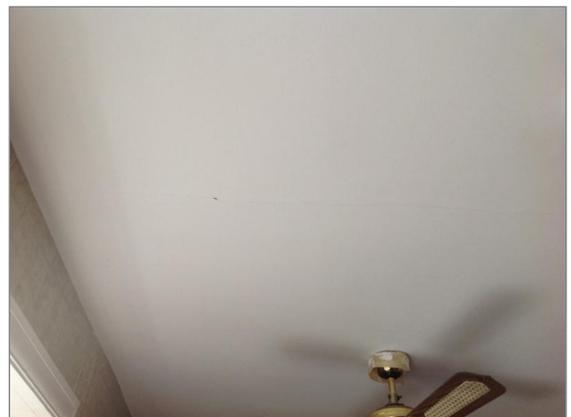
Photo - 108 Hairline cracking to joints of plasterboard of kitchen ceiling

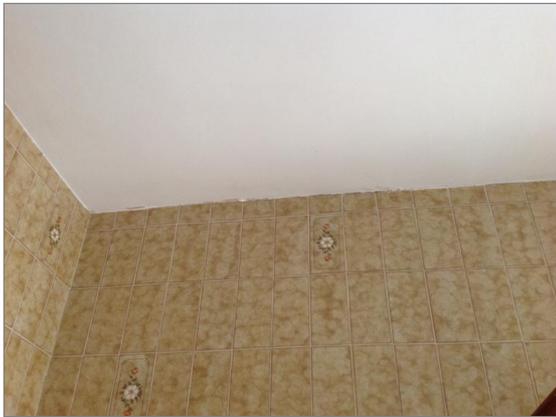
Photo - 109 Perimeter cracking to kitchen ceiling

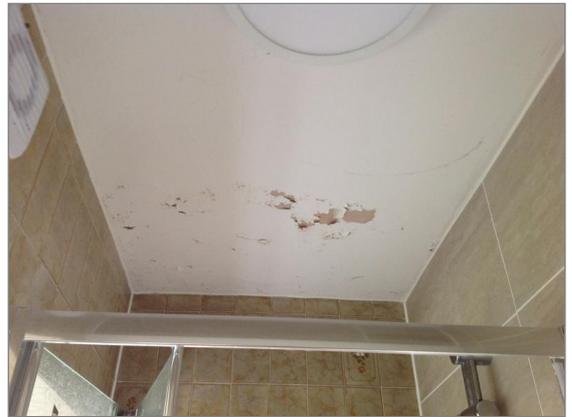
Photo - 110 Water damage to downstairs shower room ceiling

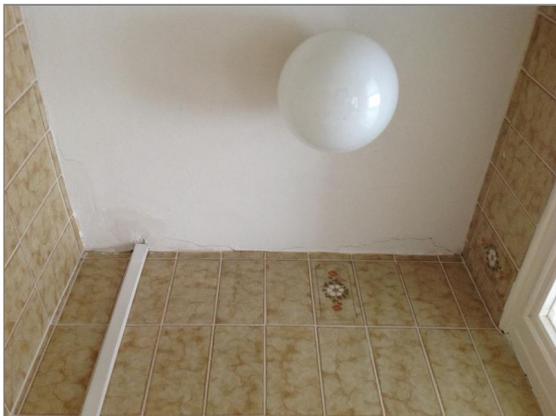
Photo - 111 Perimeter cracking to downstairs toilet ceiling

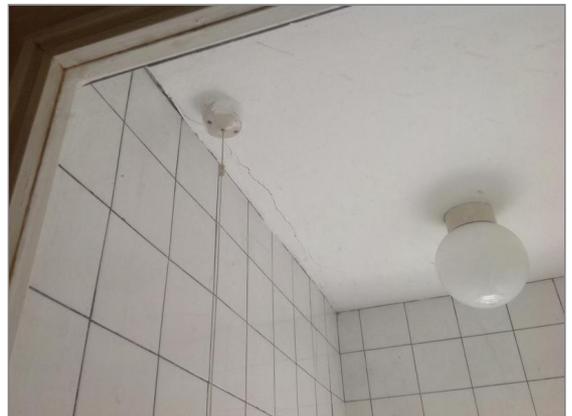
Photo - 112 Perimeter cracking to downstairs toilet ceiling

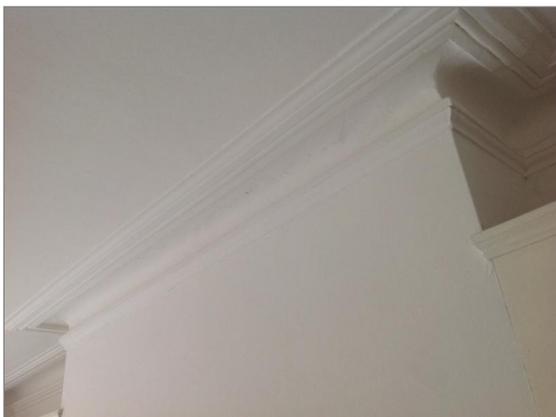
Photo - 113 Cracking to Cornice of living room ceiling

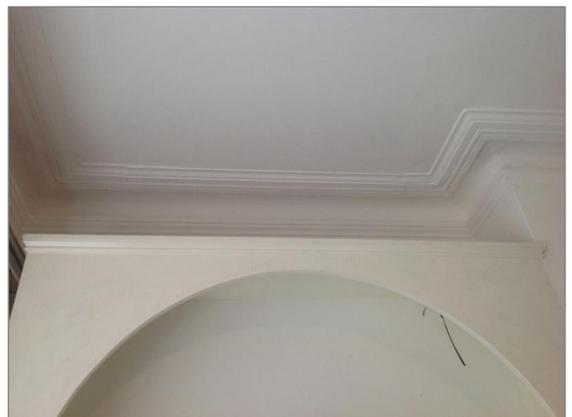
Photo - 114 Cracking to Cornice of living room ceiling

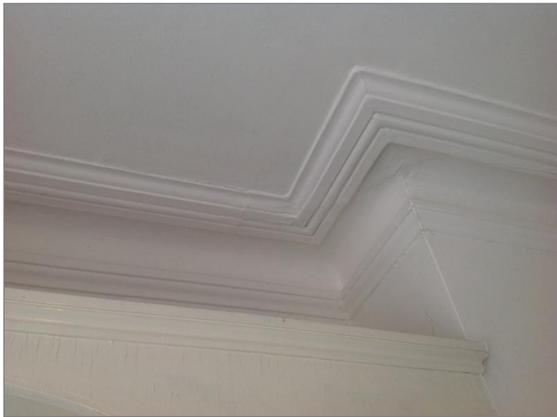
Photo - 115 Cracking to Cornice of living room ceiling

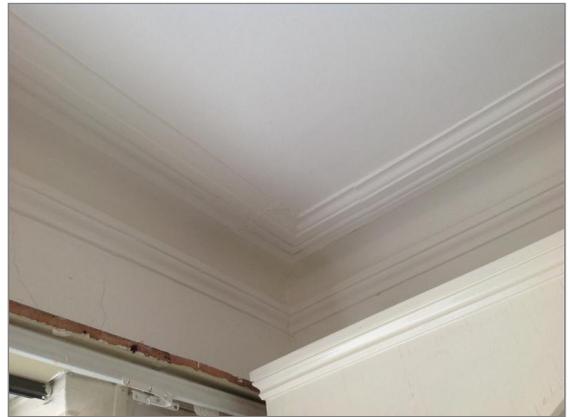
Photo - 116 Cracking to Cornice of living room ceiling

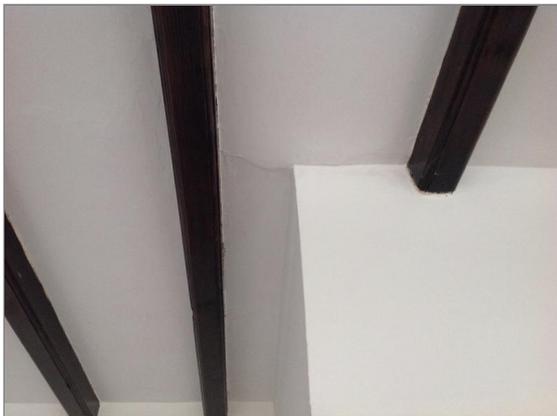
Photo - 117 Hairline crack to reception room ceiling

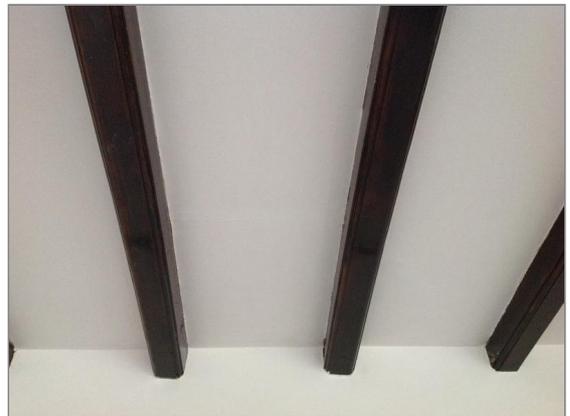
Photo - 118 Hairline crack to reception room ceiling

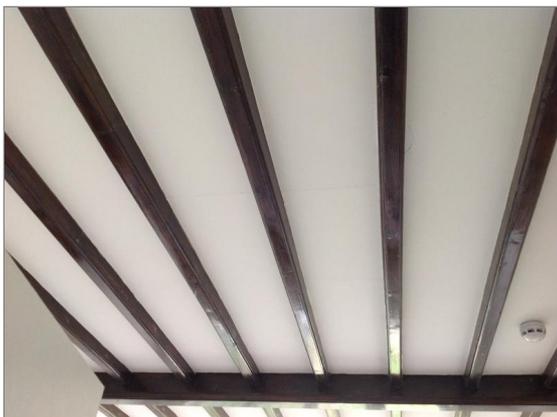
Photo - 119 Hairline crack to reception room ceiling

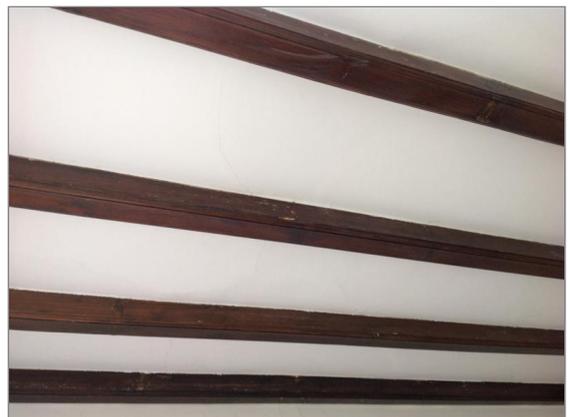
Photo - 120 Hairline crack to reception room ceiling

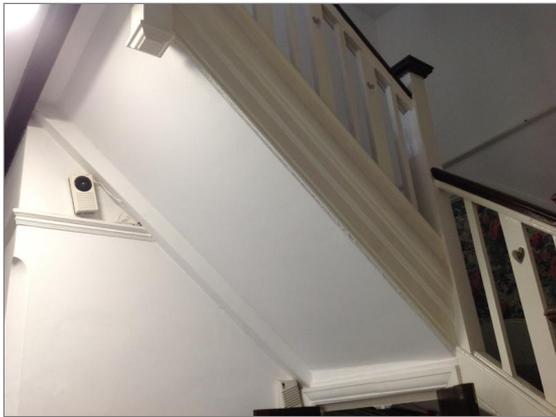
Photo - 121 Hairline crack to ceiling/underside of stairs on first floor

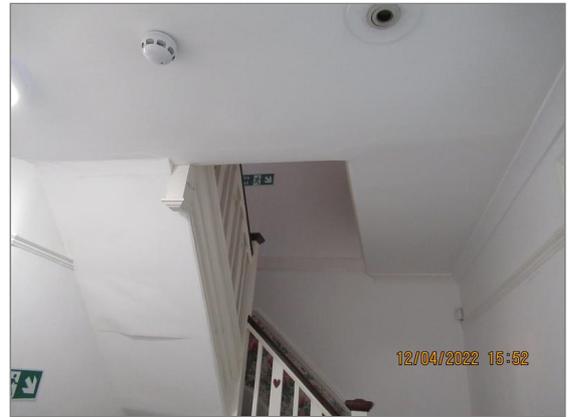
Photo - 122 Hairline crack to ceiling on first floor landing

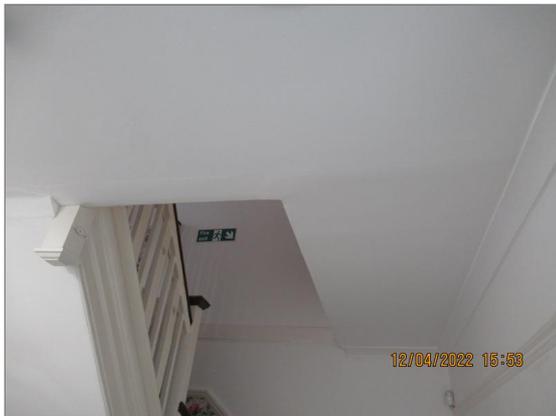
Photo - 123 Hairline crack to ceiling on first floor landing

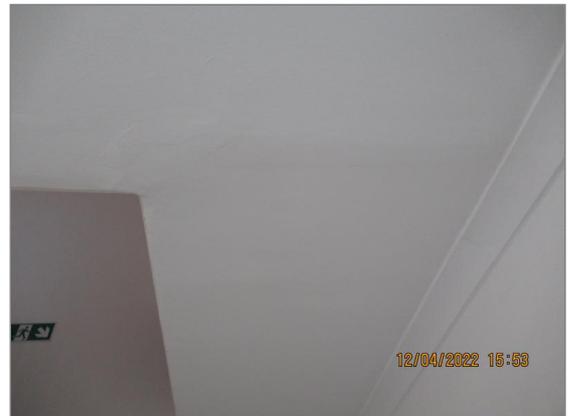
Photo - 124 Hairline crack to ceiling on first floor landing

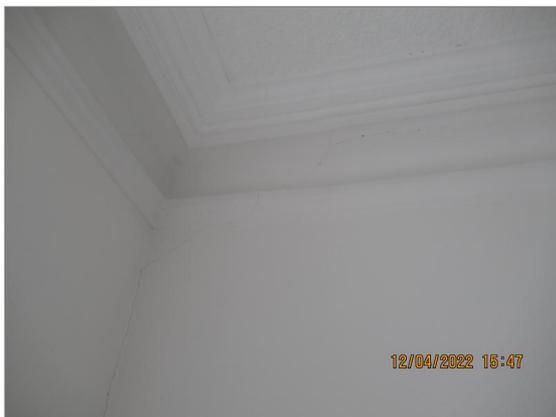
Photo - 125 Hairline cracking to cornice of 1st floor front bedroom

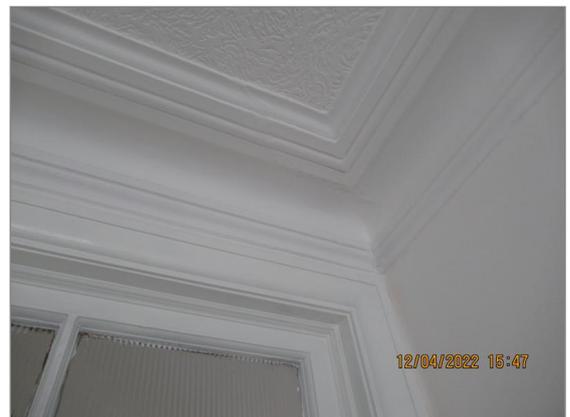
Photo - 126 Hairline cracking to cornice of 1st floor rear bedroom

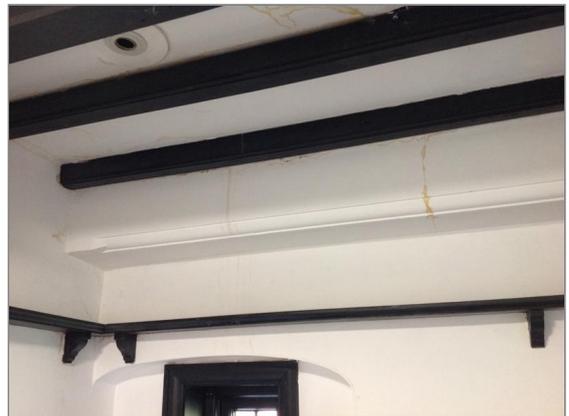
Photo - 131 Cracks to wall in hallway

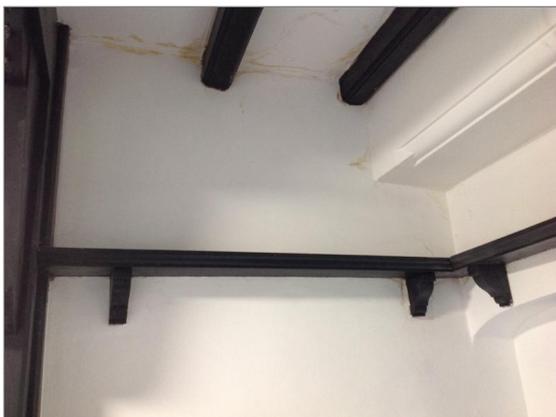
Photo - 132 Cracks to wall in hallway

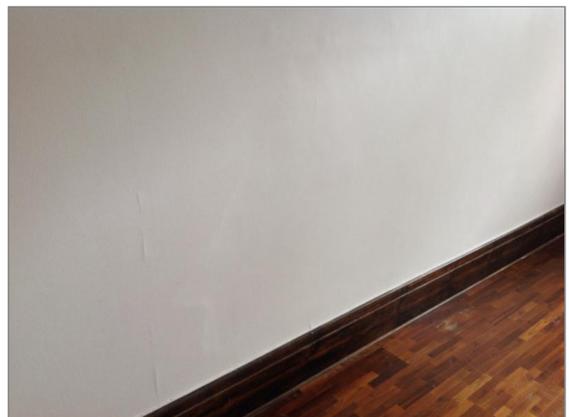
Photo - 133 Undulations to lath & plaster wall in front reception room

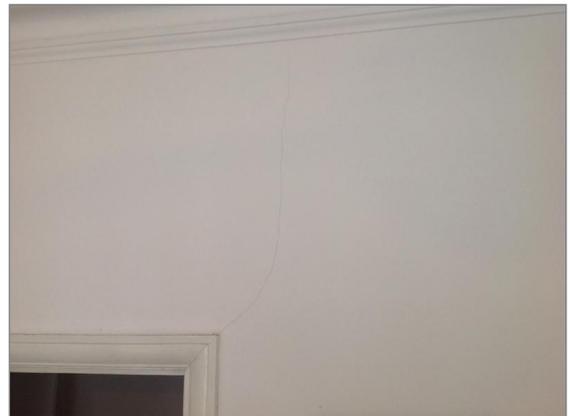
Photo - 137 Minor cracking to wall at corner of door frame in 1st floor bedroom

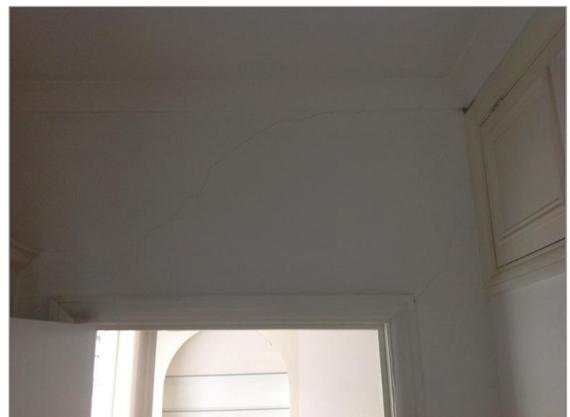
Photo - 139 Minor cracking to wall at corner of door frame in 1st floor bedroom

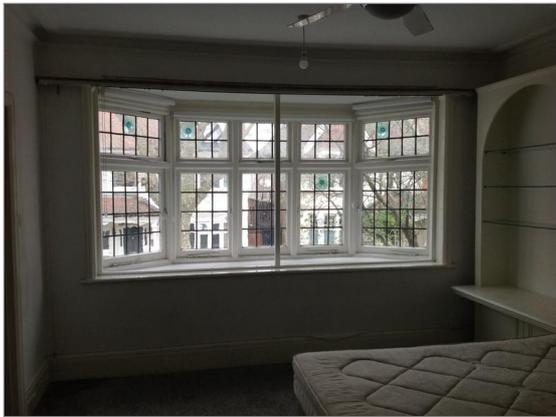
Photo - 140 Minor cracking to wall at corner of window frame in 1st floor front bedroom

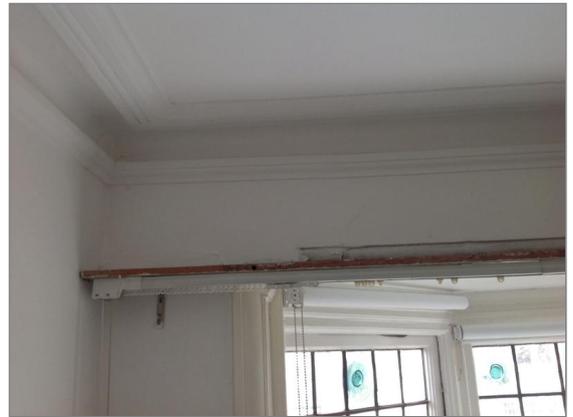
Photo - 141 Minor cracking to wall at corner of window frame in 1st floor front bedroom

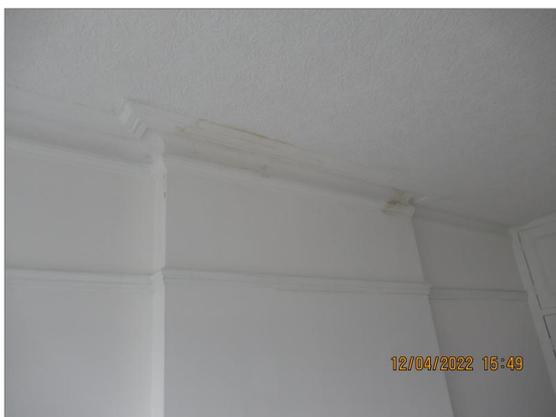
Photo - 144 Water damage to side wall in small rear bedroom

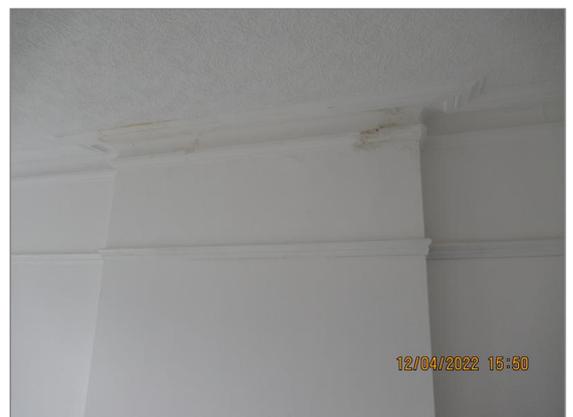
Photo - 145 Water damage to side wall in small rear bedroom

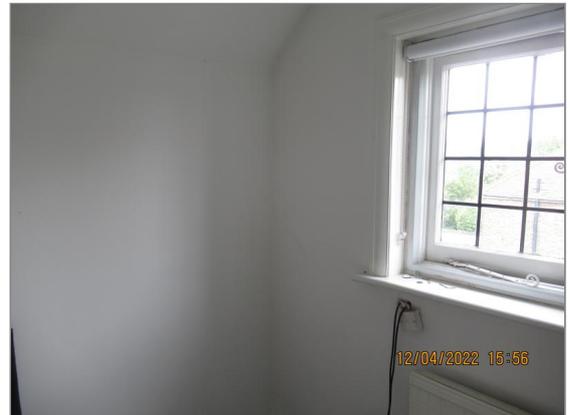
Photo - 147 Minor superficial cracking to wall in 2nd floor bedroom

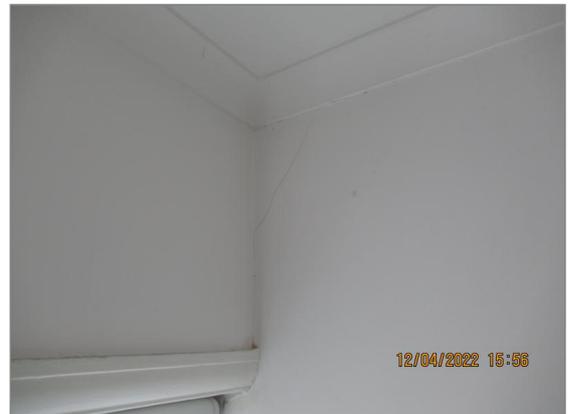
Photo - 149 Minor superficial cracking to wall in 2nd floor bedroom

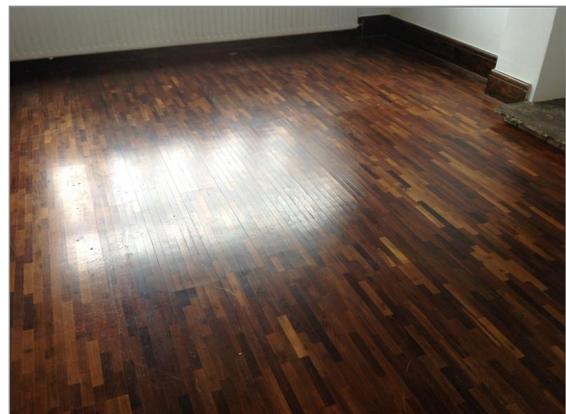
Photo - 153 Suspended timber ground floor in serviceable condition

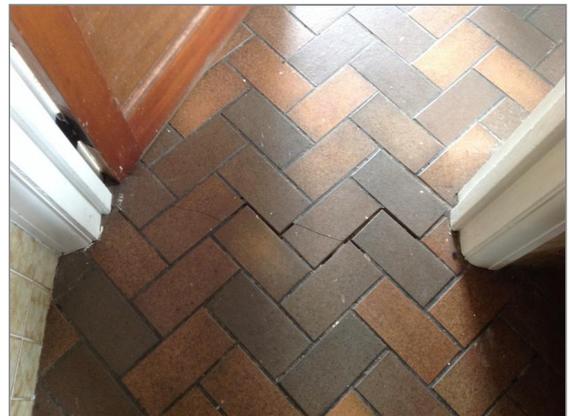
Photo - 159 Cracks to clay brick sets in kitchen floor

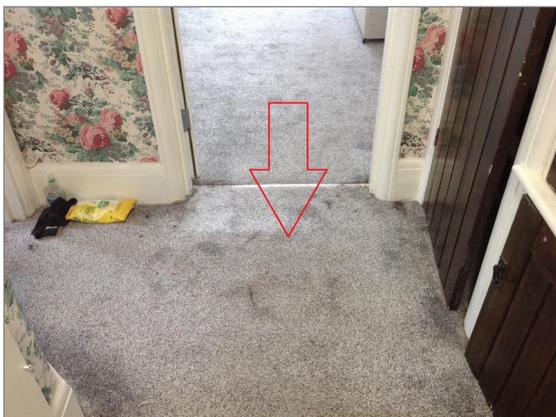
Photo - 160 Dip to suspended timber floor located at door to the front bedroom

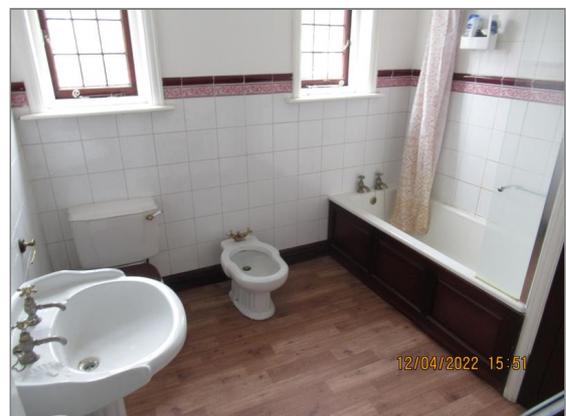
Photo - 172 Main bathroom on 1st floor

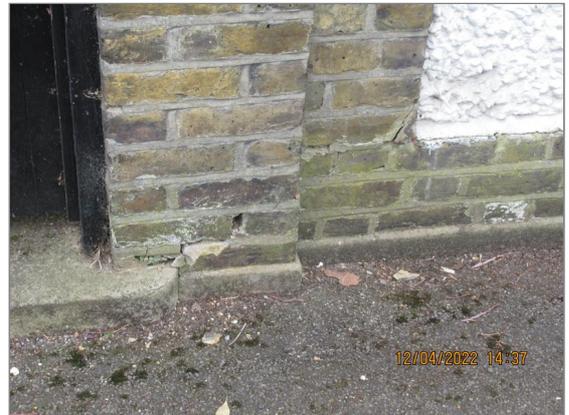
Photo - 192 Cracks apparent to base of wall where movement has occurred

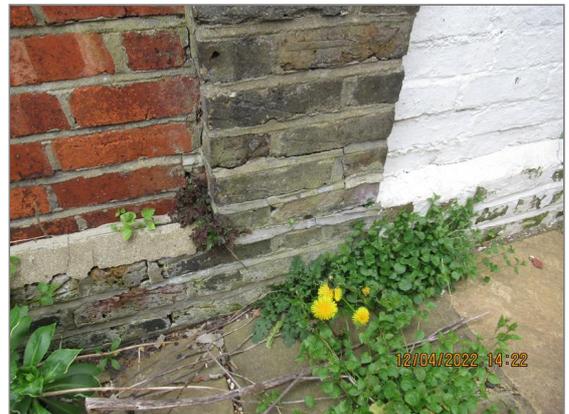
Photo - 194 Cracks apparent to base of wall where movement has occurred

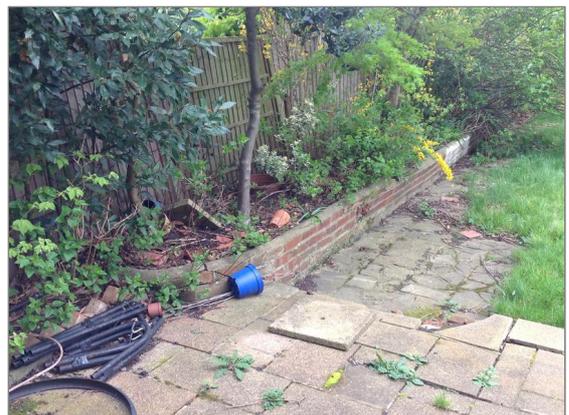
Photo - 196 Cracks noted to brick wall of planter located next to the garden fence

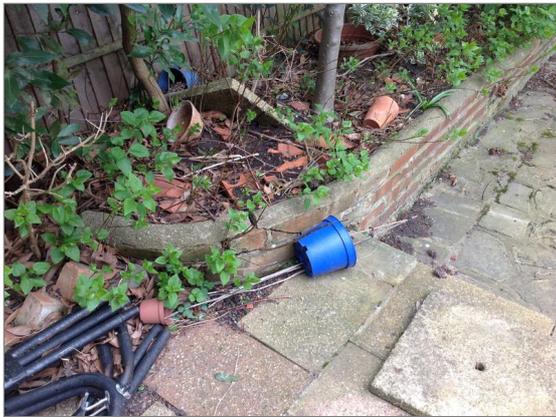
Photo - 197 Cracks noted to brick wall of planter located next to the garden fence

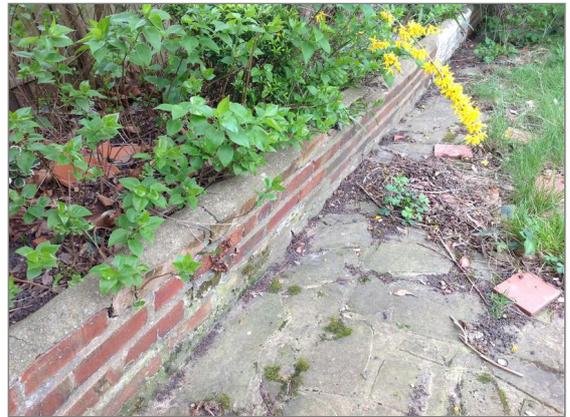
Photo - 198 Cracks noted to brick wall of planter located next to the garden fence

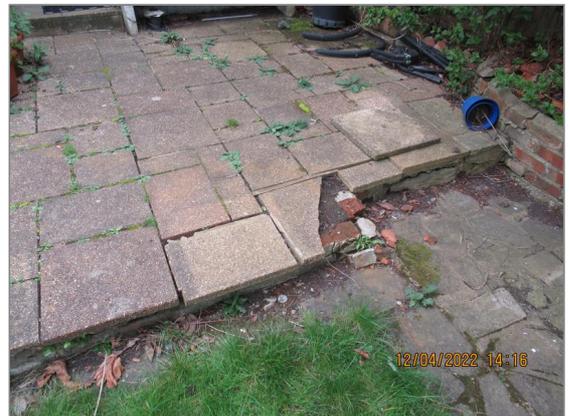
Photo - 200 Section of paving located by back door is in poor condition
