Snagging List

123 Forever Street
London
N12 8AB

4th July 2024

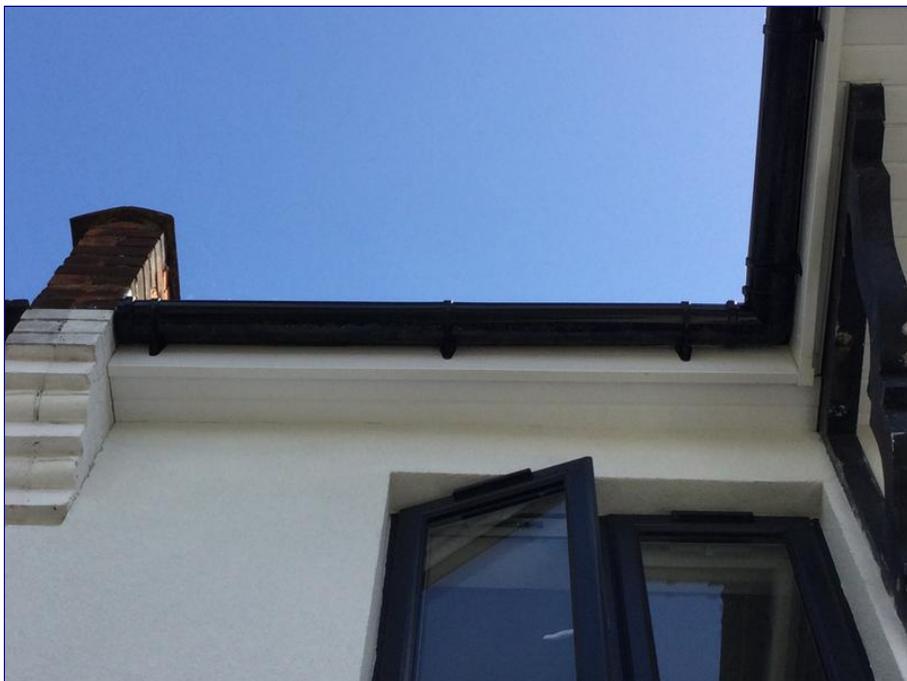
Photo 1

Item	Location	Description	Date Raised	Comments	Defect Owner	Action by Defect Owner Initial	Checked Date	Checked by Initial
1.1	External							
1.1.1	Gutters	Dirt marks to the UPVC gutters above front porch	04-07-2024	Dirt marks to the UPVC gutters above front porch Photo [1]

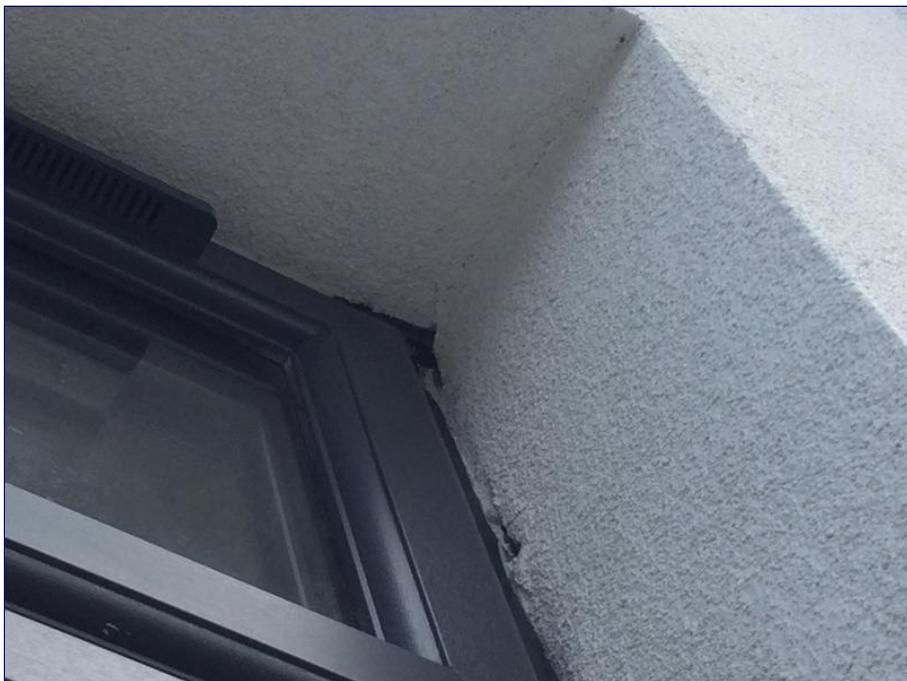
Photo 3

1.1.10	Gutters	Bowing soffit	04-07-2024	Bowing soffit Photo [126]				
1.1.11	Walls	A hairline crack running down the external rendered wall	04-07-2024	A hairline crack running down the external rendered wall Photo [3]

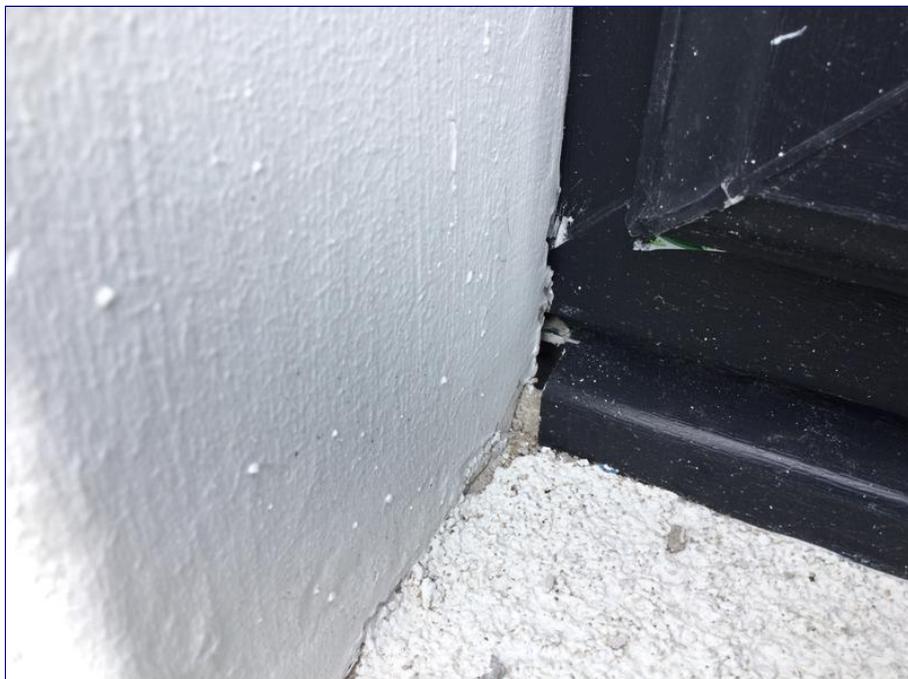
Photo 7

Item	Location	Description	Date Raised	Comments	Defect Owner	Action by Defect Owner Initial	Checked Date	Checked by Initial
1.1.15	Walls	Void between external wall and left bay window	04-07-2024	Void between external wall and left bay window Photo [7]

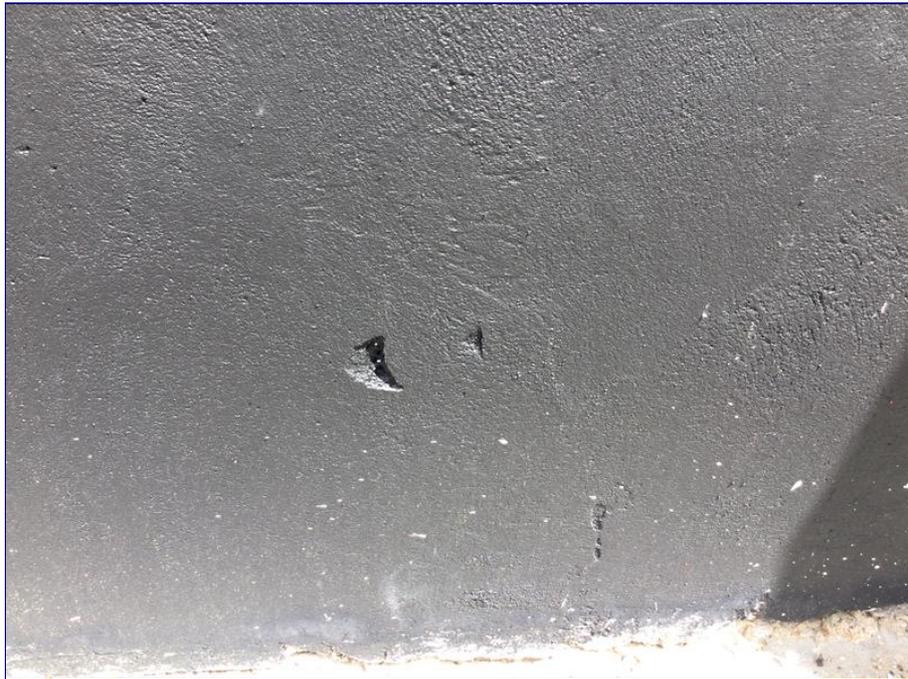
Photo 12

1.1.20	Walls	Void between external wall and right central bay window	04-07-2024	Void between external wall and right central bay window Photo [12]				
1.1.21	Walls	Impact damage was noted to the front elevation wall	04-07-2024	Impact damage was noted to the front elevation wall Photo [13]

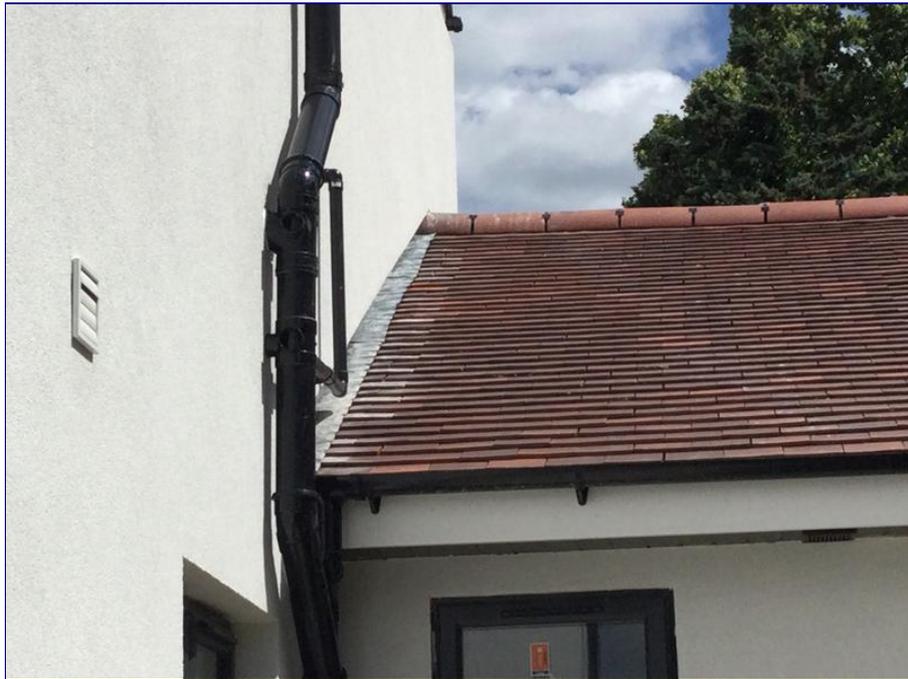
Photo 20

1.1.24	Walls	Incomplete render was noted to the front elevation below the rendered wall	04-07-2024	Incomplete render was noted to the front elevation below the rendered wall Photo [20]

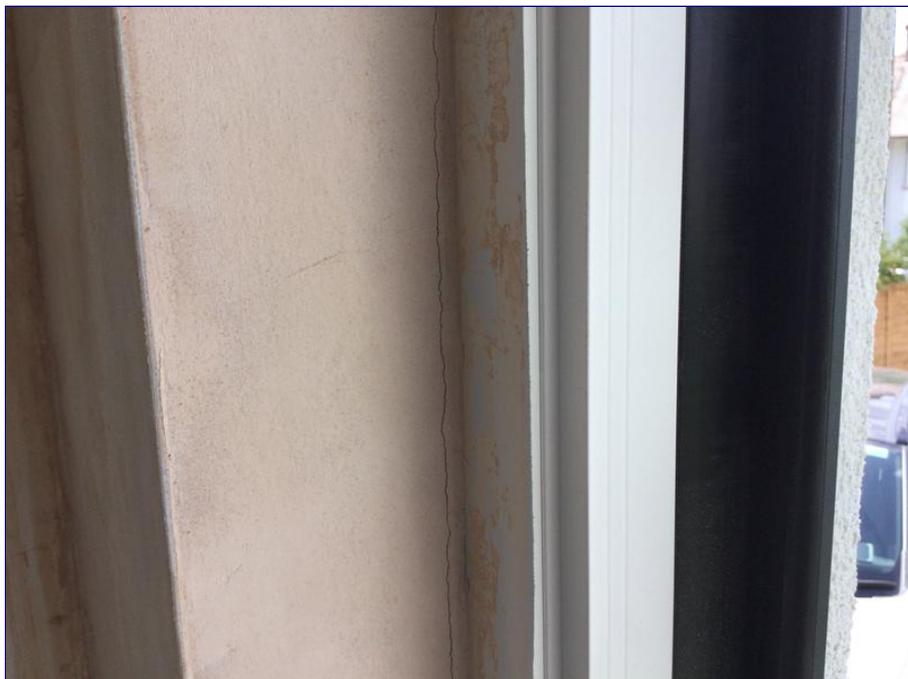
Photo 27

1.1.25	Walls	Incomplete render was noted to the wall of the front door	04-07-2024	Incomplete render was noted to the wall of the front door Photo [27]

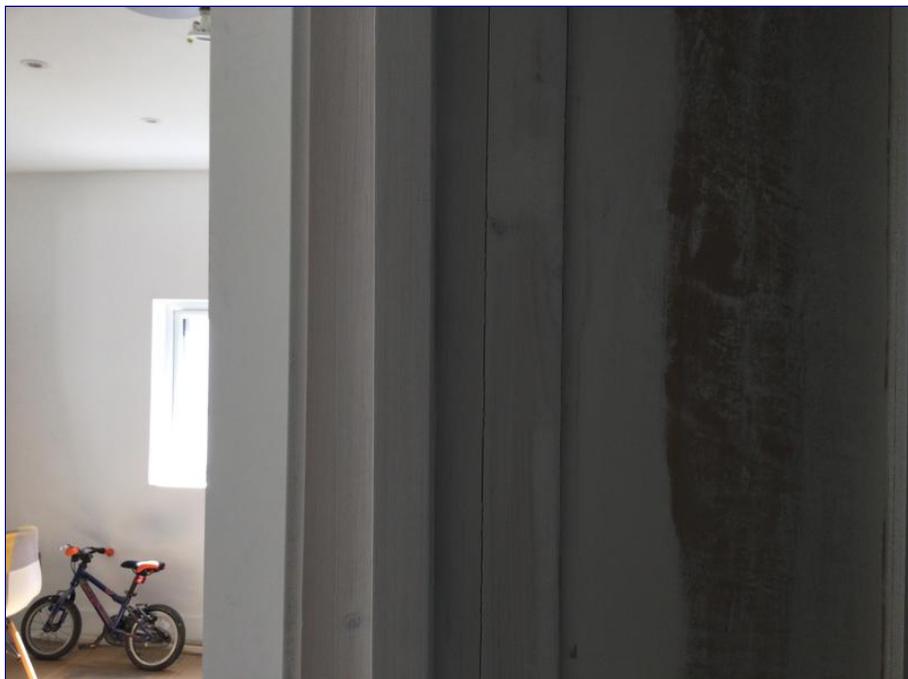
Photo 35

1.3.16	Bedroom five	Crack to skirting board in the bedroom.	04-07-2024	Crack to skirting board in the bedroom. Photo [182]				
1.4	Ceiling							
1.4.1	Hallway	Incomplete decorations to the ceiling in the hallway	04-07-2024	Incomplete decorations to the ceiling in the hallway Photo [35]

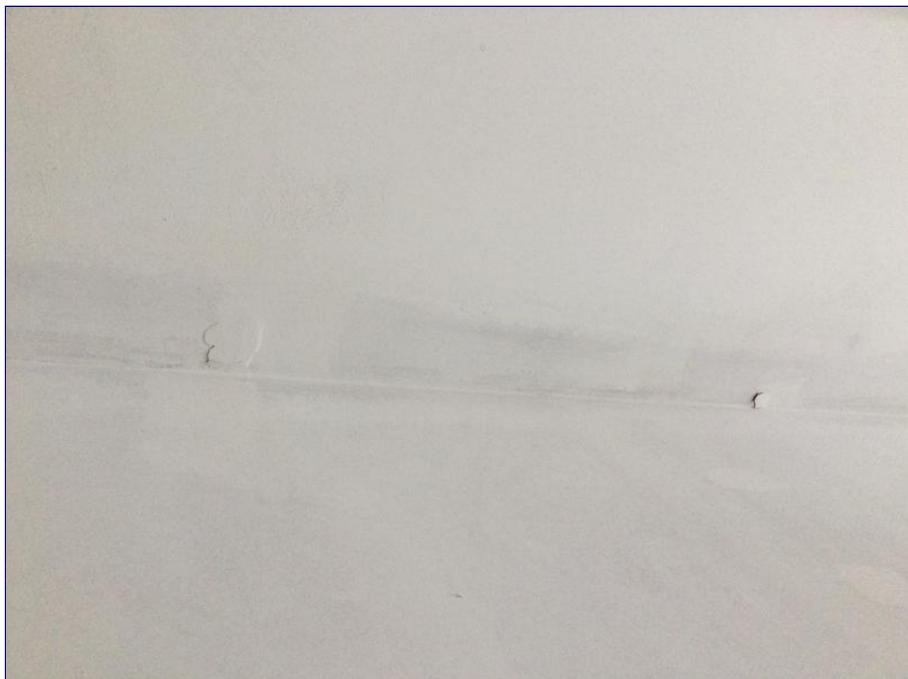
Photo 39

1.2.6	Hallway	Shrinkage crack was noted to the wall in the hallway	04-07-2024	Shrinkage crack was noted to the wall in the hallway Photo [39]

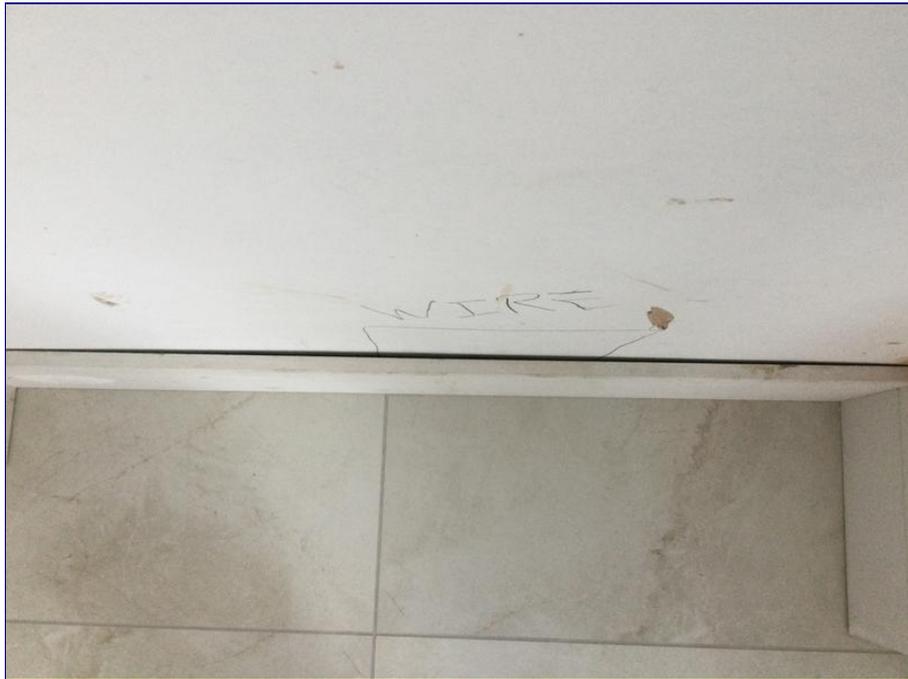
Photo 42

Item	Location	Description	Date Raised	Comments	Defect Owner	Action by Defect Owner Initial	Checked Date	Checked by Initial
1.2.7	Hallway	Hairline crack was noted to the wall below the stairs	04-07-2024	Hairline crack was noted to the wall below the stairs Photo [42]

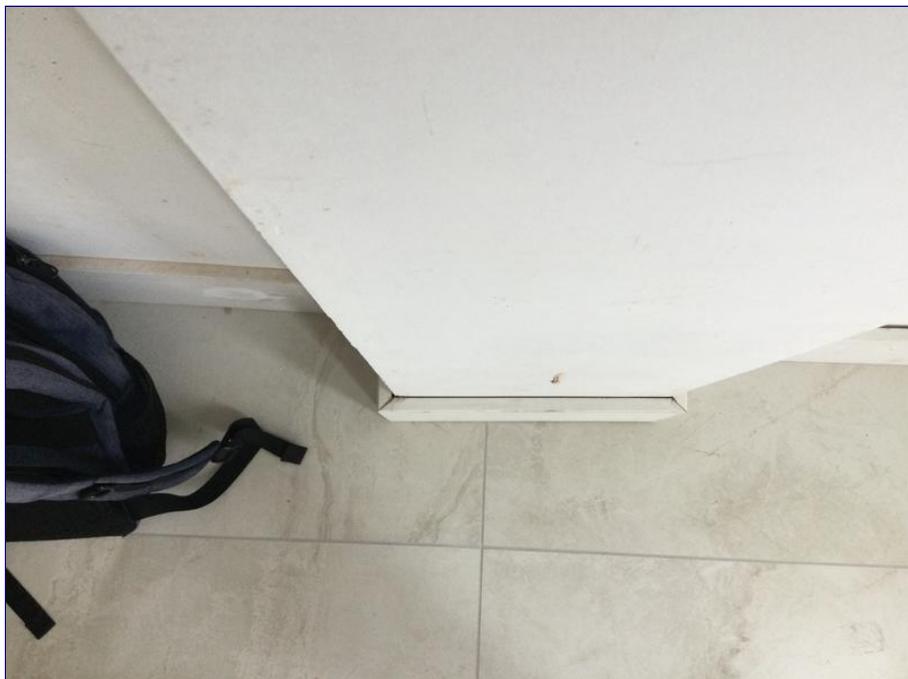
Photo 43

1.3.4	Hallway	Gaps were noted between the skirting and the wall in the hallway	04-07-2024	Gaps were noted between the skirting and the wall in the hallway Photo [43]

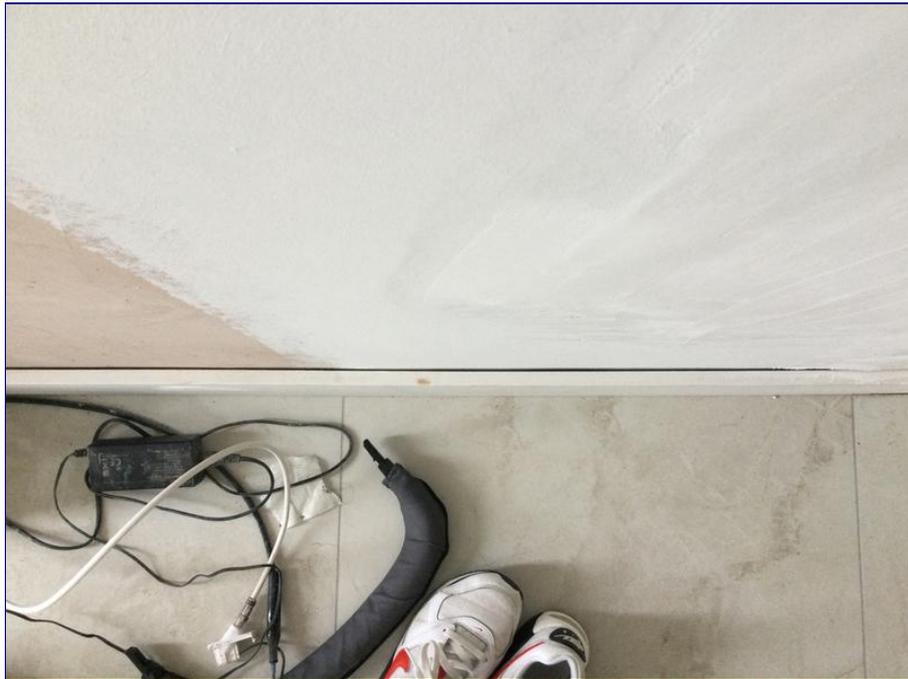
Photo 46

1.3.7	Hallway	Gaps were noted between the skirting and the wall in the hallway	04-07-2024	Gaps were noted between the skirting and the wall in the hallway Photo [46]

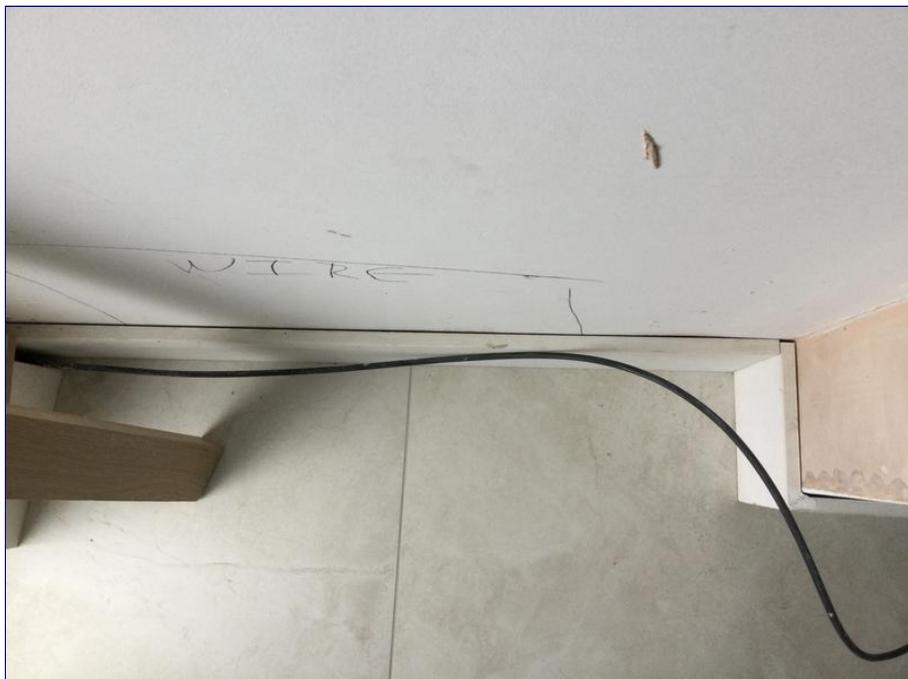
Photo 47

1.3.8	Hallway	Gaps were noted between the skirting and the wall in the hallway	04-07-2024	Gaps were noted between the skirting and the wall in the hallway Photo [47]

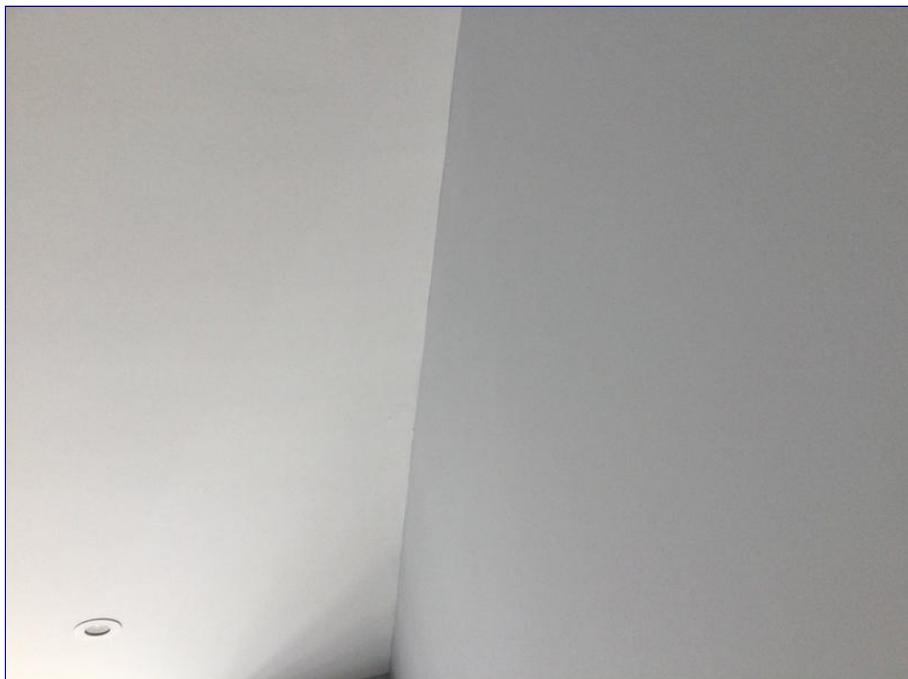
Photo 59

1.2.8	Hallway	Damage was noted to the wall in the hallway	04-07-2024	Damage was noted to the wall in the hallway Photo [52]				
1.2.9	Hallway	Hairline crack was noted to the wall running up the stairwell approximately 4 meters.	04-07-2024	Hairline crack was noted to the wall running up the stairwell approximately 4 meters. Photo [59]

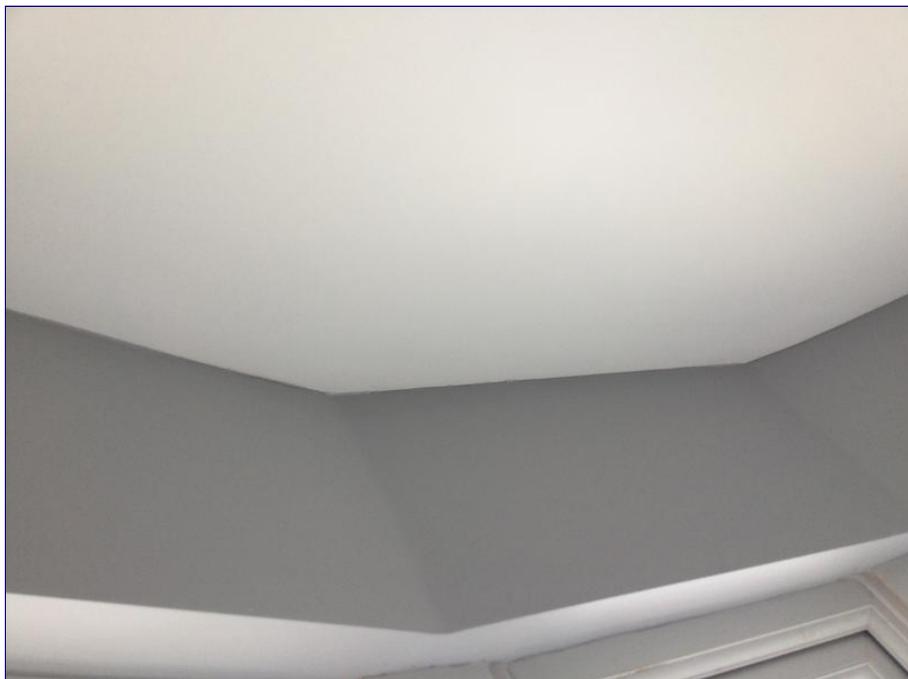
Photo 61

1.4.7	Sitting room	Patchy finish was noted to the ceiling in the sitting room	04-07-2024	Patchy finish was noted to the ceiling in the sitting room Photo [61]

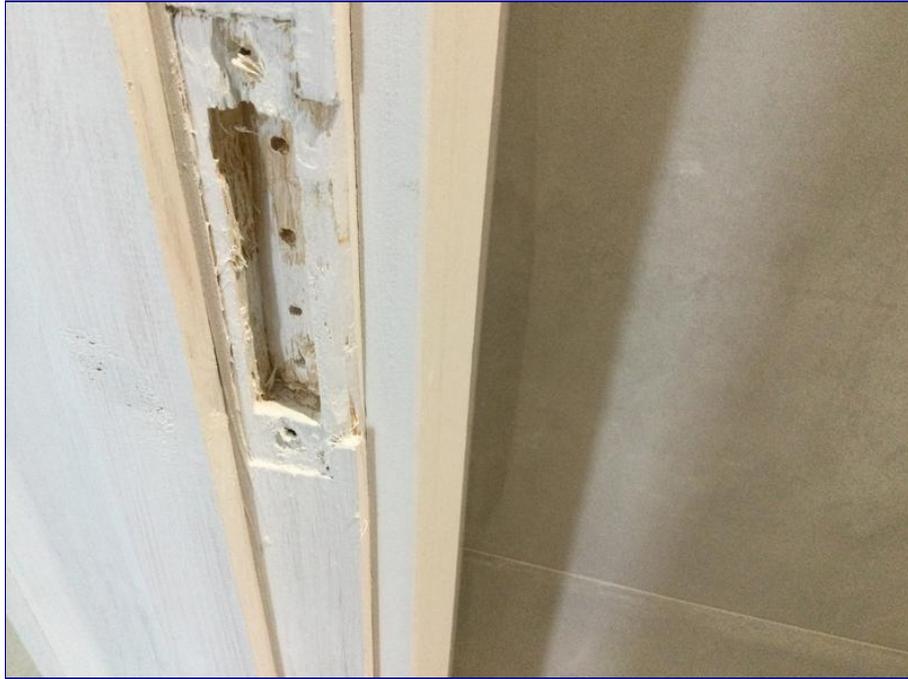
Photo 80

1.5.11	Shower room	Architrave noted to not be flush to shower room wall	04-07-2024	Architrave noted to not be flush to shower room wall Photo [80]

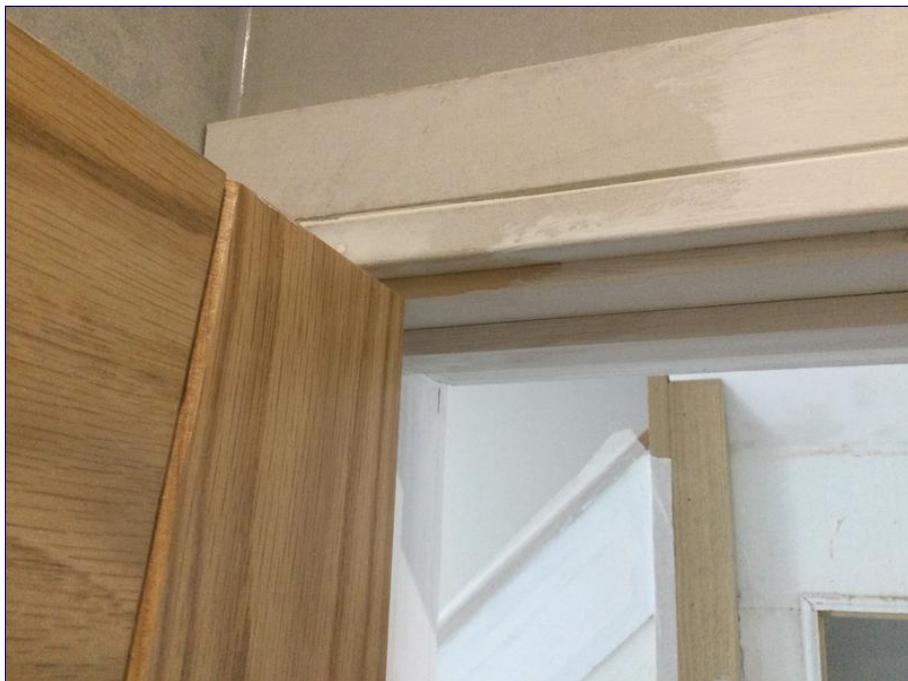
Photo 81

Item	Location	Description	Date Raised	Comments	Defect Owner	Action by Defect Owner Initial	Checked Date	Checked by Initial
1.5.12	Shower room	Poor finish was noted to the shower room door latch	04-07-2024	Poor finish was noted to the shower room door latch Photo [81]

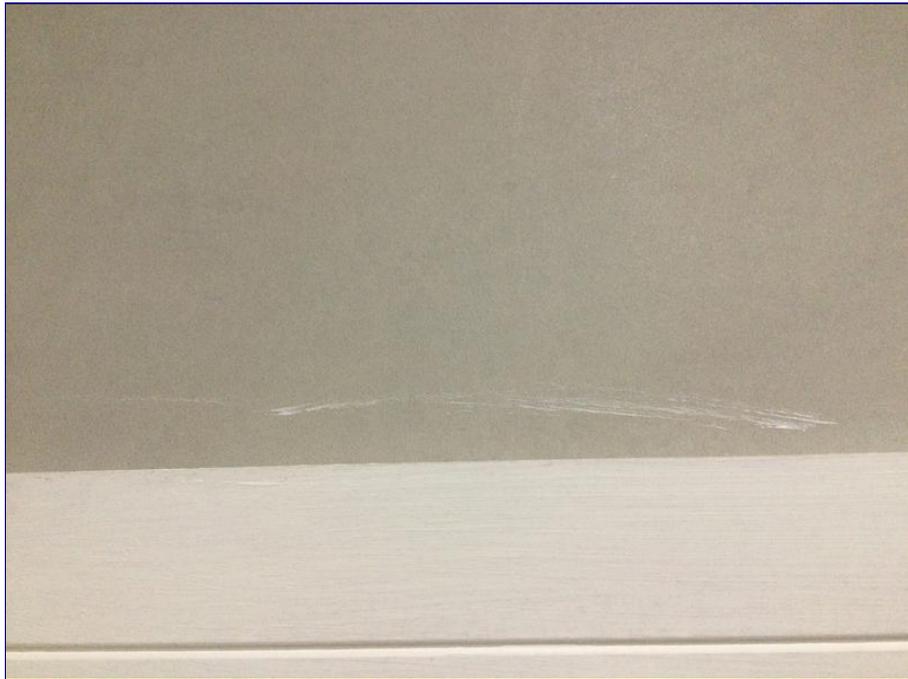
Photo 82

1.5.13	Shower room	Incomplete decorations was noted to the shower room architrave	04-07-2024	Incomplete decorations was noted to the shower room architrave Photo [82]

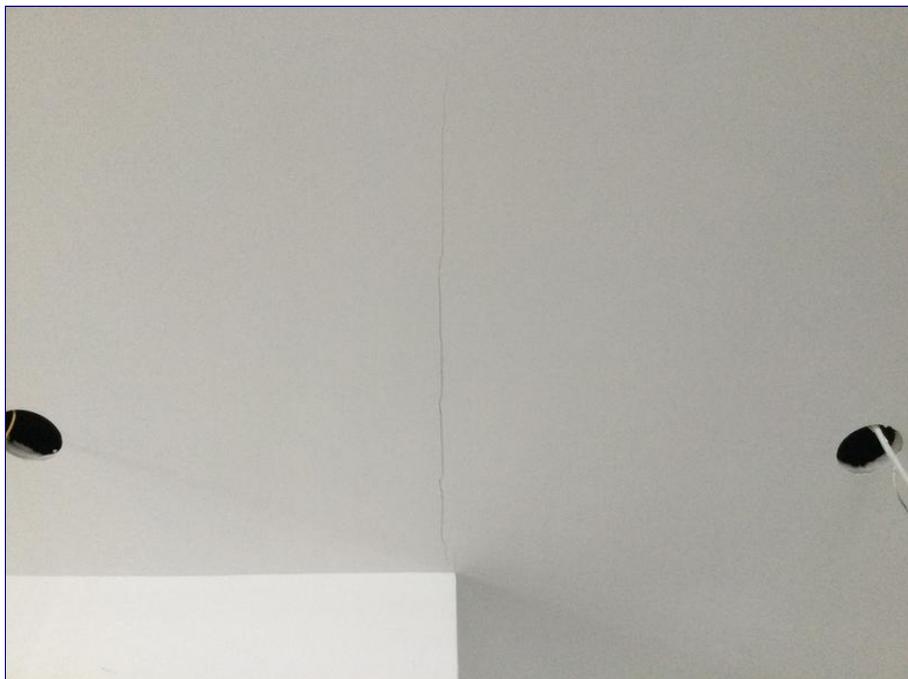
Photo 83

Item	Location	Description	Date Raised	Comments	Defect Owner	Action by Defect Owner Initial	Checked Date	Checked by Initial
1.2.14	Shower room	Paint marks were noted on the shower room wall tiles	04-07-2024	Paint marks were noted on the shower room wall tiles Photo [83]

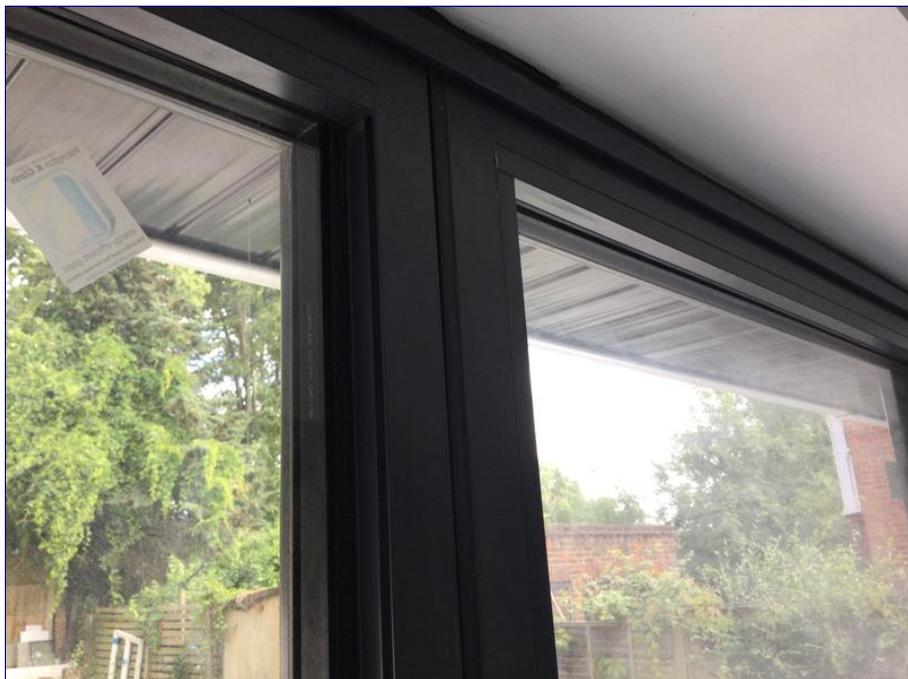
Photo 101

1.5.7	Living room/ Dining room	Cracking was noted to the architrave of the living room	04-07-2024	Cracking was noted to the architrave of the living room Photo [101]

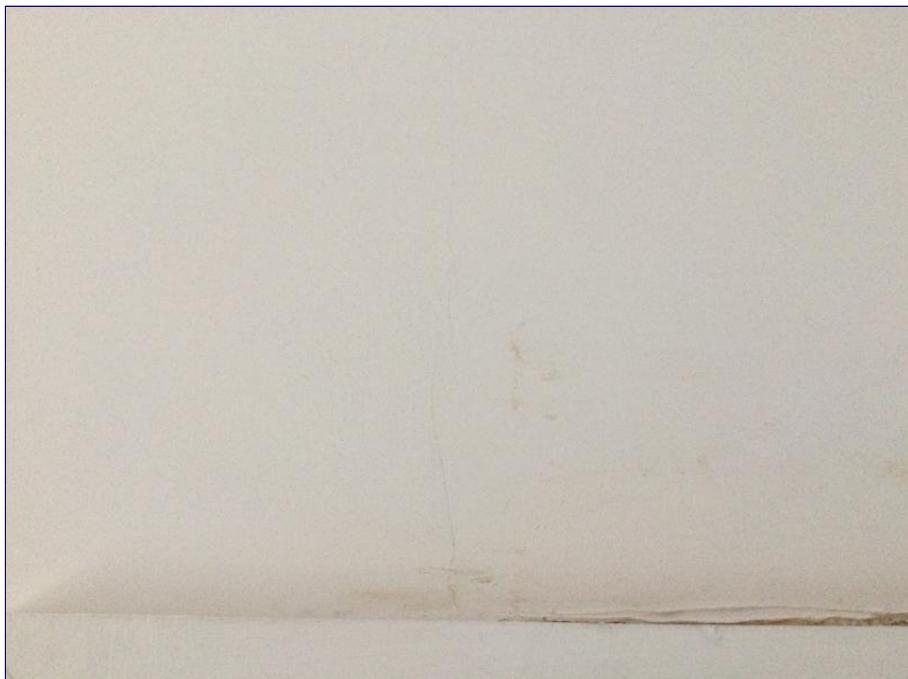
Photo 107

1.2.20	Kitchen	Damage was noted to the wall above kitchen door frame	04-07-2024	Damage was noted to the wall above kitchen door frame Photo [107]				
1.2.21	Kitchen	Hairline crack was noted to the wall above kitchen door frame	04-07-2024	Hairline crack was noted to the wall above kitchen door frame Photo [108]

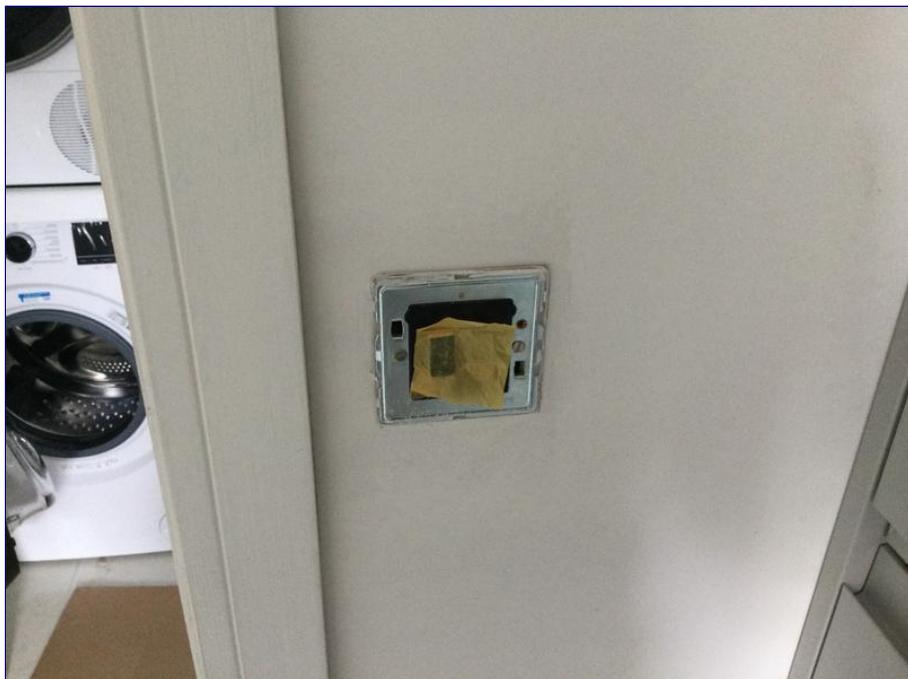
Photo 115

Item	Location	Description	Date Raised	Comments	Defect Owner	Action by Defect Owner Initial	Checked Date	Checked by Initial
1.2.22	Kitchen	Incomplete decorations to the walls in the kitchen	04-07-2024	Incomplete decorations to the walls in the kitchen Photo [115]

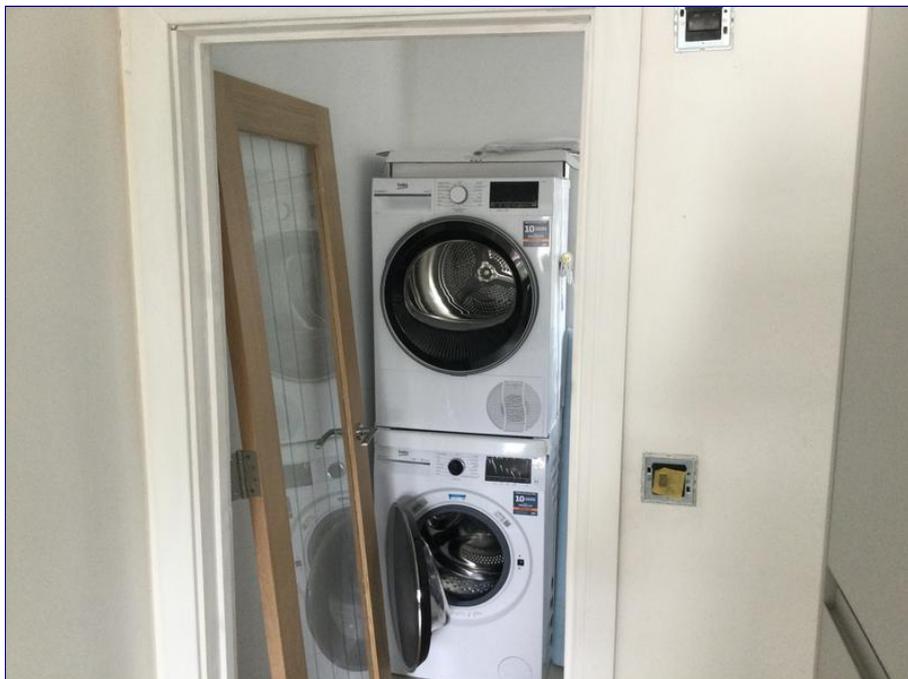
Photo 119

Item	Location	Description	Date Raised	Comments	Defect Owner	Action by Defect Owner Initial	Checked Date	Checked by Initial
1.4.12	Boiler room	Paint cracking to the ceiling in the boiler room	04-07-2024	Paint cracking to the ceiling in the boiler room Photo [119]

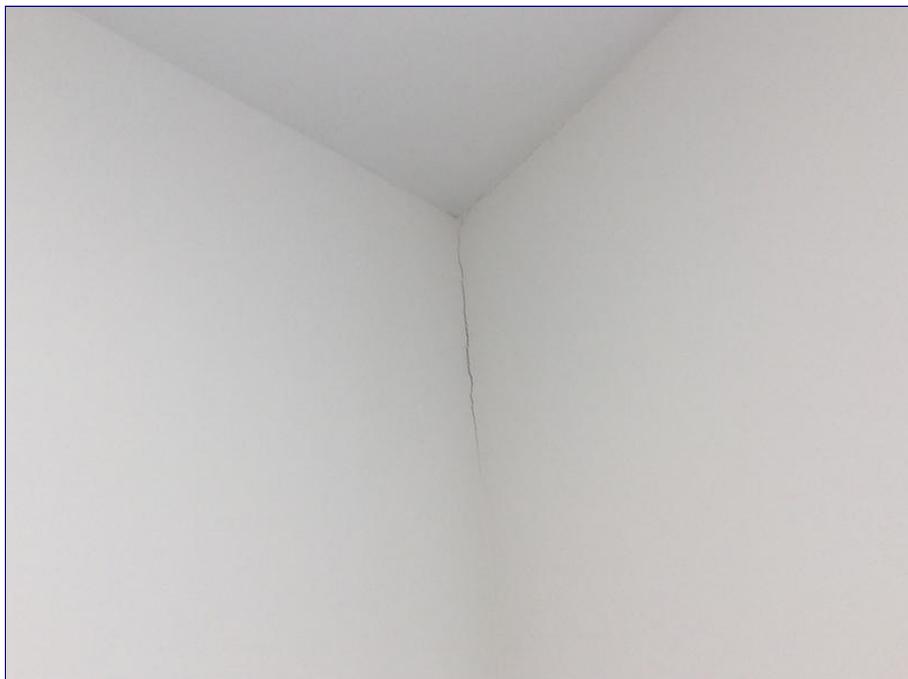
Photo 137

1.4.13	Bedroom one	Hairline crack was noted to the bedroom ceiling.	04-07-2024	Hairline crack was noted to the bedroom ceiling. Photo [137]				
1.4.14	Bedroom one	Hairline crack was noted running across the ceiling in the bedroom.	04-07-2024	Hairline crack was noted running across the ceiling in the bedroom. Photo [139]

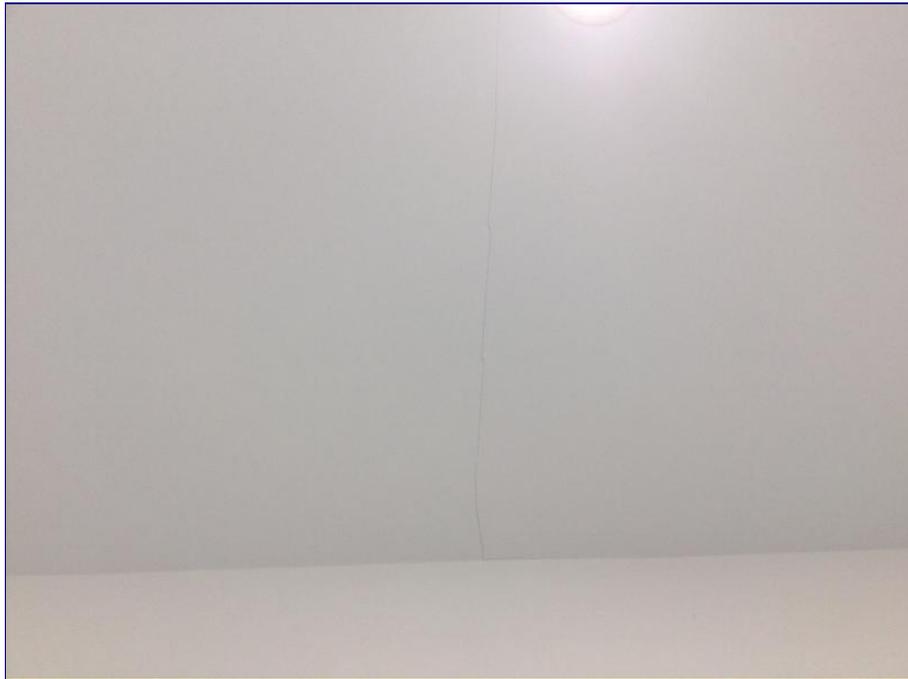
Photo 138

1.2.24	Bedroom one	Hairline crack was noted to the wall in the bedroom	04-07-2024	Hairline crack was noted to the wall in the bedroom Photo [138]				
1.2.25	Bedroom three	Hairline crack was noted running down the corner wall of the bedroom.	04-07-2024	Hairline crack was noted running down the corner wall of the bedroom. Photo [153]

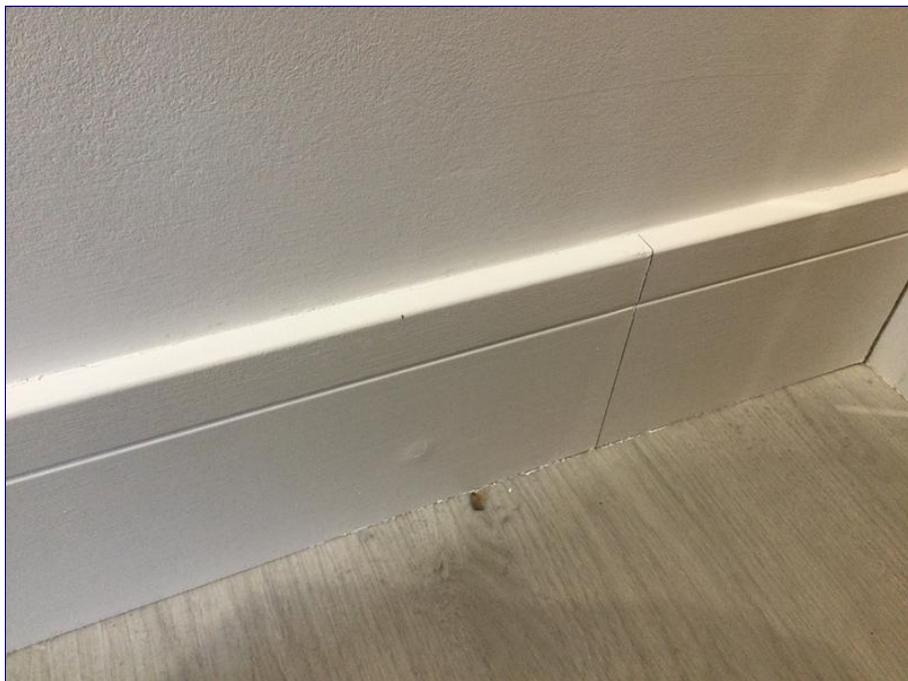
Photo 177

1.2.31	Bedroom five	Shrinkage cracking was noted to the wall in the bedroom.	04-07-2024	Shrinkage cracking was noted to the wall in the bedroom. Photo [177]

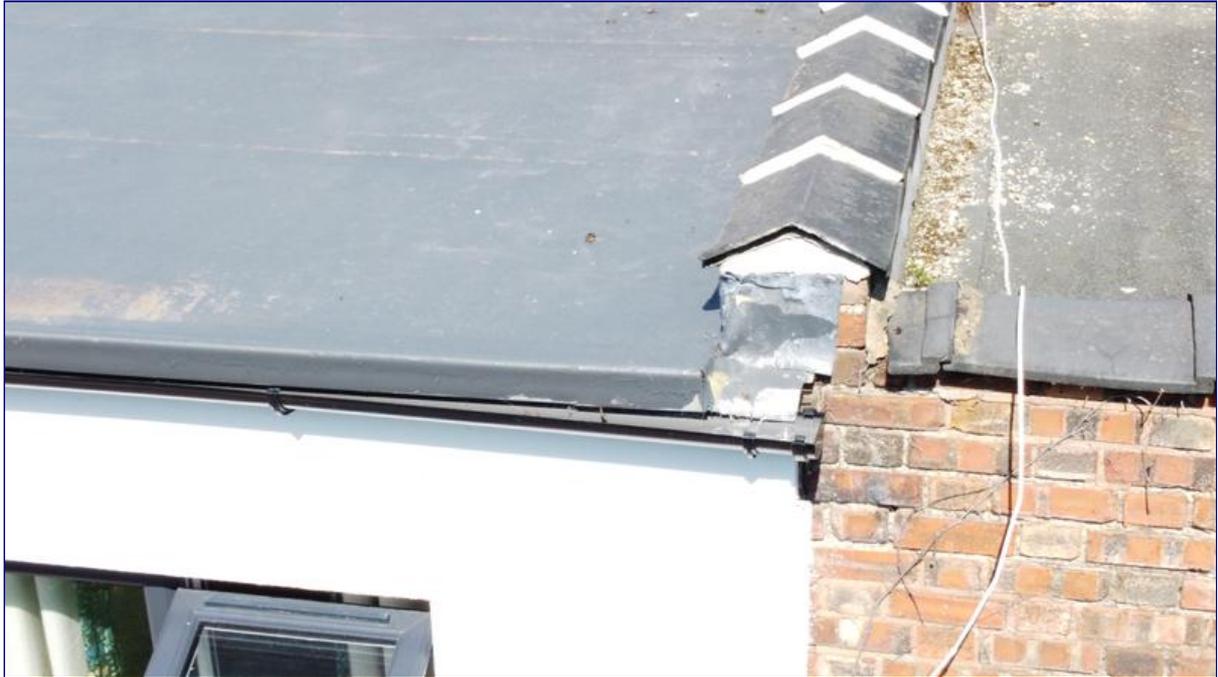
Photo 202

1.1.43	Fixtures and fittings	Rendering overlapping the light fittings	04-07-2024	Rendering overlapping the light fittings Photo [131]				
1.1.44	Flat roof	Crude finish was noted to the parapet wall to the right hand side of the flat roof	19-07-2024	Crude finish was noted to the parapet wall to the right hand side of the flat roof Photo [202]

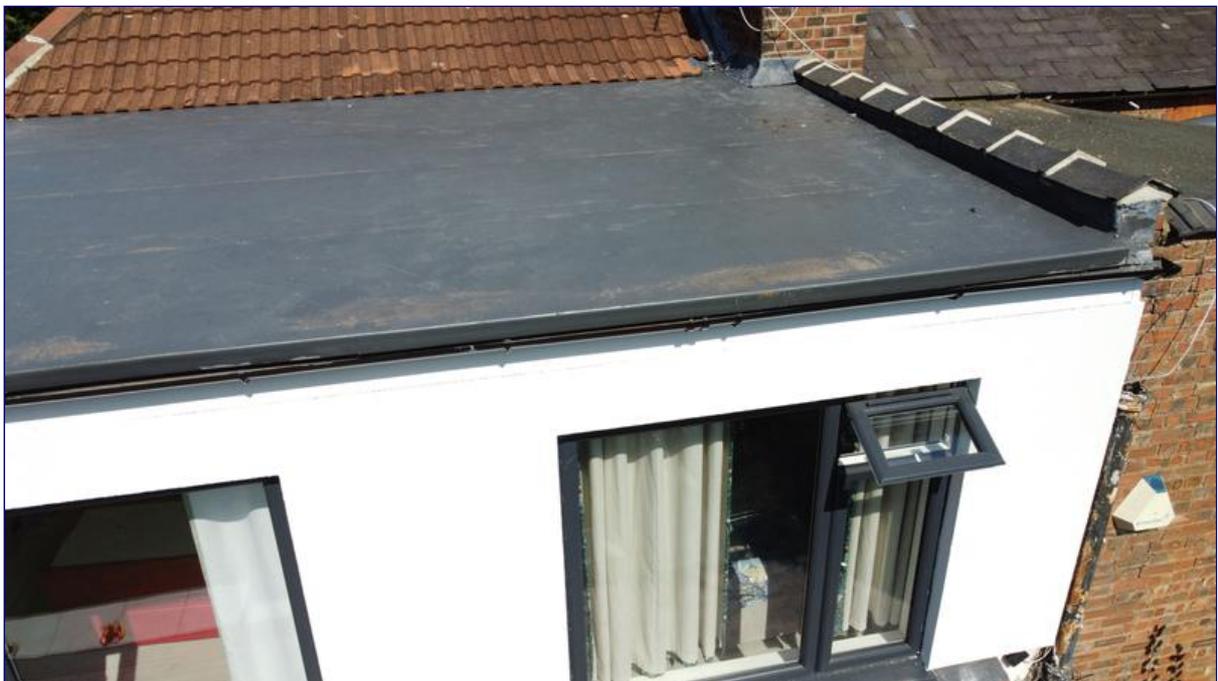
Photo 203

1.1.45	Flat roof	Crude finish was noted to the parapet wall to the right hand side of the flat roof	19-07-2024	Crude finish was noted to the parapet wall to the right hand side of the flat roof Photo [203]
