LEVEL 2

Your survey report

Inspection Date

8th December 2022

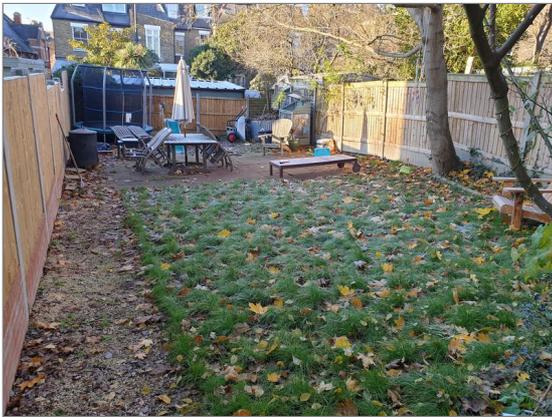
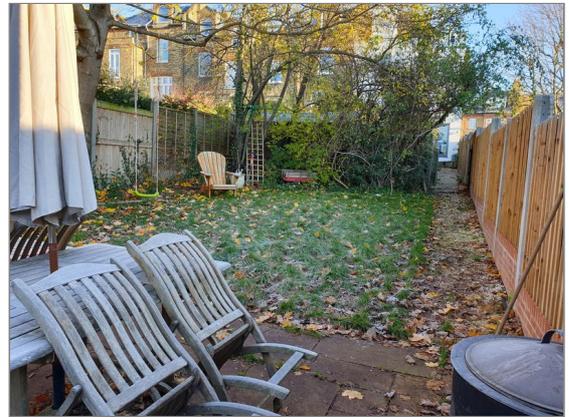
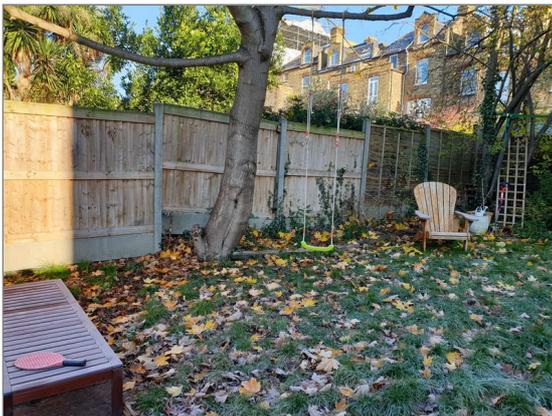
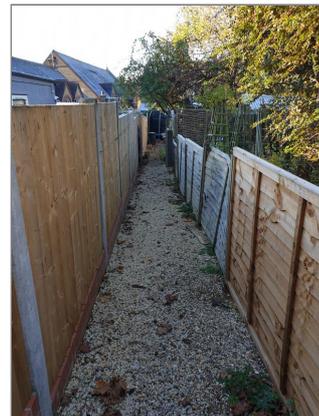
The ground is generally in good condition and it contains a mixture of grass and gravel.

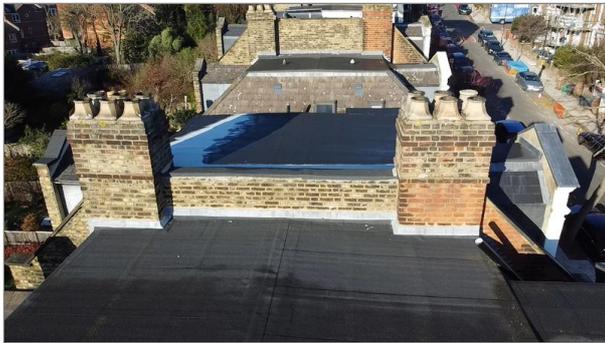
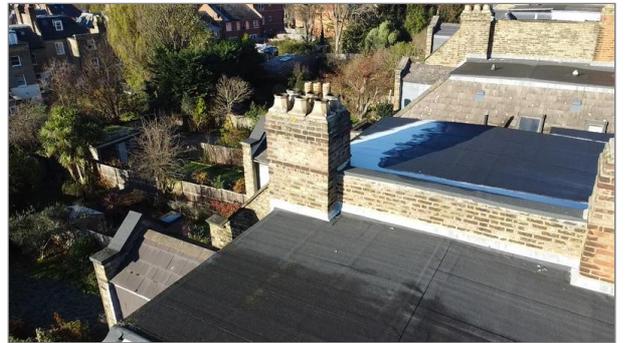
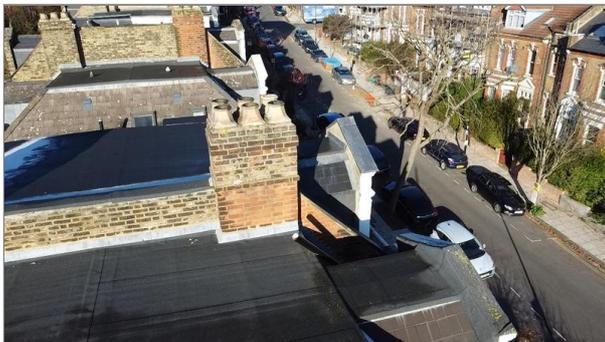
No significant defects were noted and the chimney stack was found to be structurally stable.

The flashing at the top of the stacks look to be in satisfactory condition.

Condition rating 1. No repair is currently needed. The property must be maintained in the normal way.

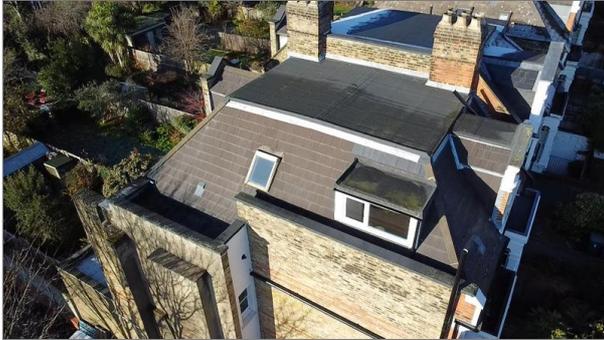
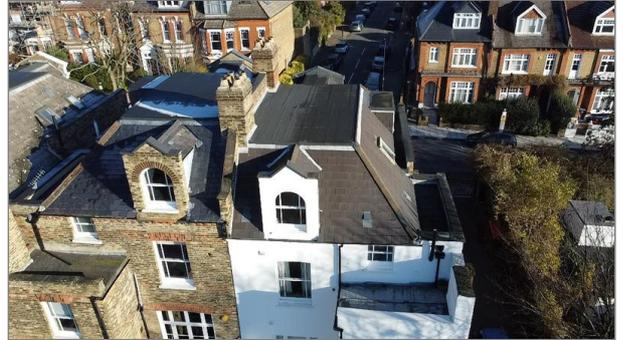
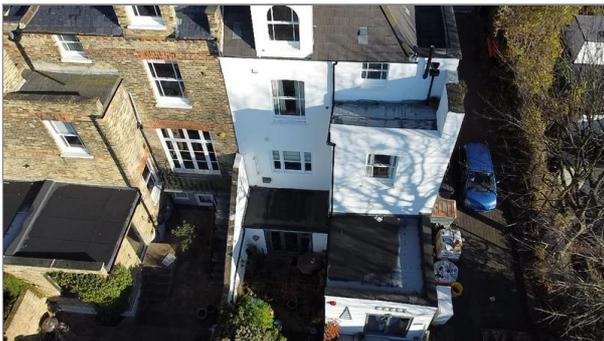
D2 Roof Coverings

The roof coverings appear to be generally fair for the age and type of the property. No significant sagging or deflection could be seen which might indicate that the structure is failing.

In this instance, the flat roof is in satisfactory condition. General maintenance is required.

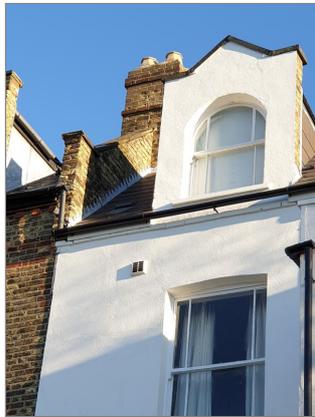
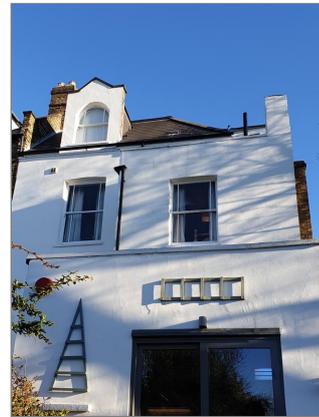
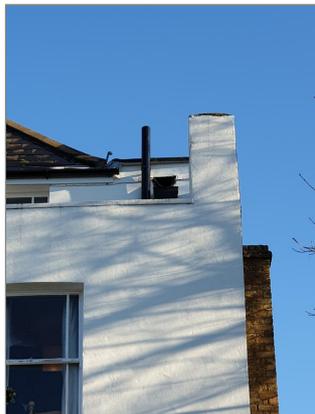
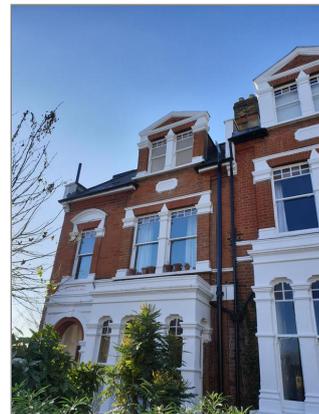
D3 Rainwater pipes and gutters

The gutters are of the half-round plastic variety and these discharge into rainwater pipes. We found the elements satisfactorily fixed. Gutters are laid to a reasonable fall and there is an adequate distribution of rainwater pipes.

The gutters are currently in a serviceable condition with no significant misalignment, although they would benefit from general cleansing to improve their appearance.

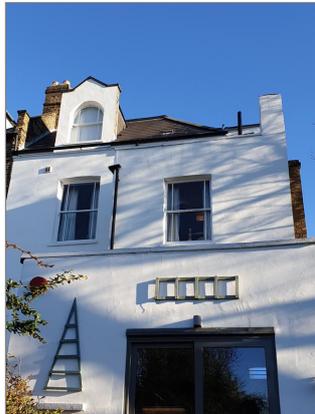
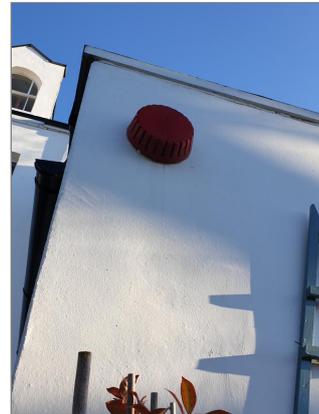
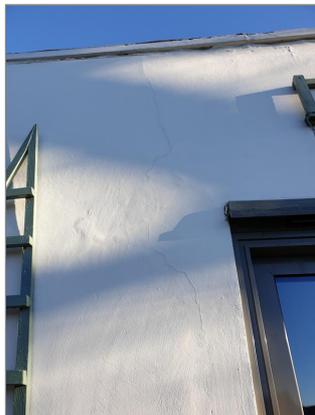
D4 Main walls

The double storey rear extension is of cavity wall construction covered in render and paint. Minor cracks observed above the kitchen door in the rear extension. The most probable cause may be weathering and bonding issues between the cavity wall and the render. Minor repair works recommended.

No evidence was seen of cracking, or other damage, which might indicate that the foundations are failing to provide adequate support for the property.

No evidence was seen of any major cracking which might indicate that the property is subject to subsidence, unusual settlement, or other exceptional movement of the ground.

The building generally does display good line and level.

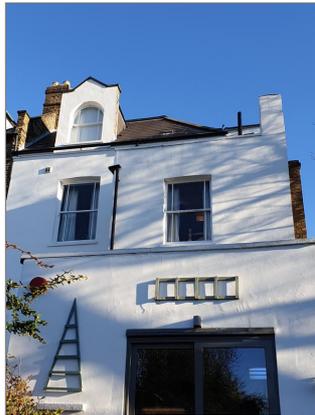
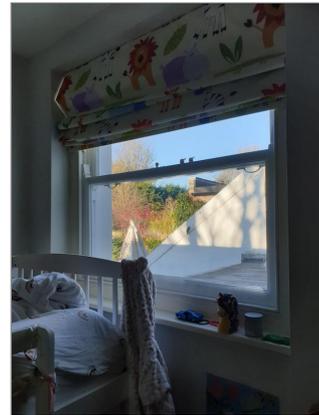
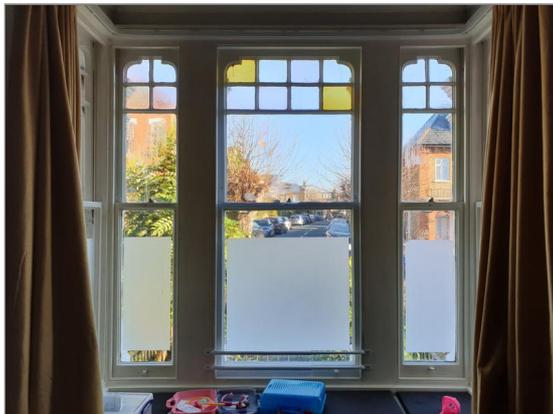
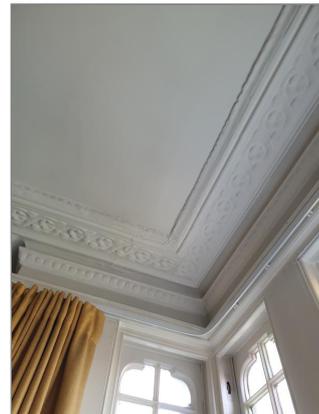
D5 Windows

Opening was attempted to selection of the windows and all checked for normal operation. The condensation levels in certain weather conditions can disguise evidence of blown double glazed units. In this instance, there was no evidence of blown double glazed units.

On further research, I was unable to find any documentation for the installation of the UPVC windows on FENSA on-line database. Please speak to your legal advisor in regards to the double glazing guarantee and in regard to the conservation area.

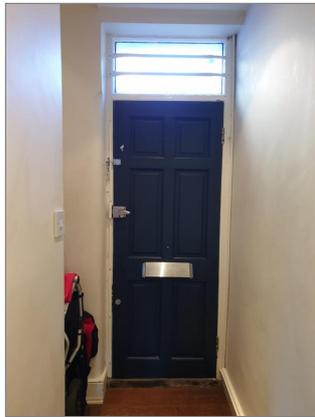
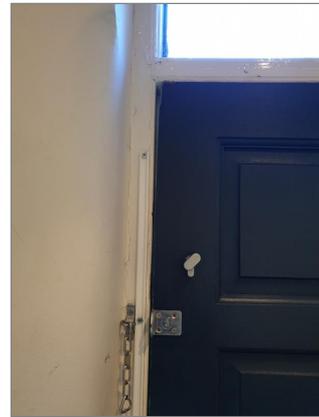
D6 Outside doors (including patio doors)

I carefully checked and tested the door and its night-latch and locking mechanism for normal operation and they were found to be fully functional.

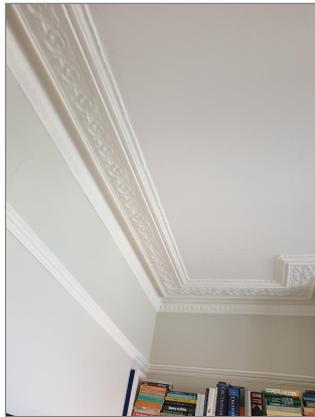
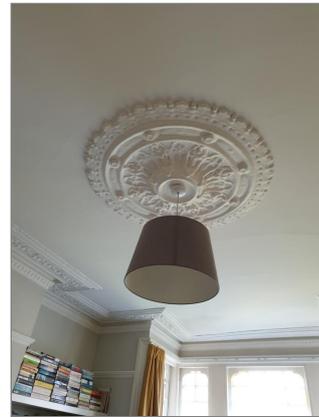
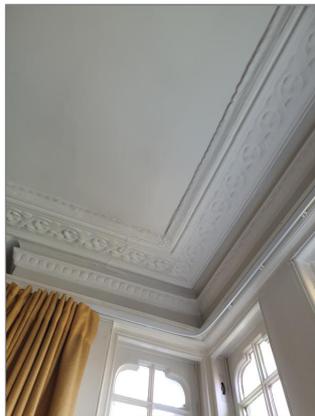
No significant issues were noted, other than that of a decorative nature, ceilings display good line and level. No undue levels of movement or detachment were observed during the survey.

There are Victorian age plaster mouldings along the ceiling and at the centre of the front living room. Minor hairline cracks were noted on some of these borders however, this is expected for a property of this age. Ceiling cracks are common and usually not a significant concern. The older the home, the more likely for cracks to appear, often they are maintenance or cosmetic issue.

Normal future maintenance is required, including filling and redecorating any cracks as necessary.

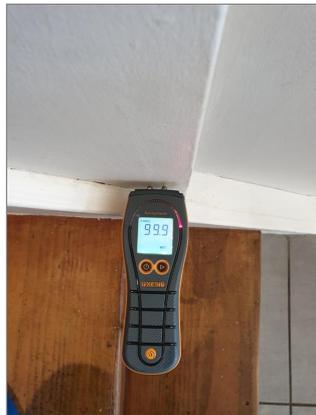
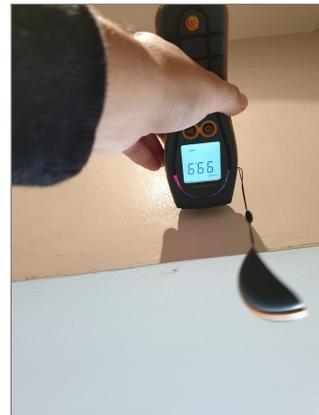
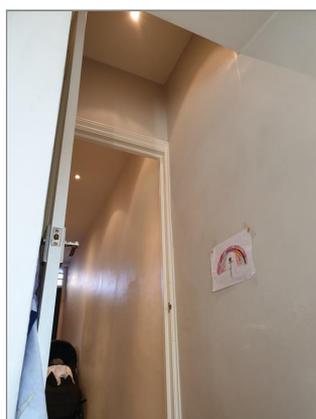
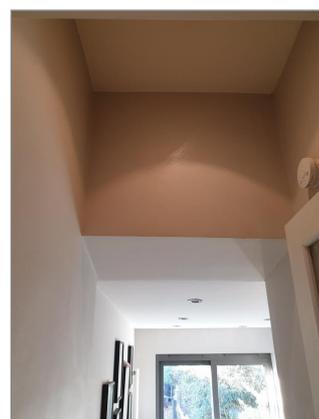
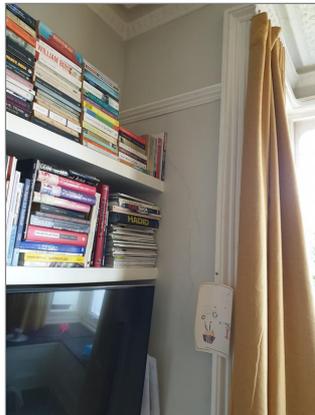
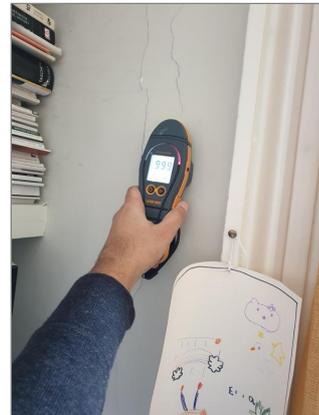
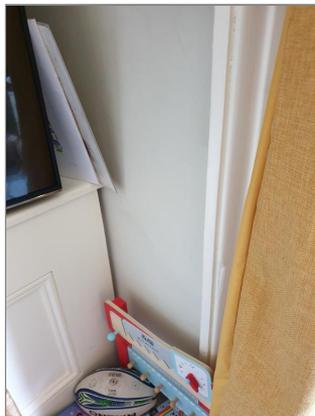
E3 Walls and partitions

Severe cracks in the plaster was observed in the living room to the right hand side of the window. High moisture meter readings were observed on the wall in various locations. Upon further investigations, I identified a discontinued ivy plant on the external façade behind the down water pipes. Ivy plants are fairly intrusive and in this instance has caused penetrating damp into the living room walls. There was also water marks above the opening for the down water pipes suggesting that historical leaks or minor splash backs may have occurred; it is difficult to make this assumption as I could not identify an active water leak at the time of survey. I would recommend for the the ivy plants to be removed off the external walls; replastering and decorating recommended. There was no further high moisture readings on the remaining walls in the living room.

High moisture meter readings were observed in the kitchen above the stairs leading into the main hallway. There is evidence of condensation and minor grease on the walls. The most probable cause for this may be the air circulation in the kitchen being trapped in this location due to the kitchen door being closed. There may be a possibility that the cooker extraction fan may not be used when cooking in some instances.

Some minor hairline cracking of the internal walls can be noted in a variety of locations, primarily on the inside faces of external walls. It is common for cracking to occur as the materials of the building expand and contract during normal heating and cooling. Often this cracking is focused on the weakest areas of the walls which are the openings of, such as windows and doors. Commonly cracking is found around the top corners of windows and doors in the area where a supporting lintel is built into the structure. This occurs because the expansion rate of the lintel differs from that of the surrounding masonry.

There is evidence of penetrating damp in the living room to the right hand side of the windows. The penetrating damp is being caused by discontinued ivy plants on the external brickwork. The ivy plants should be removed to prevent further penetrating damp and long term affects to the wall.

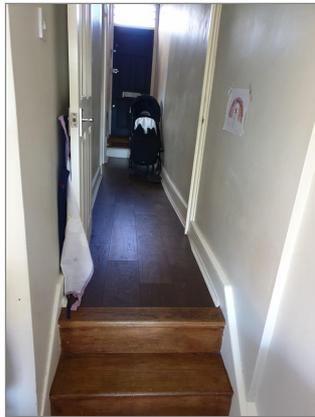
E4 Floors

No significant defects were noted to the floors within the living accommodation, bearing in mind the limitations of our inspection.

Floors within the property generally display good line and level. None of the floors were found to be unusually noisy or springy when walked upon, suggesting that the underlying structures are not affected by significant timber defects. Minor uneven floors inspected throughout the property, however this is expected for a property of this age.

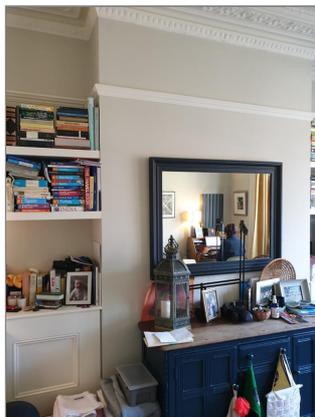
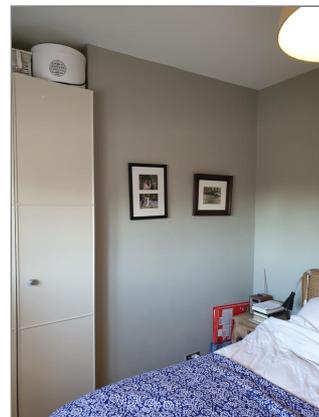
E5 Fireplaces, chimney breasts and flues

No significant defects were noted during my inspection and the chimney breast was found to be structurally sound.

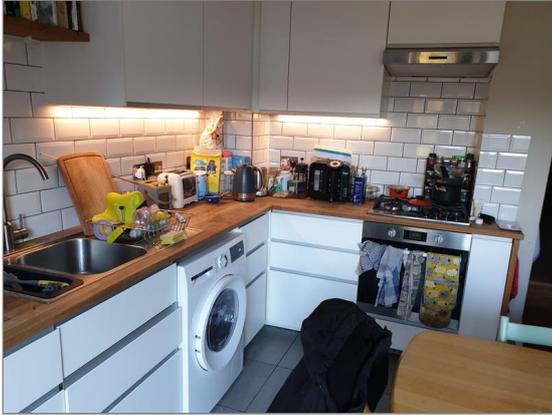
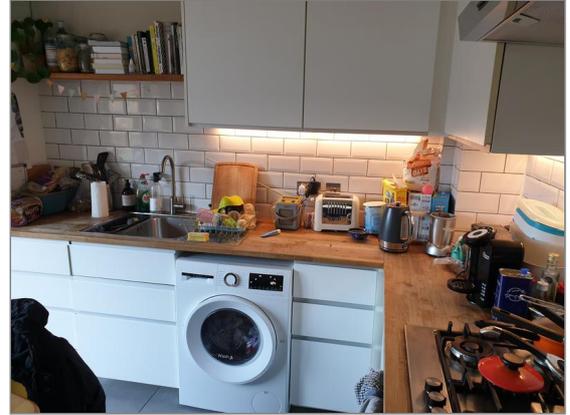
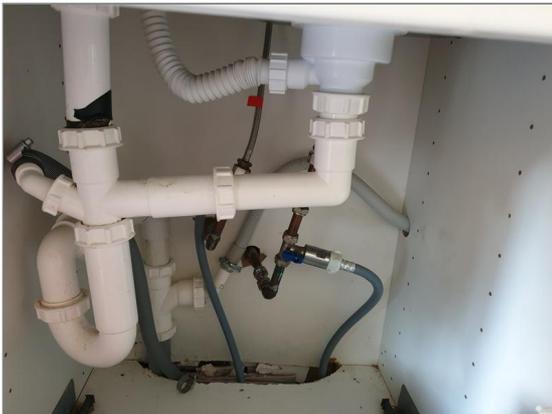
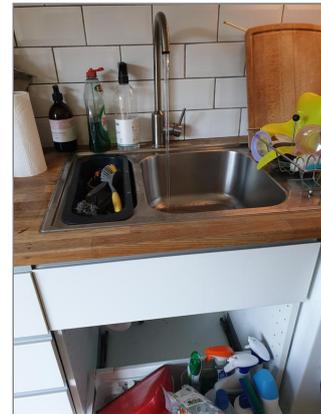
E6 Built-in fittings (built-in kitchen and other fittings, not including appliances)

The flow of water at the kitchen sink was found to be within a normal range and considered to be suitable for the intended use.

Drainage pipes beneath the sink were also carefully examined; no obvious signs of leakages or blockages were observed.

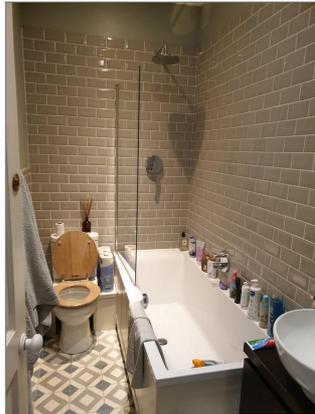
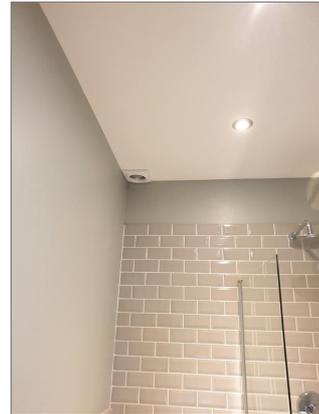
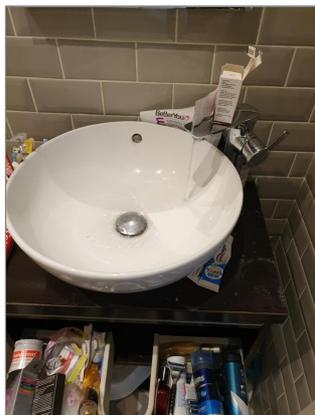
All bathroom fittings to modern standards.

Mechanical ventilation system was operational at the time of survey. However, there are no windows in the bathroom.

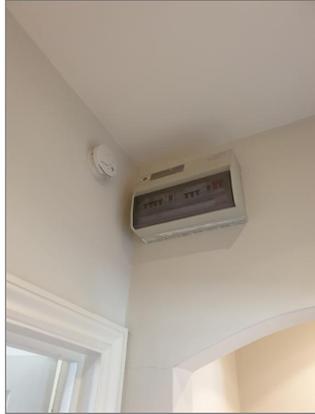
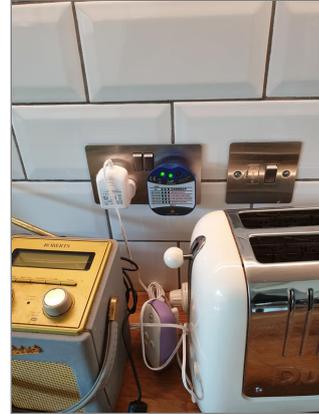
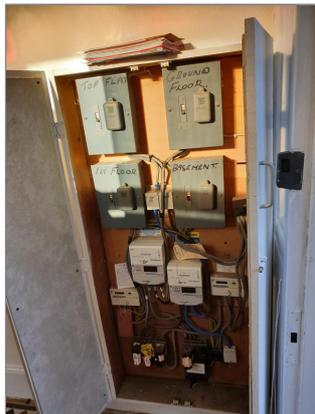
No evidence of broken, loose or damaged parts of the installation was seen, nor were any obvious amateur alterations or interventions noted.

The visual inspection has revealed that there are no obvious defects or deficiencies that could suggest that there might be problems with the electrical system of the main dwelling. Because of the specialised nature of the installation, we cannot advise whether it is safe and efficient. If you want to be sure, then a test should be arranged before a legal commitment to purchase is entered into. It is good practice to test a system at ten-year intervals and at a change of ownership.

The condition rating of "3" is compulsory for the surveyor and does not necessarily reflect that the electrical installation is faulty or dangerous.

A Periodic Inspection Report (PIR) should be requested or commissioned and produced by a qualified person.

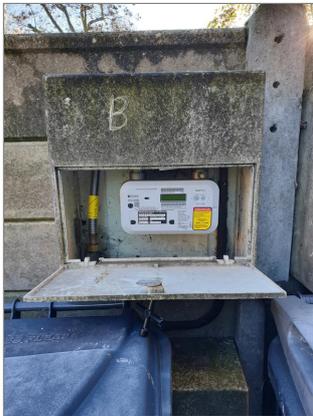
F2 Gas/oil

No significant defects were noted but see also recommendation in below with regard to a full test and inspection.

The absence of a test certificate constitutes a hazard and necessitates the imposition of a

Condition 3 Rating.

'Homebuyers cannot always be sure when the gas appliances in their new home were last safety checked and serviced. Ask your vendor for an annual gas safety record which shows that a Gas Safe registered engineer has checked the gas appliances. If your vendor cannot supply an up to date annual gas safety record, you should get a Gas Safe registered engineer to check the gas appliances before you move in. This check should include the gas boiler, oven and hob.

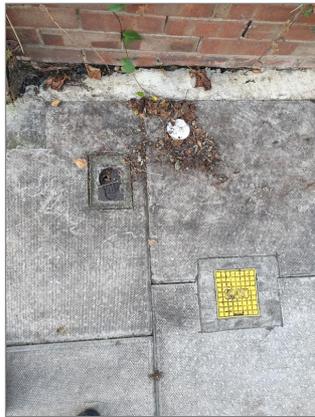
F3 Water

The incoming mains pipework material could not be positively confirmed but internal sections that could be seen were found to be copper.

The flow of water at all outlets was found to be within a normal range.

No obvious issues were noted with this water installation system on the day of my inspection.

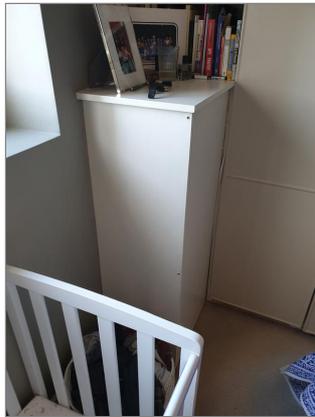
F4 Heating

I have given the heating a condition rating 3 because i did not physically inspect the boiler.

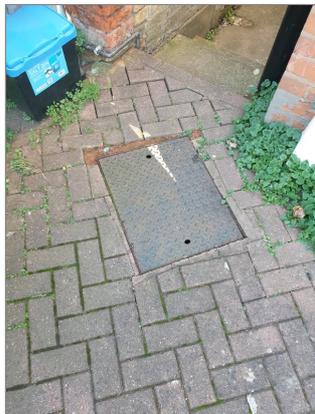
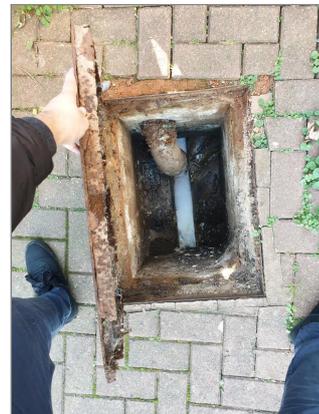
There is an inspection chamber at the front of the property to the left hand side before entering the passage to the entrance door for the flat.

Internally, all taps were run and WC's flushed, and water was seen to be running clear from the internal services.

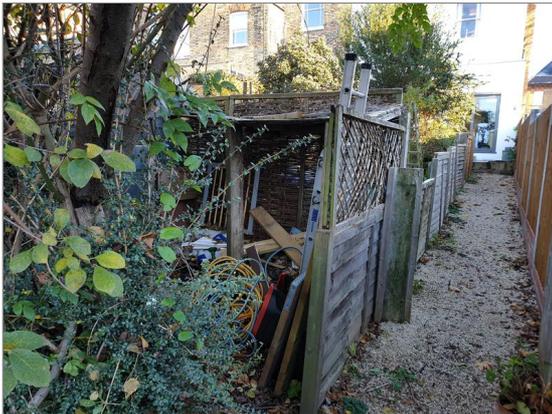
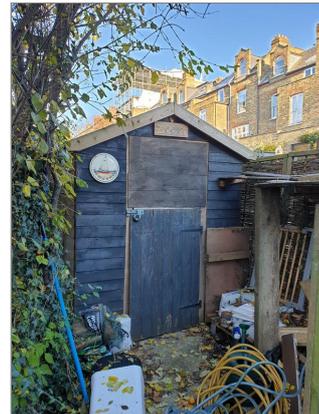
The shed was found to be in a stable condition.
