Your survey report

6 Leicester Road,
London,
N2 8EB

20th October 2023

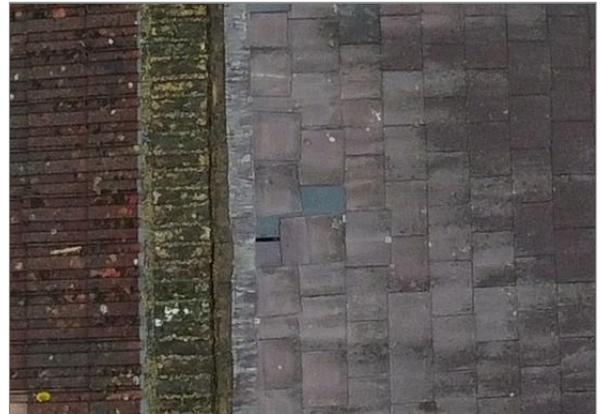
- Damp staining was noted to the front elevation left-hand parapet wall (see photo below).
- Gaps were noted between the tiles on the rear elevation main roof (see photo below). This will allow rainwater ingress to the timber structure of the roof, leading to damp and rot (refer to section 'E1 Roof structure' for further information).

Photo - 17 Gaps were noted between the tiles on the rear elevation main roof

Repair or replace slipped or missing tiles so that there are no gaps between roof tiles for rainwater to penetrate.

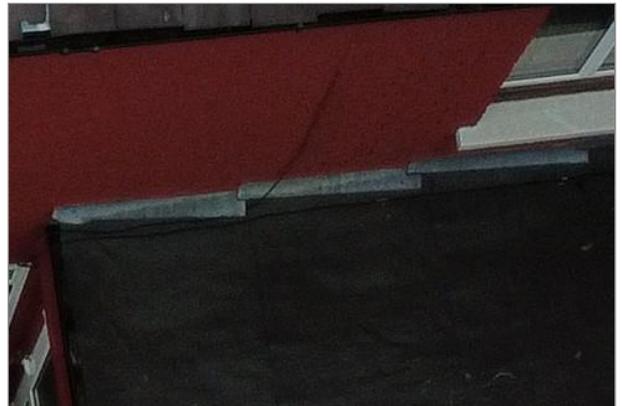
- Gaps were noted to the lead flashing on the flat roof (see photo below).

Photo - 21 Gaps were noted to the lead flashing on the flat roof

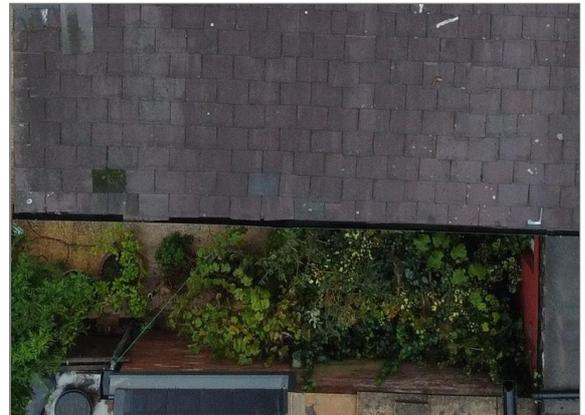
- Items were noted to be blocking the guttering on the rear elevation (see photo below).

Photo - 26 Slipped tiles were blocking the guttering on the rear elevation

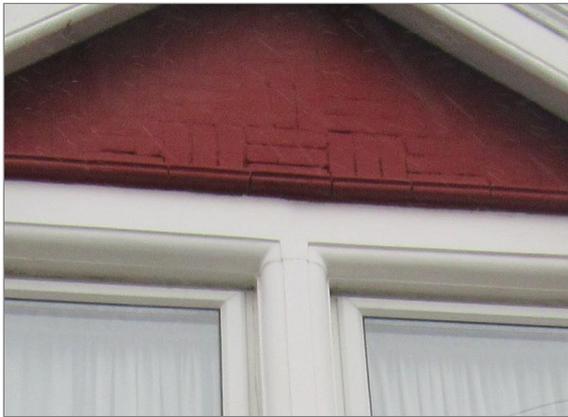
Photo - 29 Gaps were noted in the mortar pointing on the front elevation

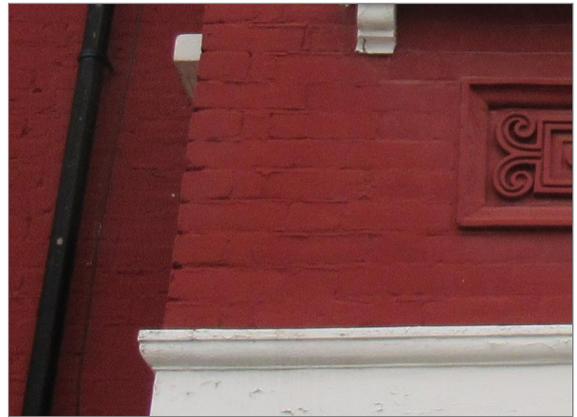
Photo - 30 Gaps were noted in the mortar pointing on the front elevation

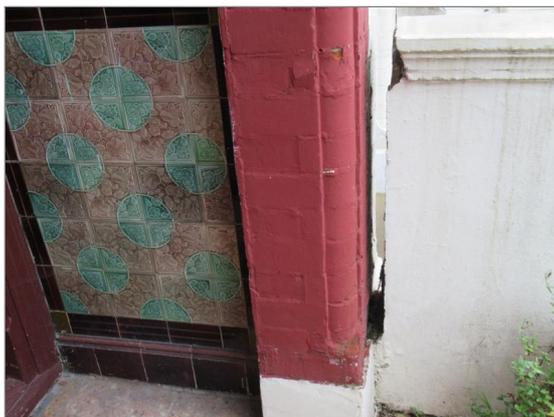
Photo - 33 Damp was noted at the base of the walls on the front elevation

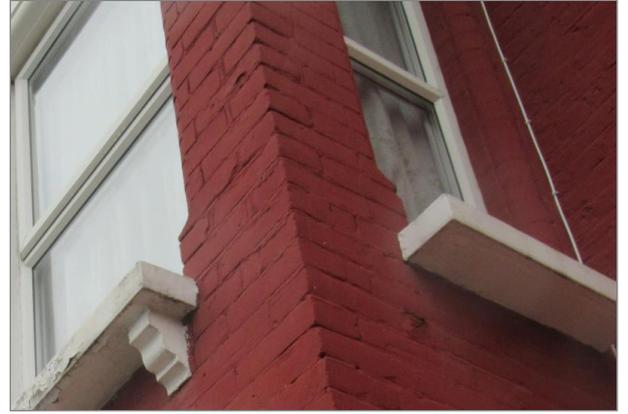
Photo - 36 Damp was noted to the brickwork on the front elevation

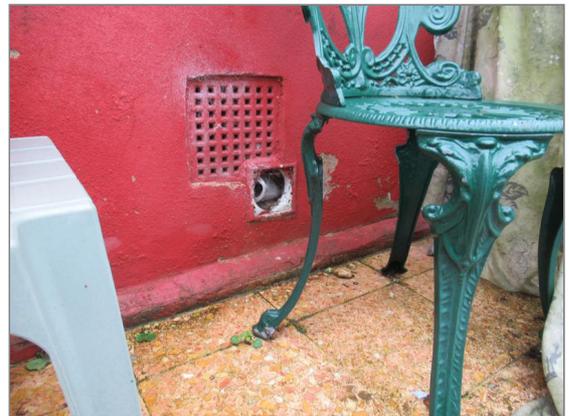
Photo - 38 An uncovered vent was noted to the rear elevation wall

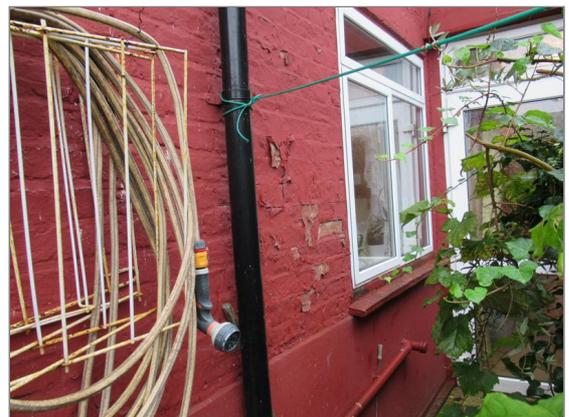
Photo - 40 Damp was noted to the brickwork on the rear elevation

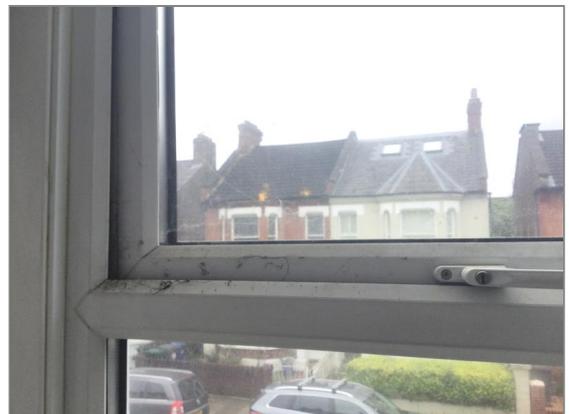
Photo - 42 The window in the front bedroom was noted to be defective and would not close sufficiently

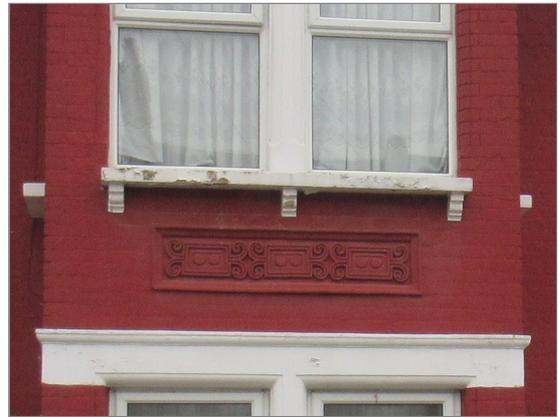
Photo - 44 Weathering was noted to the external concrete window cills on the front elevation

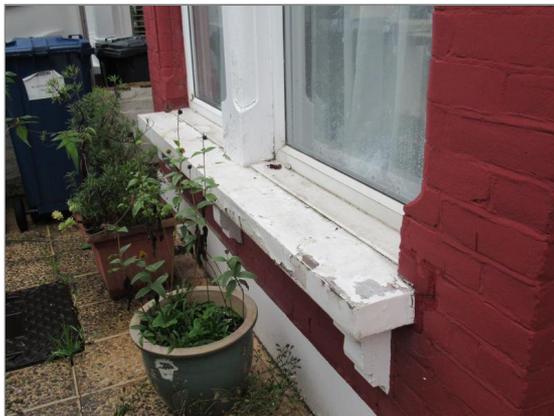
Photo - 45 Weathering was noted to the external concrete window cills on the front elevation

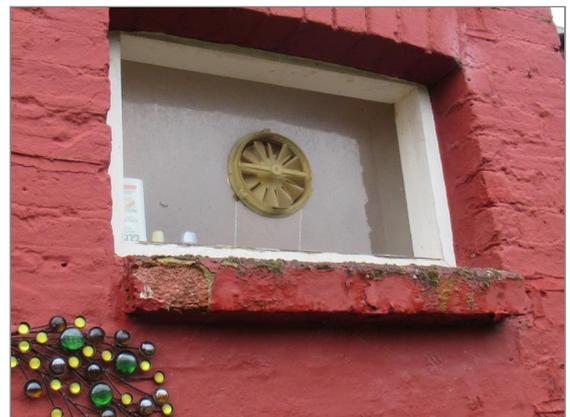
Photo - 48 Damp was noted to the brick window cill on the rear elevation

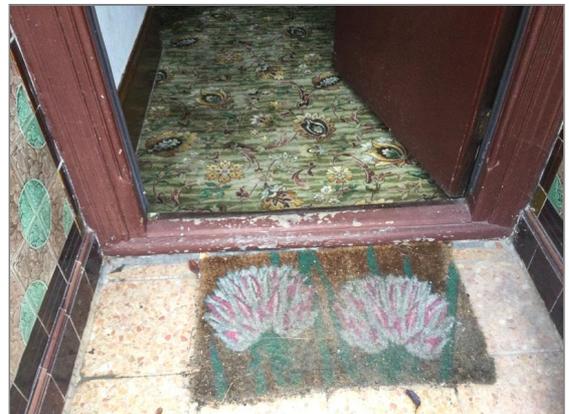
Photo - 50 The front door was noted to be weathered

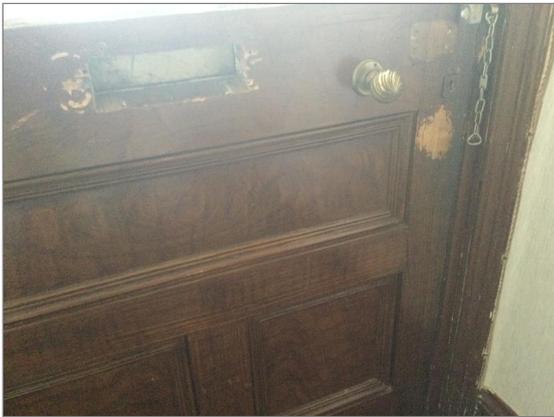
Photo - 51 The front door was noted to be weathered

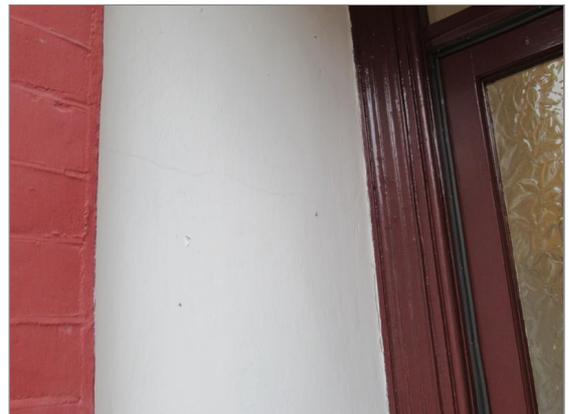
Photo - 57 Cracks were noted to the walls of the porch

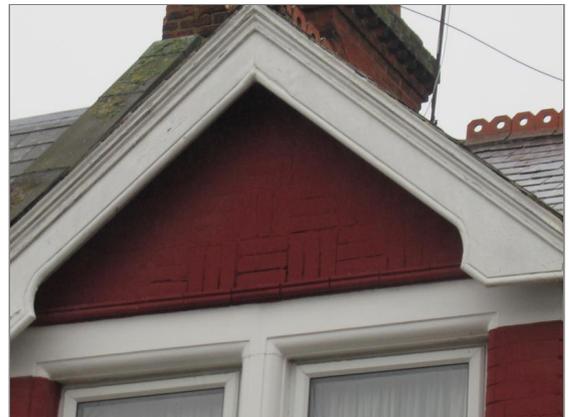
Photo - 60 Weathering was noted to the front elevation soffit and fascia boards

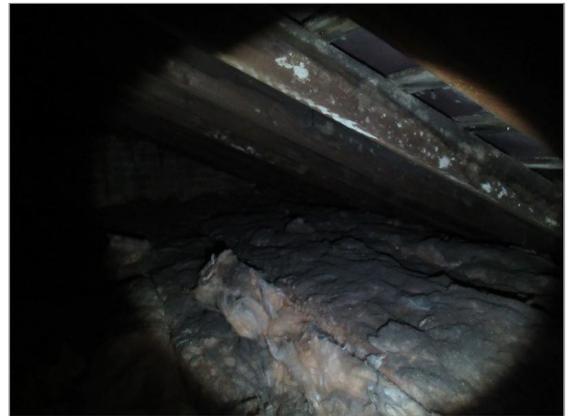
Photo - 63 Damp and mould was noted to the timber roof structure

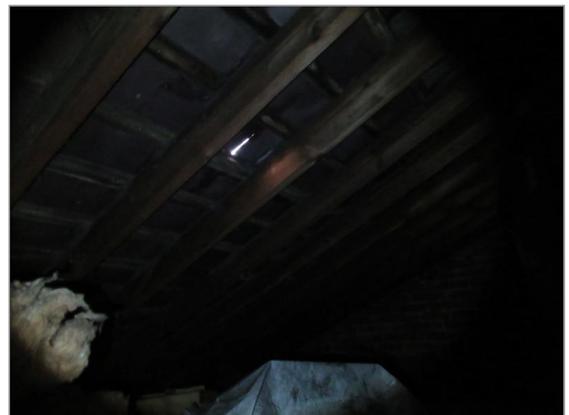
Photo - 65 Gaps were noted to the roof covering

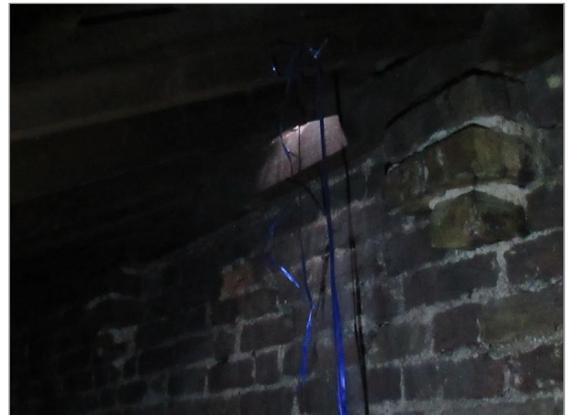
Photo - 67 Gaps were noted to the roof covering

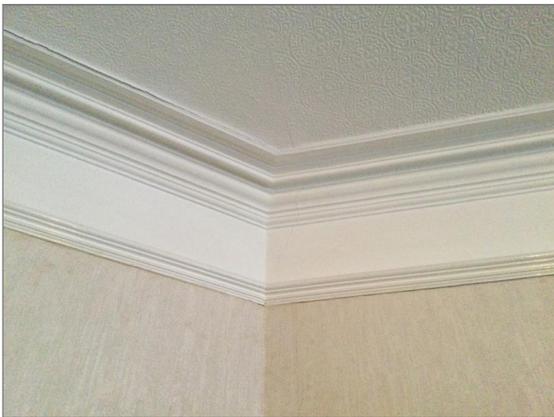
Photo - 69 Hairline cracking was noted to the coving in the front living room

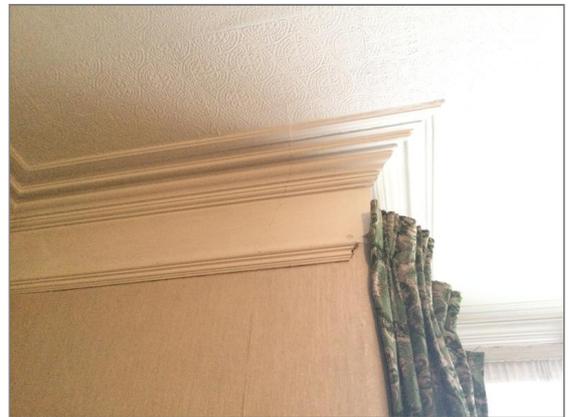
Photo - 70 Hairline cracking was noted to the coving in the front living room

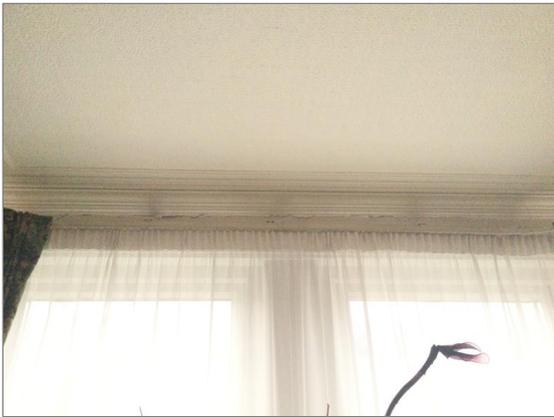
Photo - 71 Cracking was noted to the ceiling above the bay window in the front living room

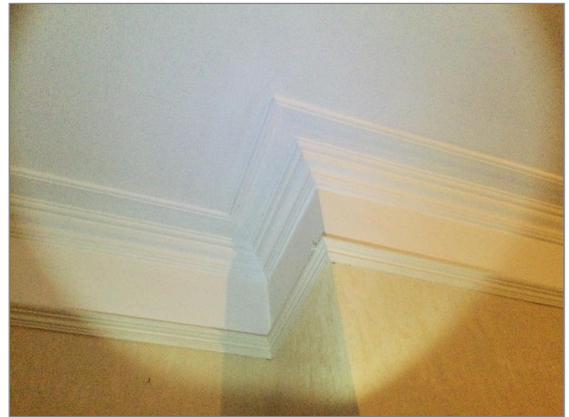
Photo - 72 Hairline cracking was noted to the ceiling in the second living room

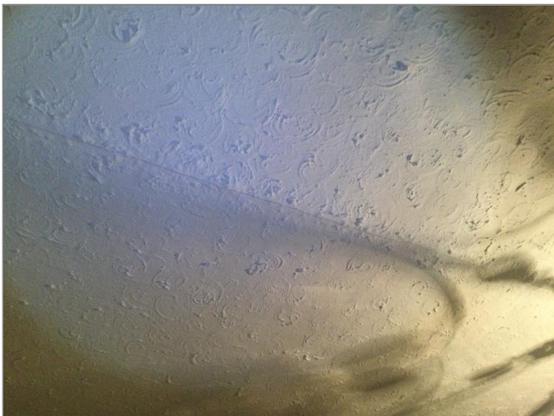
Photo - 73 Cracking was noted to the ceiling in the dining room

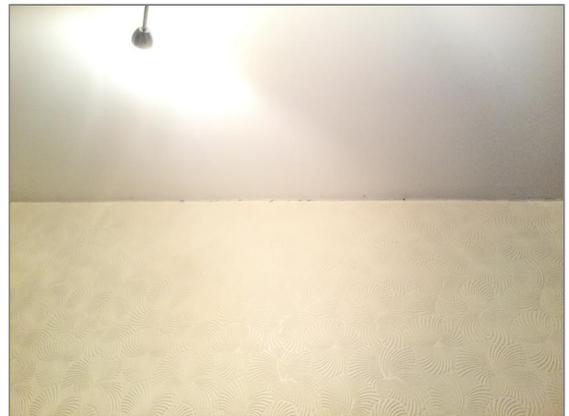
Photo - 74 Perimeter cracking was noted to the ceiling in the rear left shower room

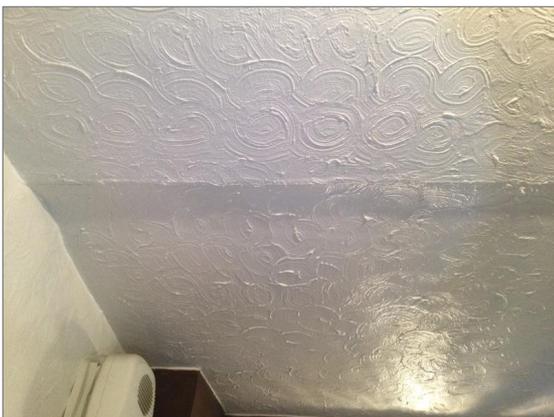
Photo - 75 Cracking was noted to the ceiling in the rear shower room

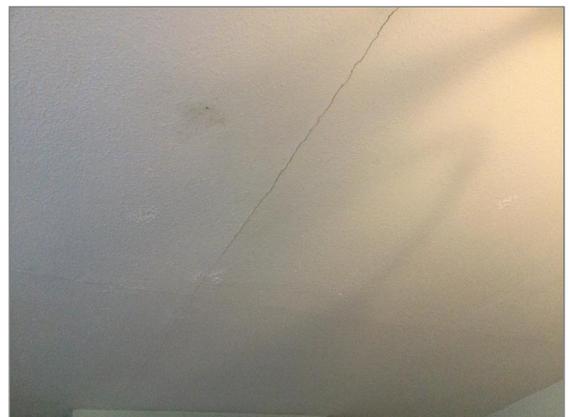
Photo - 76 Cracking was noted to the ceiling in the front bedroom

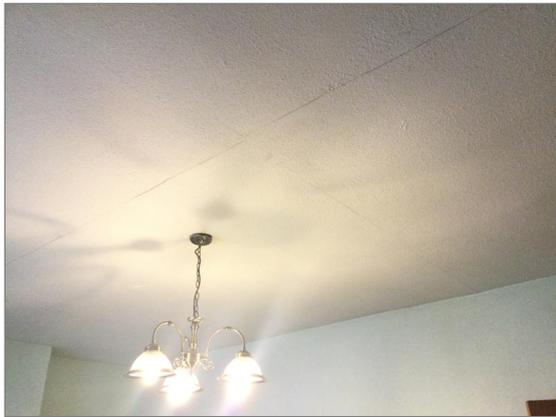
Photo - 77 Cracking was noted to the ceiling in the front bedroom

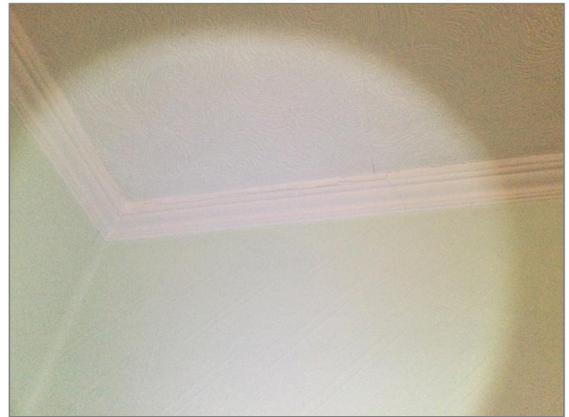
Photo - 78 Hairline cracking was noted to the coving in the first left hand bedroom

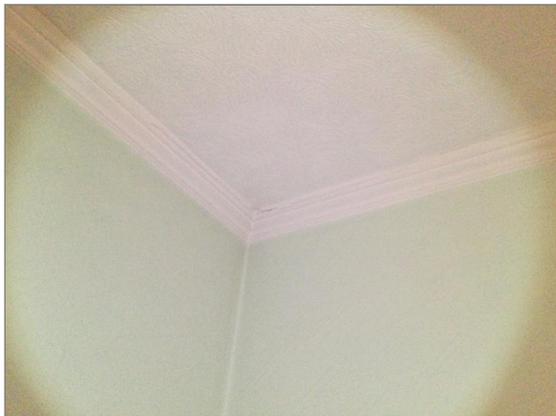
Photo - 79 Hairline cracking was noted to the coving in the first left hand bedroom

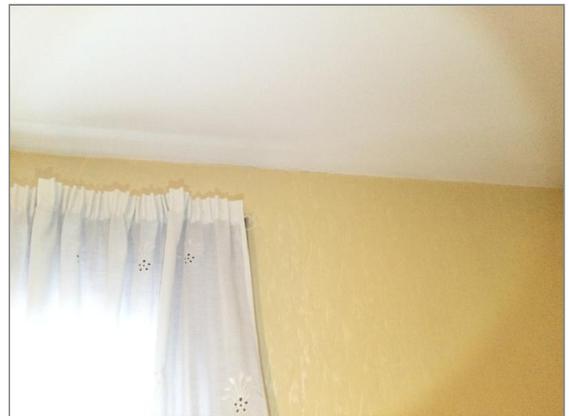
Photo - 80 Perimeter cracking was noted to the ceiling in the second left hand bedroom

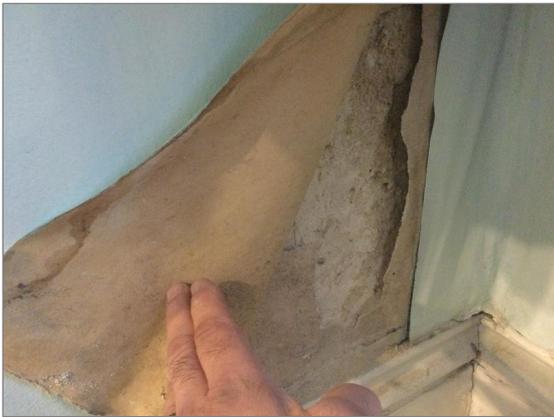
Suspected rising damp was identified to numerous walls throughout the property (refer to section 'E4 Walls and partitions' for further information). Further investigation will be required to ascertain the extent of the suspected rising damp noted and the cost of any remedial works.

Photo - 81 Damp was noted to the walls in the front bedroom

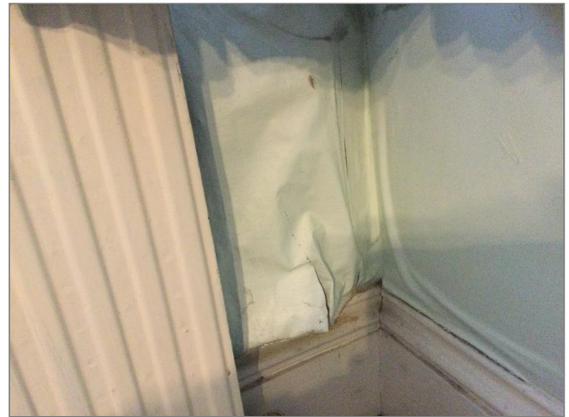
Photo - 82 Damp was noted to the walls in the front bedroom

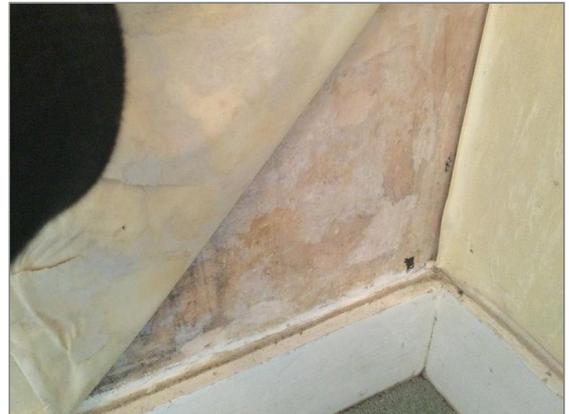
Photo - 84 Damp was noted to the wall in the third left hand bedroom

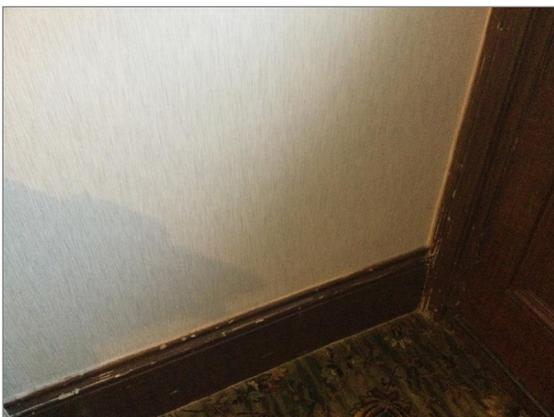
Photo - 85 High moisture meter readings were recorded on the wall adjacent to the front door

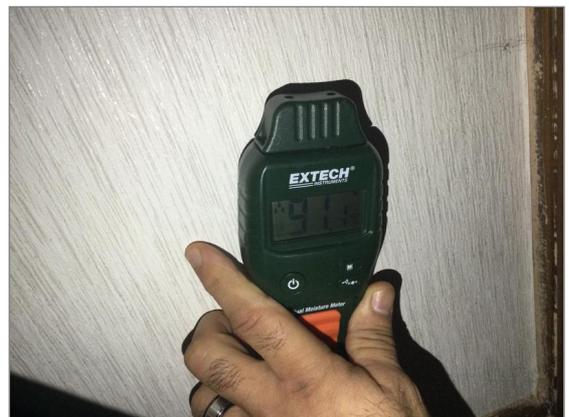
Photo - 86 High moisture meter readings were recorded on the wall adjacent to the front door

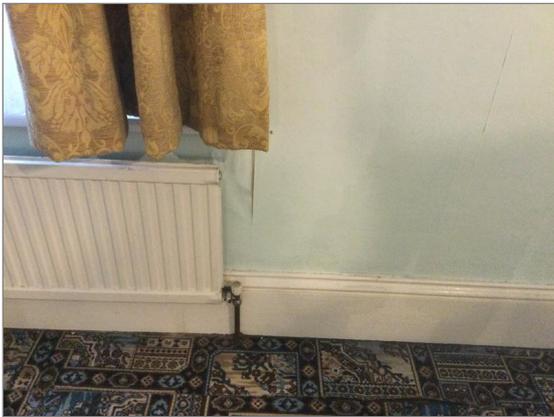
Photo - 87 High moisture meter readings were recorded on the wall in the front bedroom

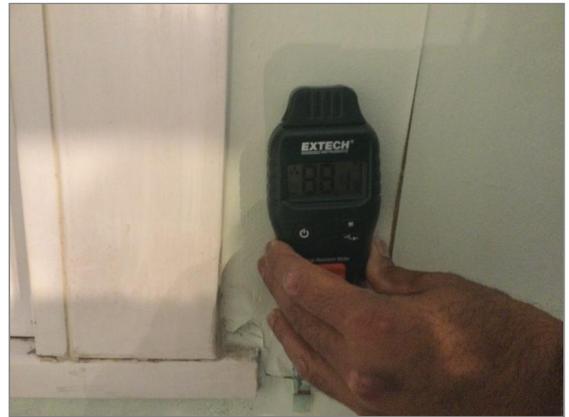
Photo - 88 High moisture meter readings were recorded on the wall in the front bedroom

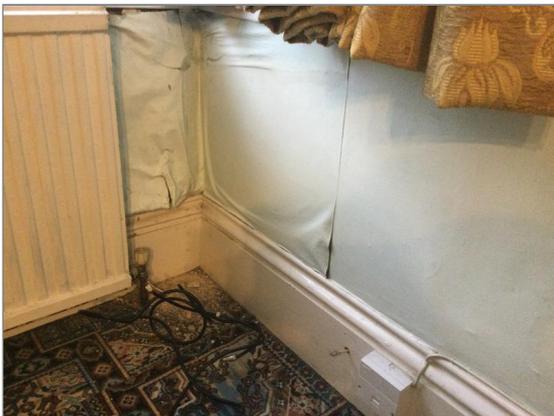
Photo - 89 High moisture meter readings were recorded on the wall in the front bedroom

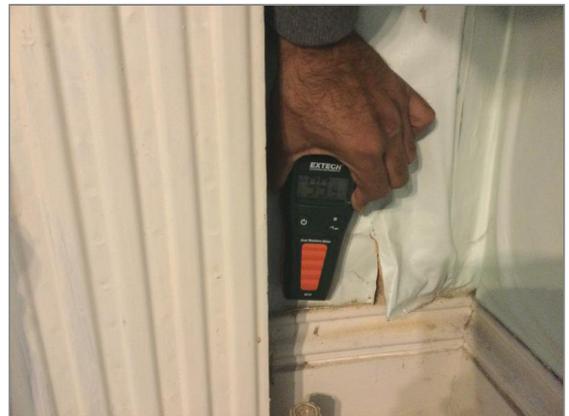
Photo - 90 High moisture meter readings were recorded on the wall in the front bedroom

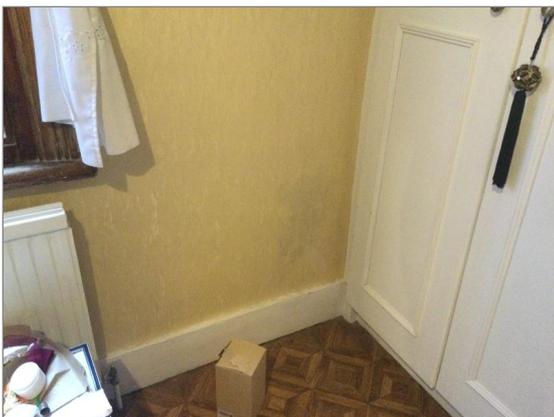
Photo - 91 High moisture meter readings were recorded on the wall in the second left-hand bedroom

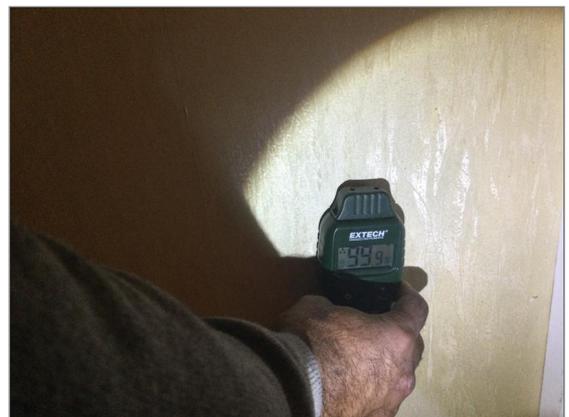
Photo - 92 High moisture meter readings were recorded on the wall in the second left-hand bedroom

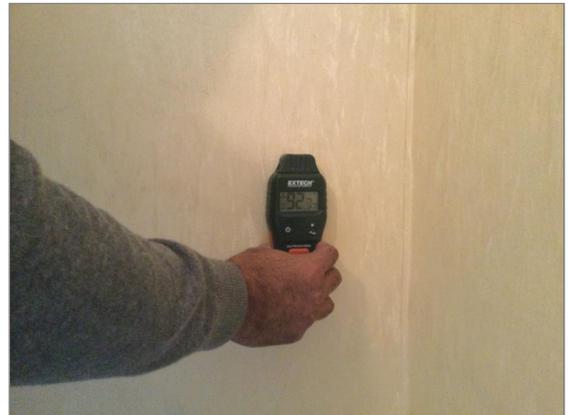
Photo - 94 High moisture meter readings were recorded on the wall in the third left-hand bedroom

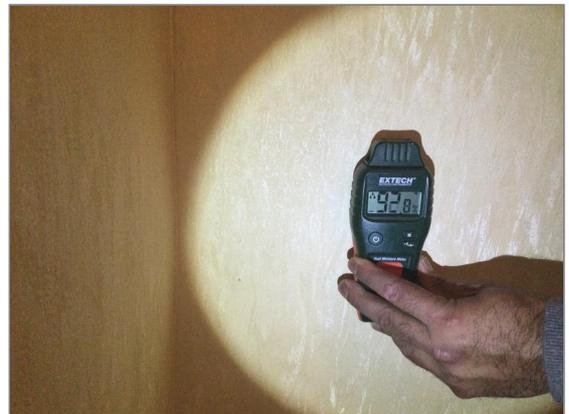
Photo - 96 High moisture meter readings were recorded on the wall in the third left-hand bedroom

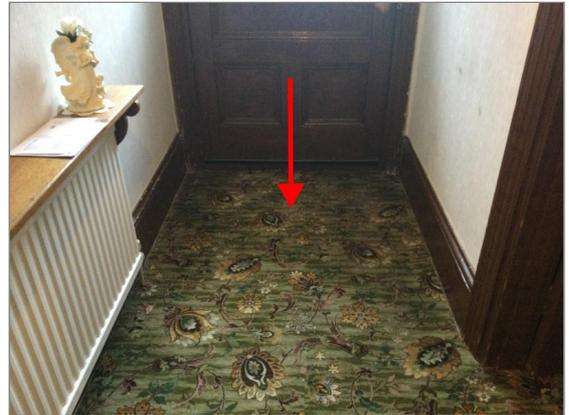
Photo - 98 A dip was noted to the flooring by the front door

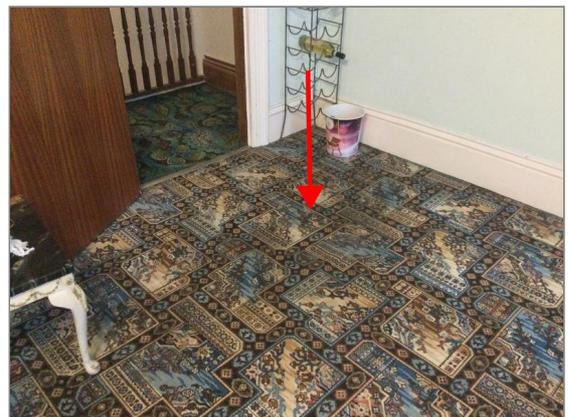
Photo - 100 A dip was noted to the flooring in the front bedroom

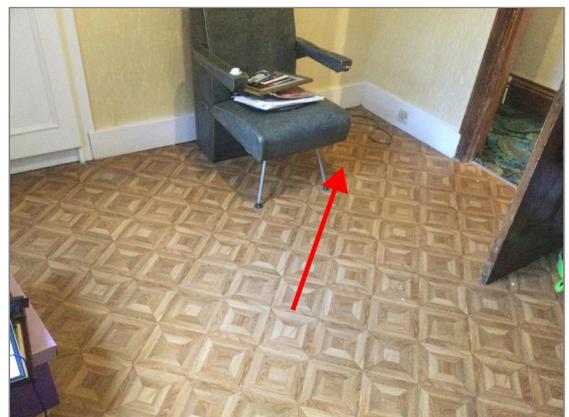
Photo - 102 The flooring in the second left hand bedroom was noted to be sloping

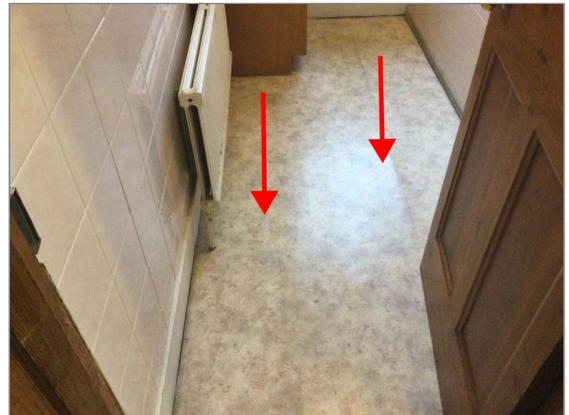
Photo - 104 Floorboards were noted to deflect when traversed in the first floor bathroom

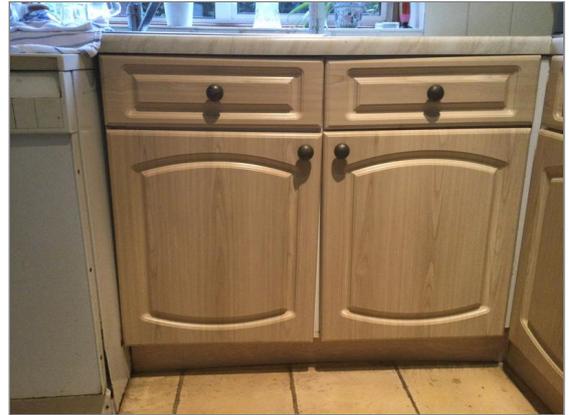
Photo - 110 The cupboard doors were noted to have dropped on their hinges

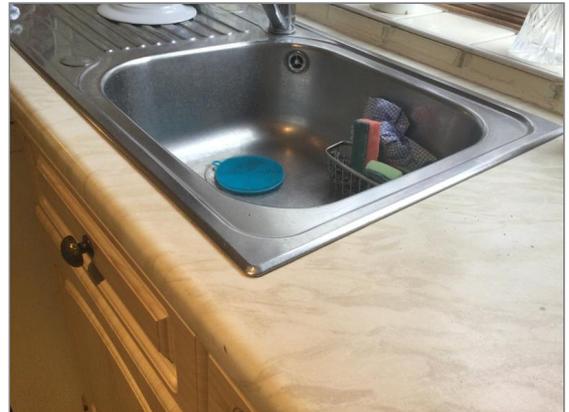
Photo - 112 The sealant was noted to be missing from around the sink

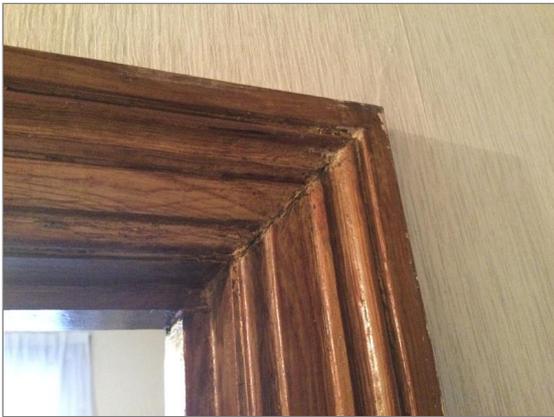
Photo - 115 Example of shrinkage cracking to the timber architrave

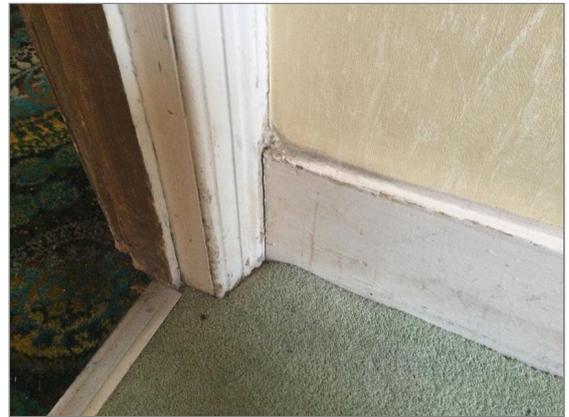
Photo - 116 Example of shrinkage cracking to the skirting boards

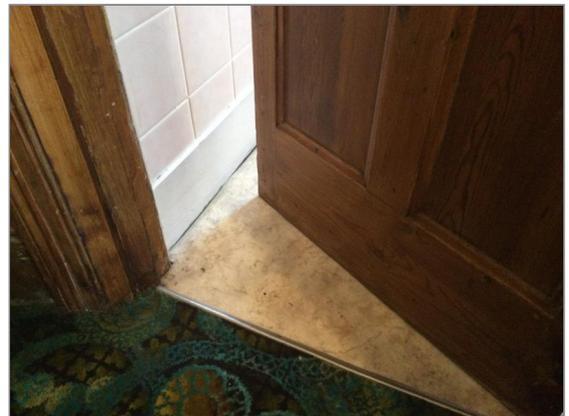
Photo - 118 The first floor bathroom door was noted to scuff the floor when operated

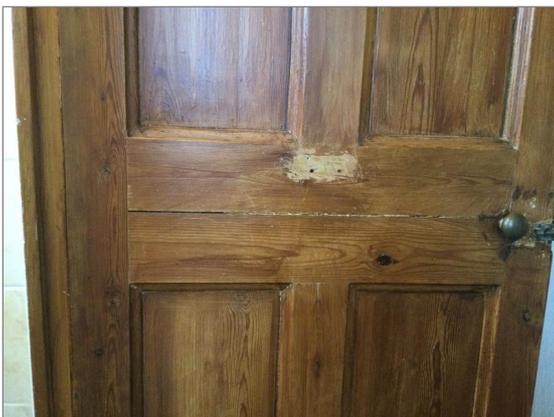
Photo - 119 Shrinkage cracking was noted to the first floor WC timber door

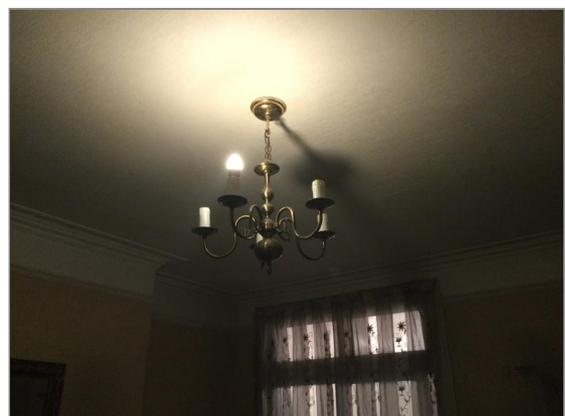
Photo - 128 Bulbs were noted to be missing in the second living room

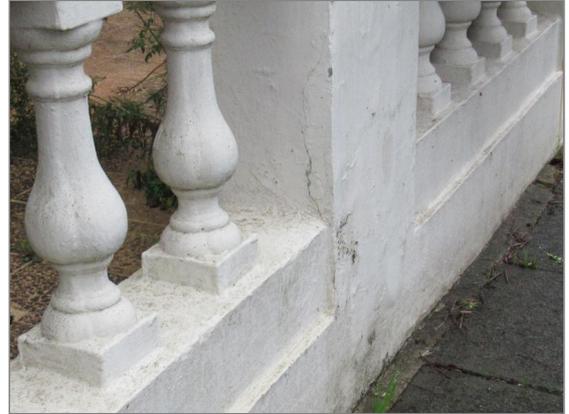
Photo - 137 Cracks were noted to the front boundary wall

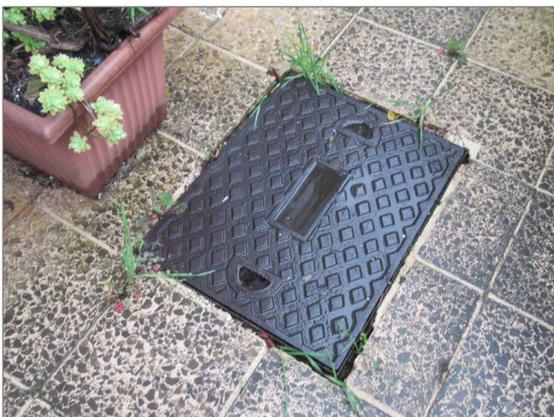
Photo - 140 The manhole cover was noted to rock when traversed on the front elevation

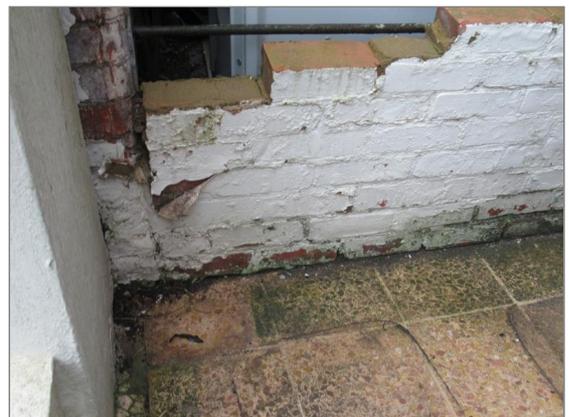
Photo - 141 The front left-hand boundary wall was noted to be leaning and defective

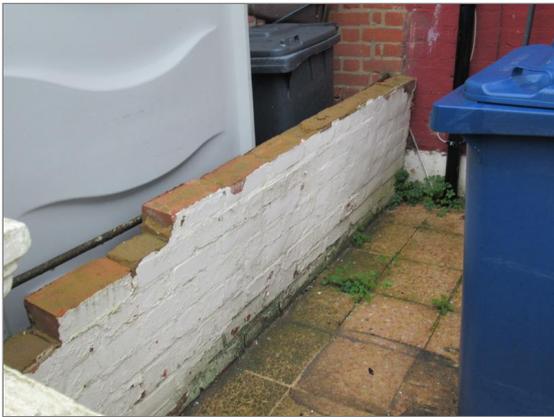
Photo - 142 The front left-hand boundary wall was noted to be leaning and defective

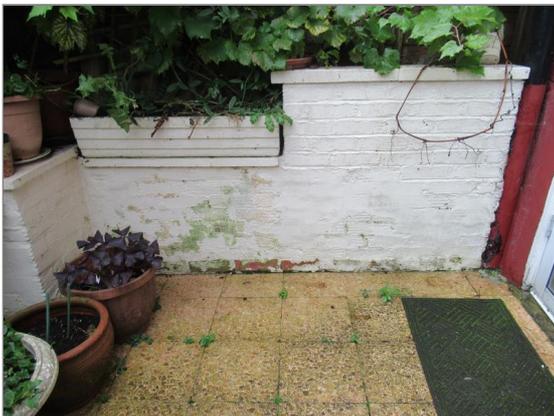
Photo - 144 Damp was noted to the rear right-hand boundary wall

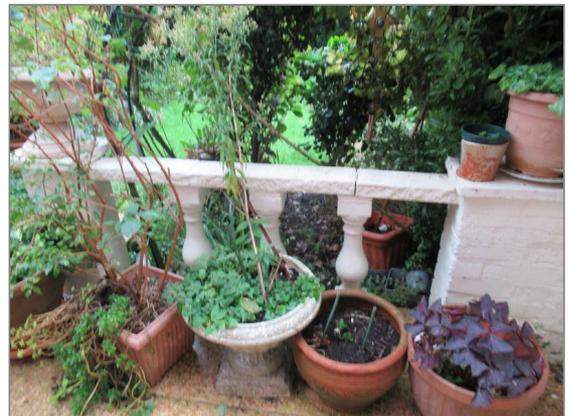
Photo - 145 A crack was noted to the coping stone on the rear garden wall

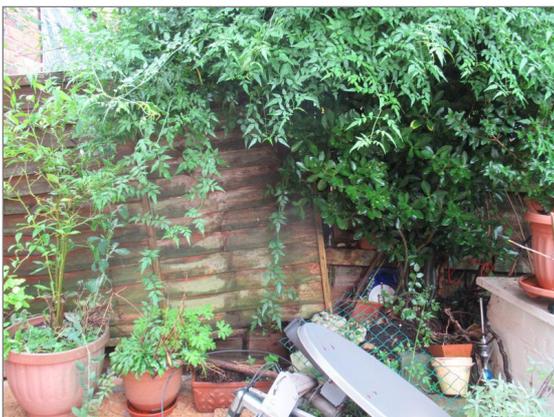
Photo - 146 The rear left-hand boundary fence was noted to be defective

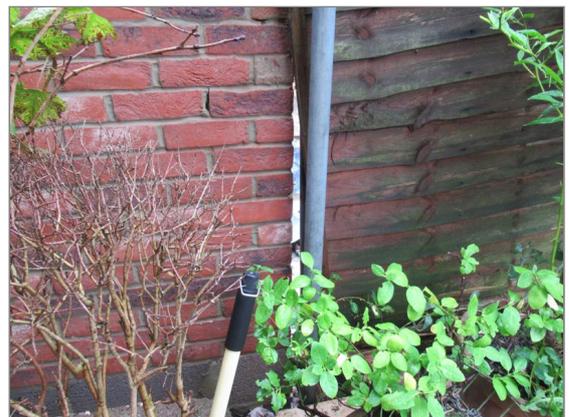
Photo - 147 The rear left-hand boundary fence was noted to be defective

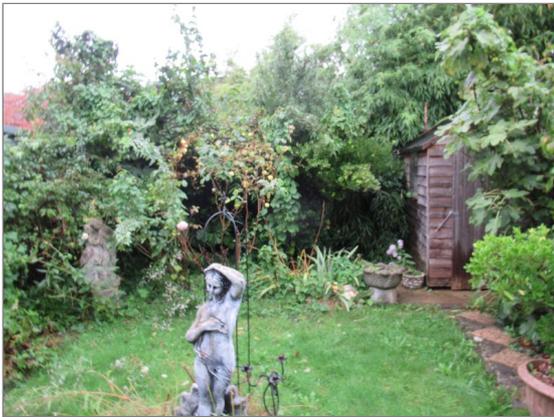
Photo - 148 Overgrown shrubbery was noted to the rear of the property

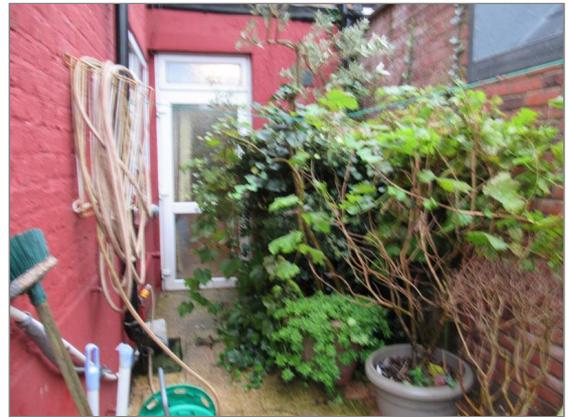
Photo - 149 Overgrown shrubbery was noted to the rear of the property

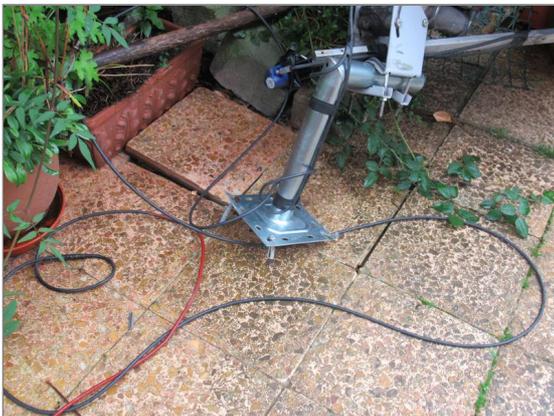
Photo - 150 Paving slabs were noted to be loose on the rear pathway
