# Your survey report

6 Leicester Road,  
London,  
N2 8EB

20th October 2023

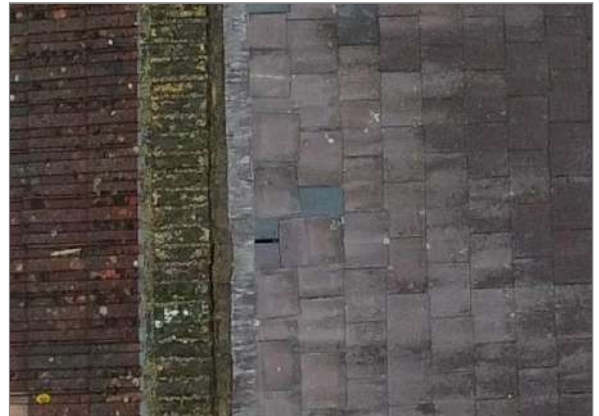
- Damp staining was noted to the front elevation left-hand parapet wall (see photo below).
- Gaps were noted between the tiles on the rear elevation main roof (see photo below). This will allow rainwater ingress to the timber structure of the roof, leading to damp and rot (refer to section 'E1 Roof structure' for further information).

*Photo - 17 Gaps were noted between the tiles on the rear elevation main roof*

Repair or replace slipped or missing tiles so that there are no gaps between roof tiles for rainwater to penetrate.

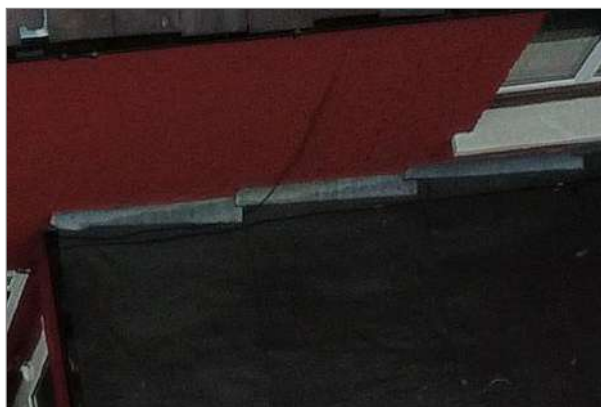
- Gaps were noted to the lead flashing on the flat roof (see photo below).

*Photo - 21 Gaps were noted to the lead flashing on the flat roof*

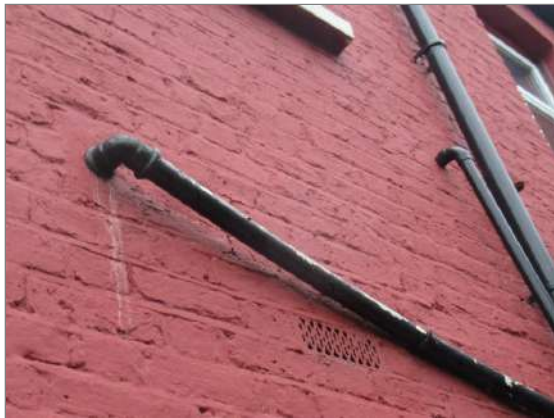
- Staining was noted to the joints of the downpipe on the front elevation (see photo below).
- Staining was noted to the bathroom waste pipe on the rear elevation (see photo below).

*Photo - 25 Staining was noted to the bathroom waste pipe on the rear elevation*

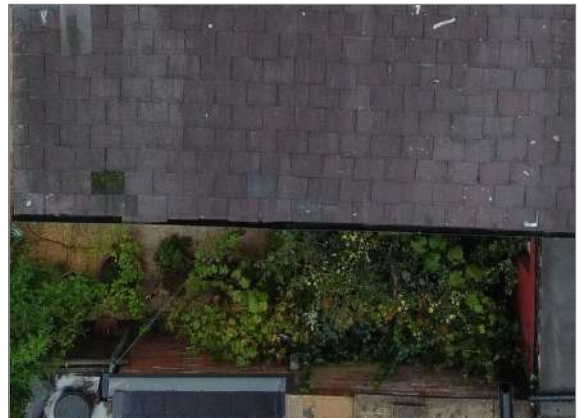
*Photo - 26 Slipped tiles were blocking the guttering on the rear elevation*

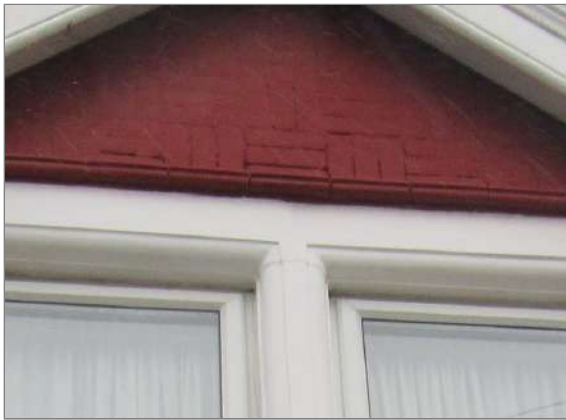
*Photo - 30 Gaps were noted in the mortar pointing on the front elevation*

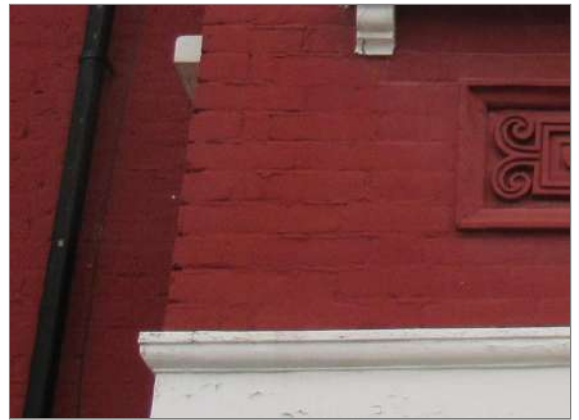
*Photo - 32 Gaps were noted in the mortar pointing on the front elevation*

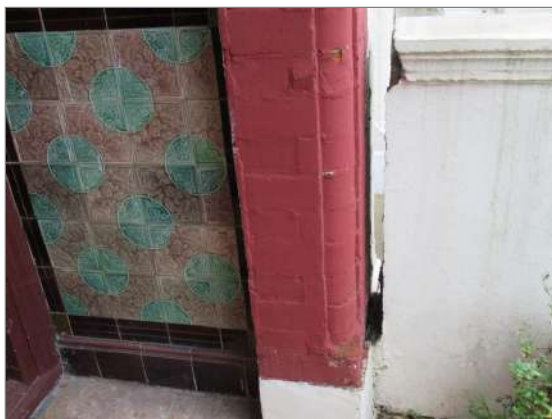
*Photo - 34 Damp was noted at the base of the walls on the front elevation*

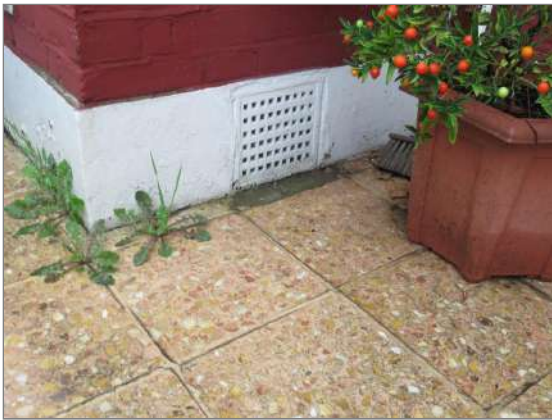
*Photo - 36 Damp was noted to the brickwork on the front elevation*

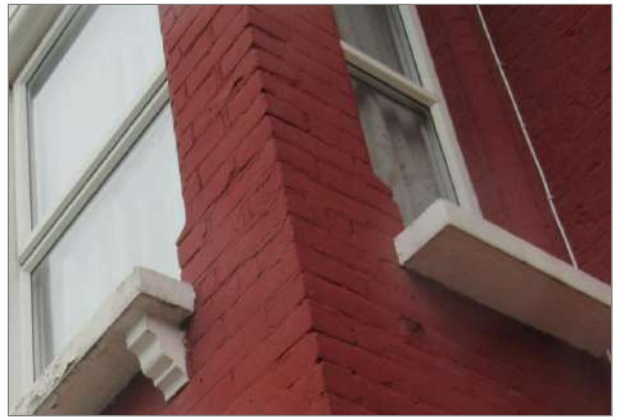
*Photo - 37 Damp was noted to the brickwork on the front elevation*

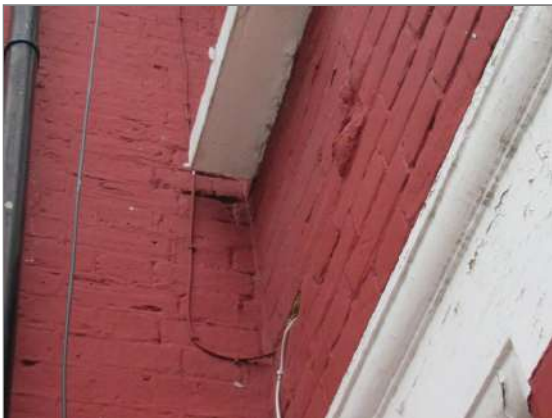
*Photo - 38 An uncovered vent was noted to the rear elevation wall*

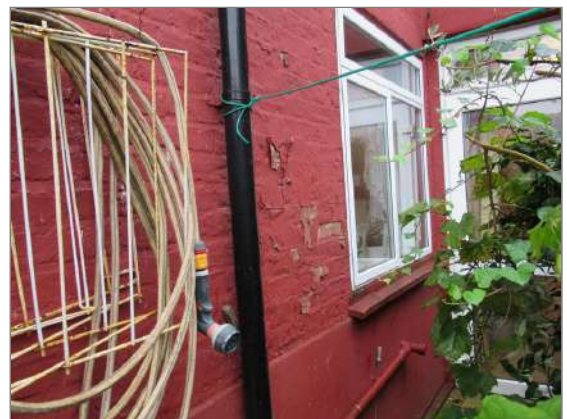
*Photo - 40 Damp was noted to the brickwork on the rear elevation*

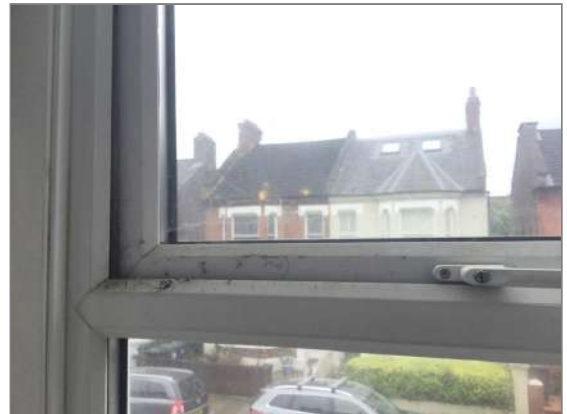
*Photo - 43 The window in the front bedroom was noted to be defective and would not close sufficiently*

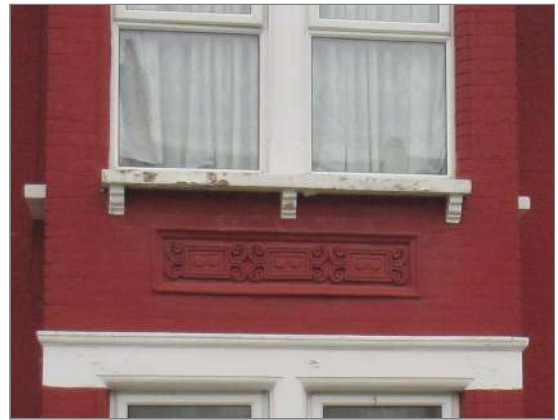
*Photo - 44 Weathering was noted to the external concrete window cills on the front elevation*

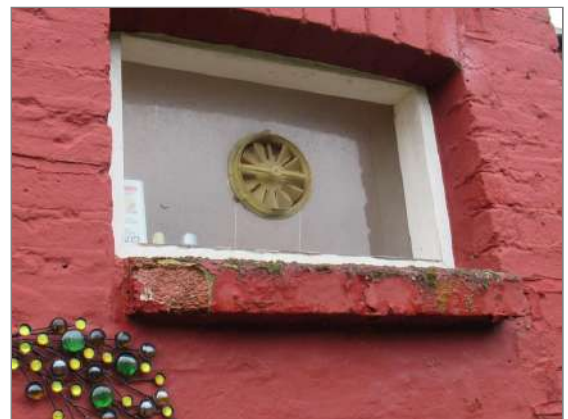
*Photo - 48 Damp was noted to the brick window cill on the rear elevation*

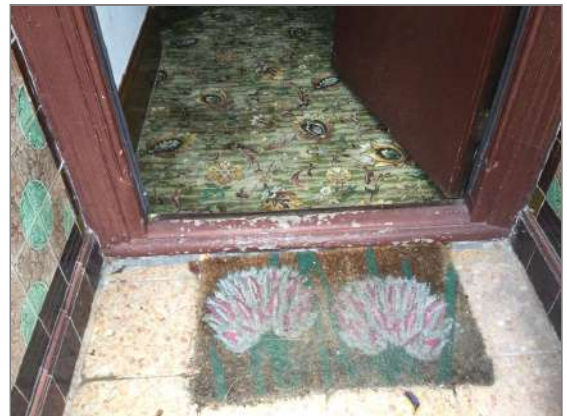
*Photo - 51 The front door was noted to be weathered*

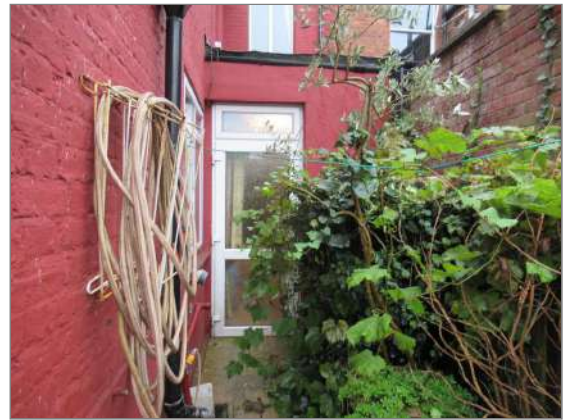
*Photo - 54 The rear side door was noted to be defective when operated*

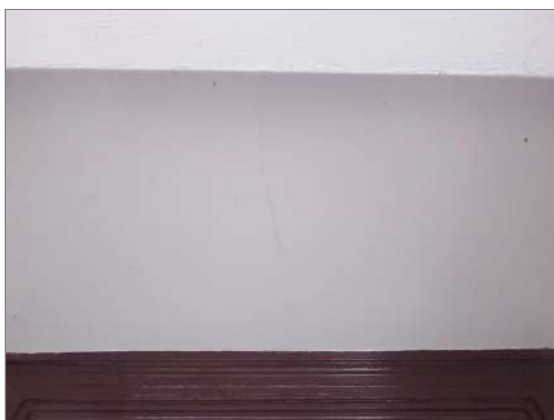
*Photo - 56 Cracks were noted to the walls of the porch*

Repair the cracks to the porch and redecorate as required.

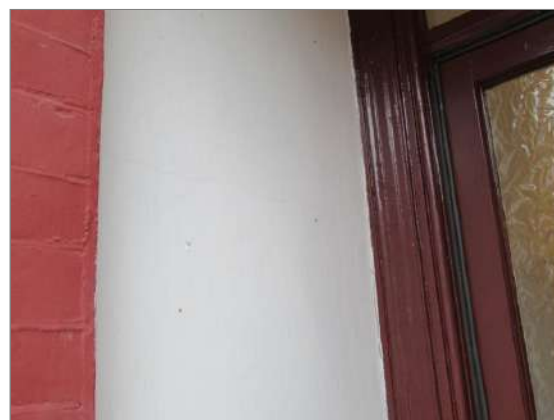
*Photo - 57 Cracks were noted to the walls of the porch*

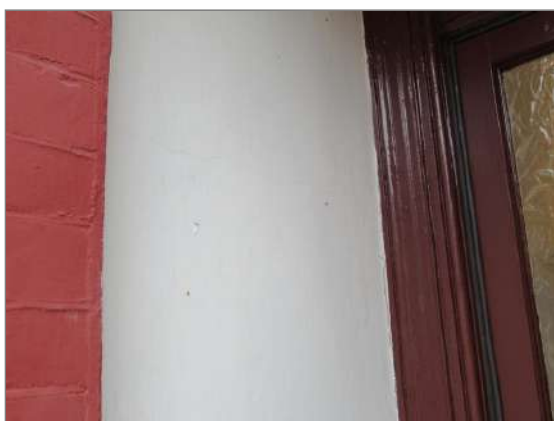
*Photo - 58 Cracks were noted to the walls of the porch*

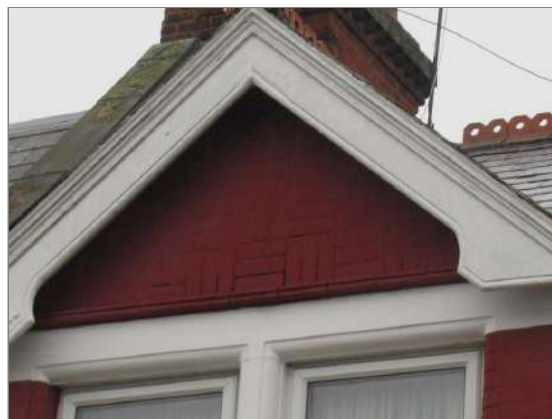
*Photo - 60 Weathering was noted to the front elevation soffit and fascia boards*

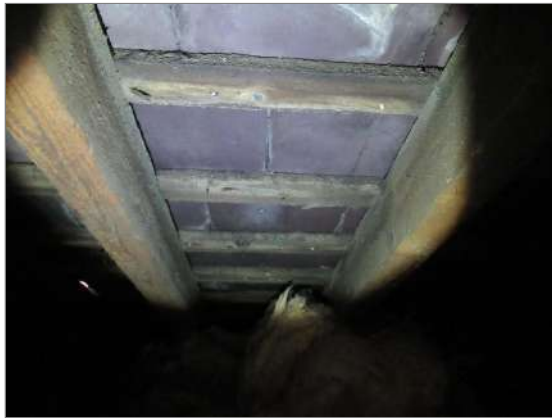
*Photo - 62 No sarking present*

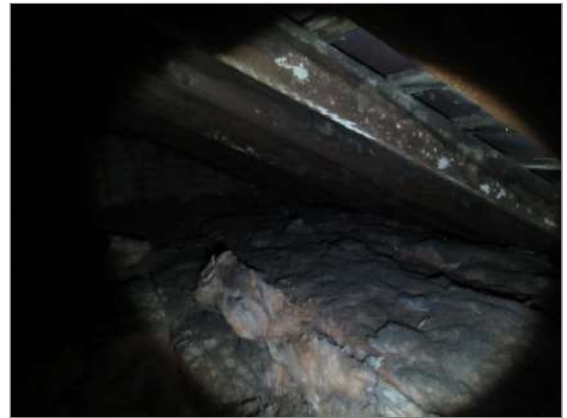
*Photo - 63 Damp and mould was noted to the timber roof structure*

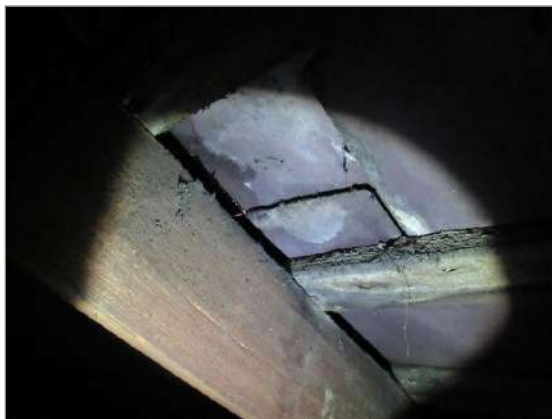
*Photo - 64 Damp and mould was noted to the timber roof structure*

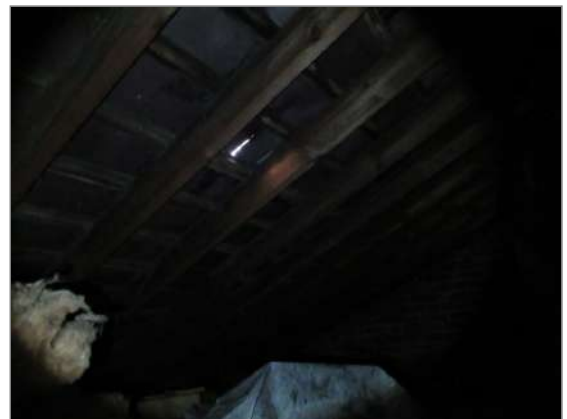
*Photo - 65 Gaps were noted to the roof covering*

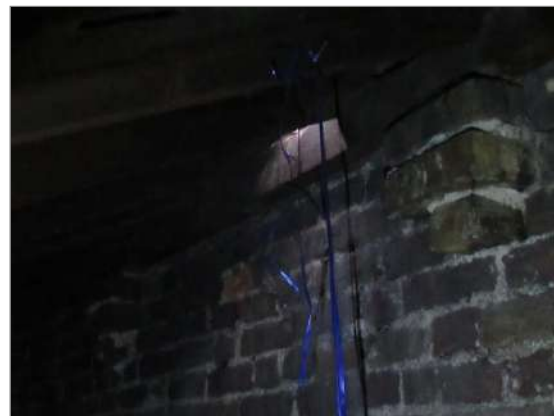
*Photo - 67 Gaps were noted to the roof covering*

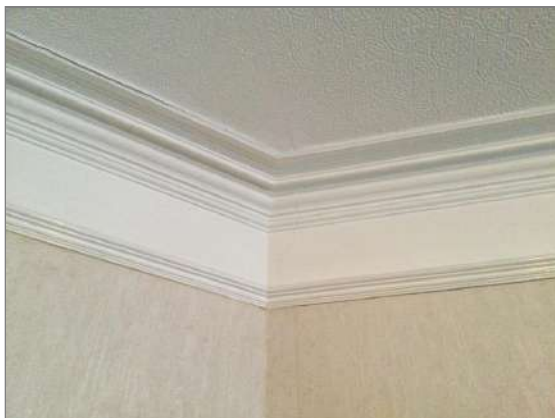
*Photo - 69 Hairline cracking was noted to the coving in the front living room*

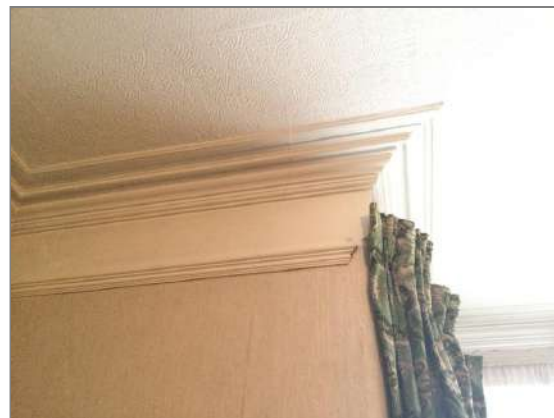
*Photo - 70 Hairline cracking was noted to the coving in the front living room*

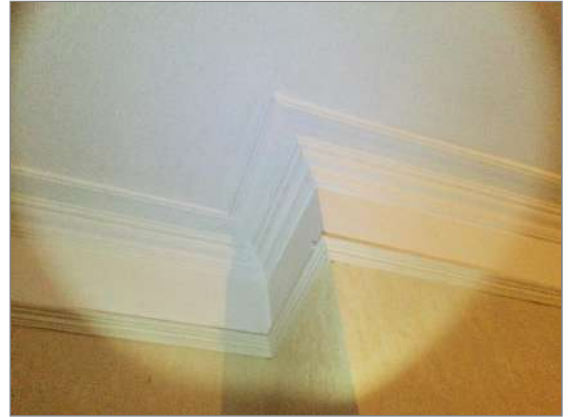
*Photo - 72 Hairline cracking was noted to the coving in the second living room*

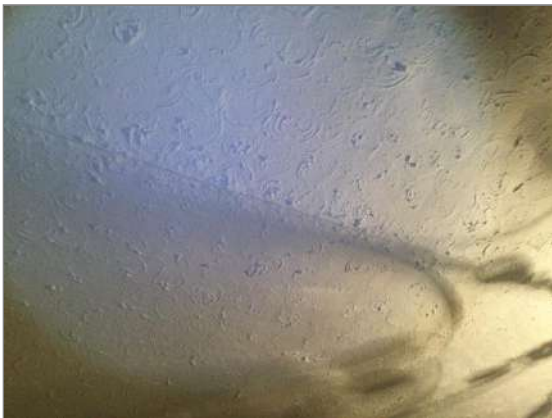
*Photo - 73 Cracking was noted to the ceiling in the dining room*

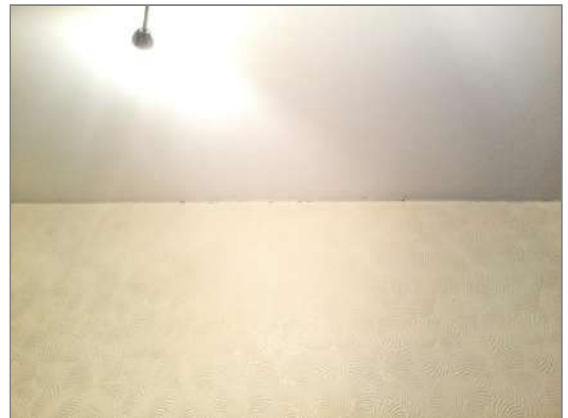
*Photo - 74 Perimeter cracking was noted to the ceiling in the rear left shower room*

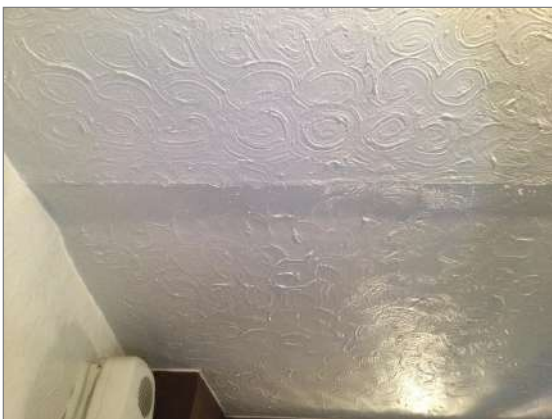
*Photo - 75 Cracking was noted to the ceiling in the rear shower room*

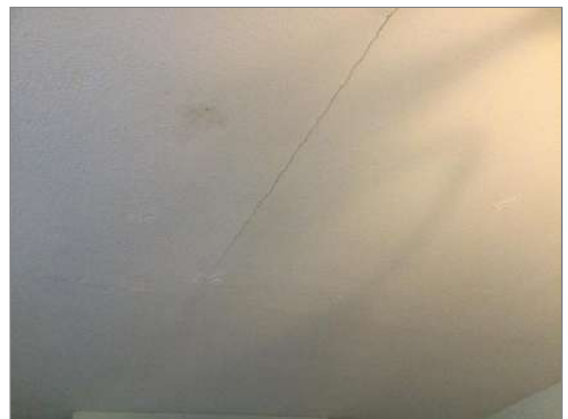
*Photo - 76 Cracking was noted to the ceiling in the front bedroom*

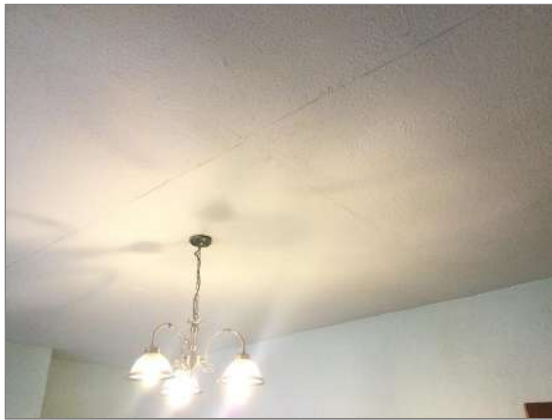
*Photo - 77 Cracking was noted to the ceiling in the front bedroom*

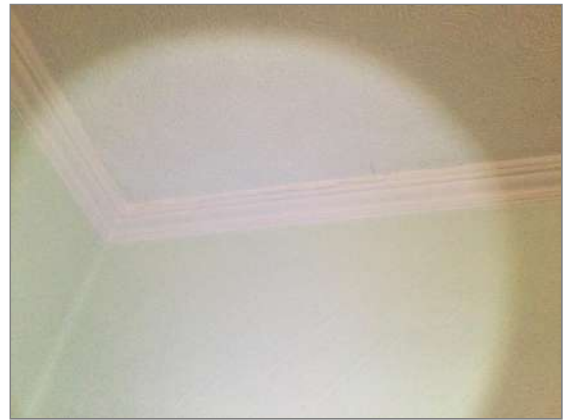
*Photo - 78 Hairline cracking was noted to the coving in the first left hand bedroom*

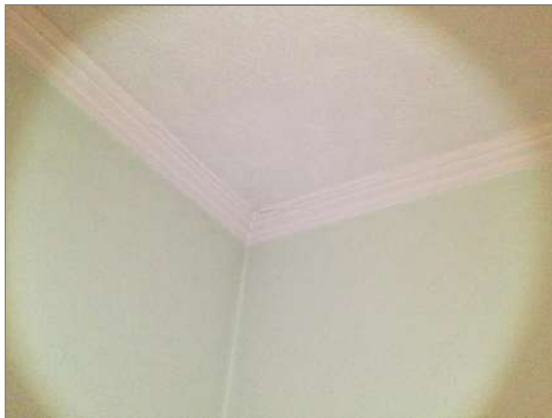
*Photo - 79 Hairline cracking was noted to the coving in the first left hand bedroom*

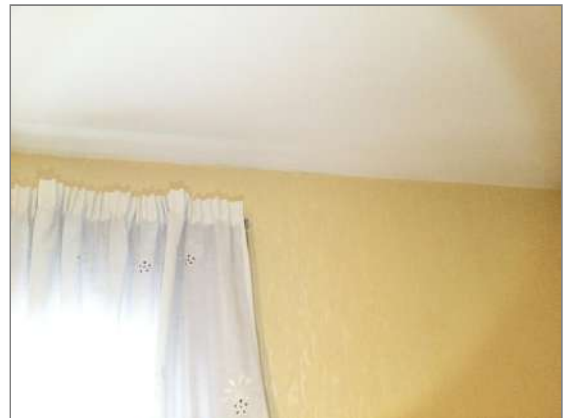
*Photo - 80 Perimeter cracking was noted to the ceiling in the second left hand bedroom*

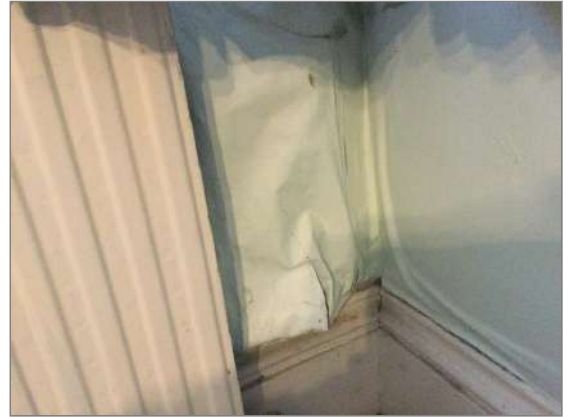
*Photo - 82 Damp was noted to the walls in the front bedroom*

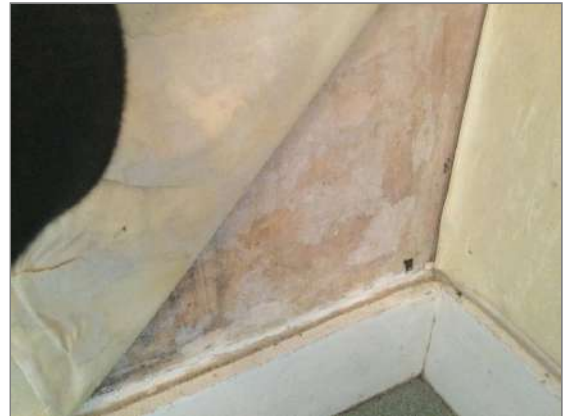
*Photo - 84 Damp was noted to the wall in the third left hand bedroom*

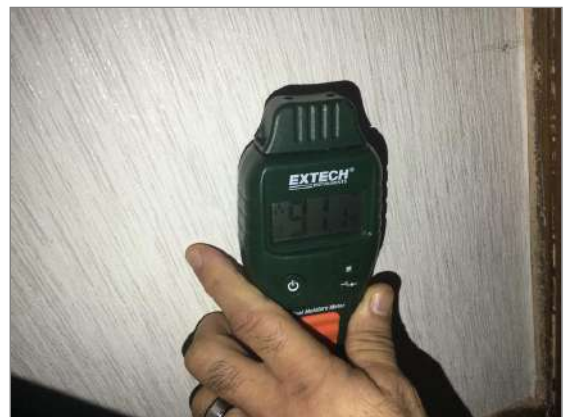
*Photo - 86 High moisture meter readings were recorded on the wall adjacent to the front door*

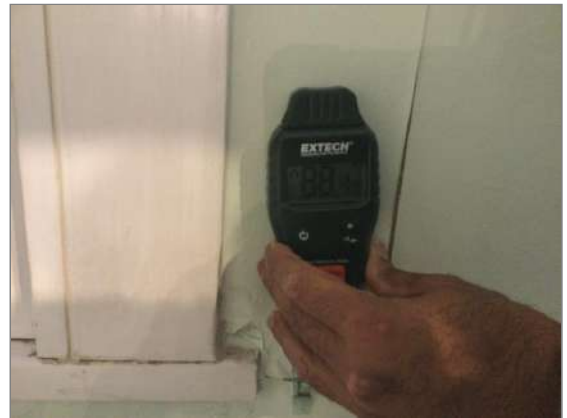
*Photo - 88 High moisture meter readings were recorded on the wall in the front bedroom*

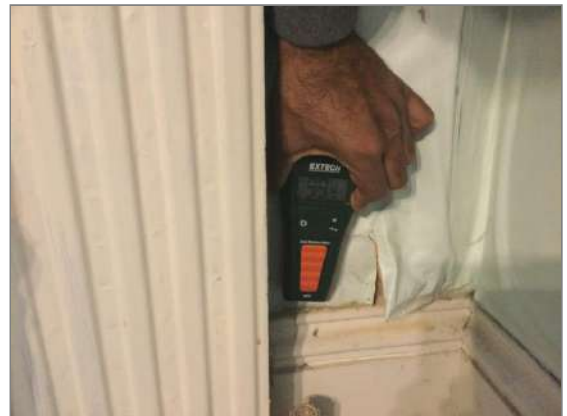
*Photo - 90 High moisture meter readings were recorded on the wall in the front bedroom*

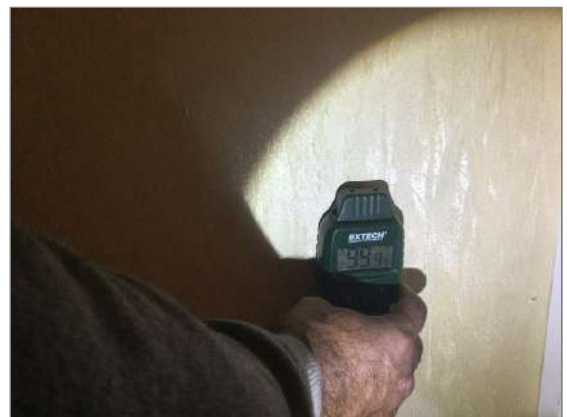
*Photo - 92 High moisture meter readings were recorded on the wall in the second left-hand bedroom*

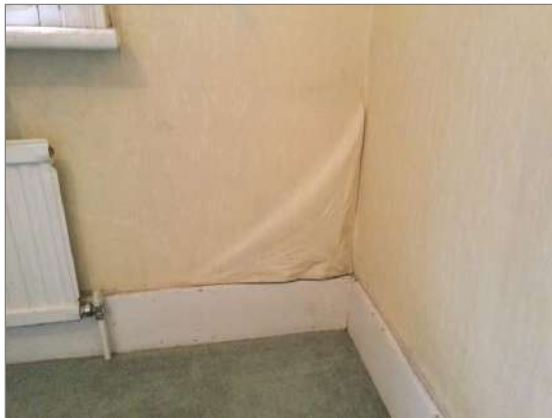
*Photo - 93 High moisture meter readings were recorded on the wall in the third left-hand bedroom*

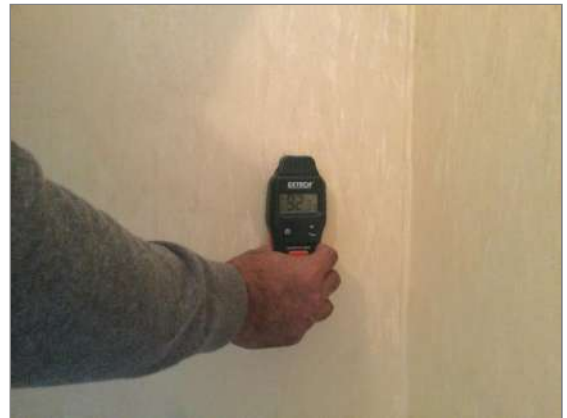
*Photo - 94 High moisture meter readings were recorded on the wall in the third left-hand bedroom*

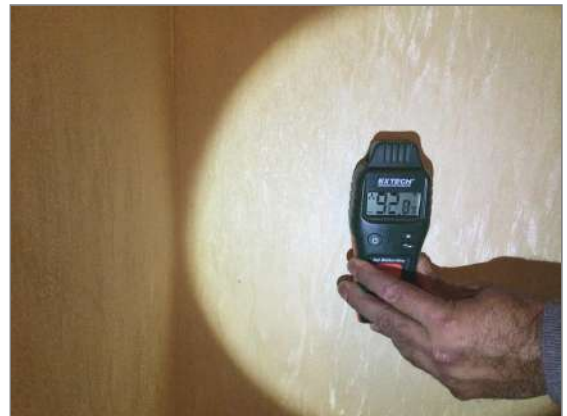
*Photo - 96 High moisture meter readings were recorded on the wall in the third left-hand bedroom*

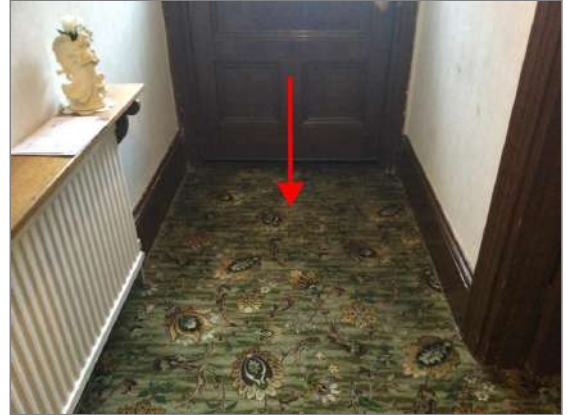
*Photo - 98 A dip was noted to the flooring by the front door*

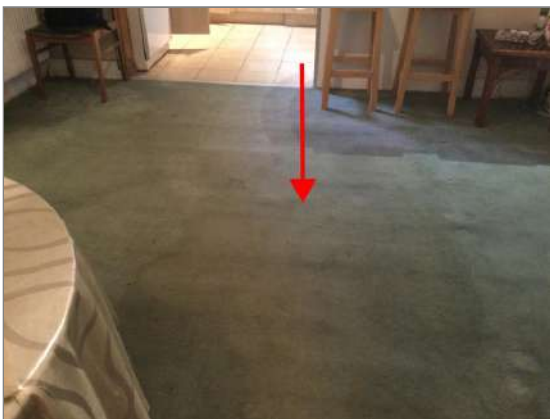
*Photo - 99 The flooring was noted to be raised in the dining room*

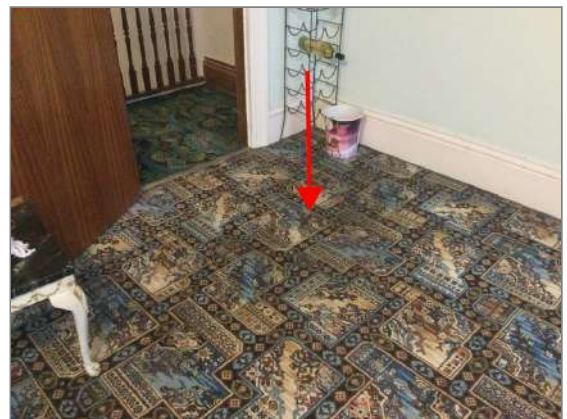
*Photo - 100 A dip was noted to the flooring in the front bedroom*

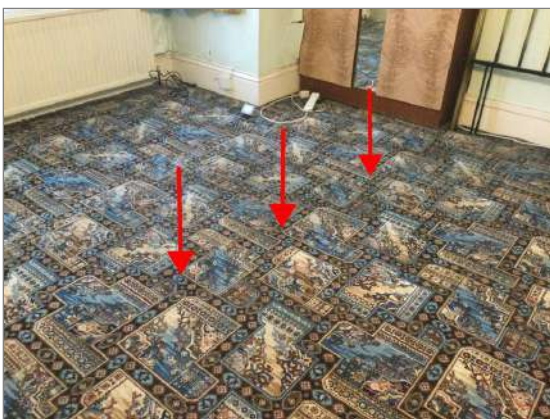
*Photo - 101 The flooring was noted to be raised in the front bedroom*

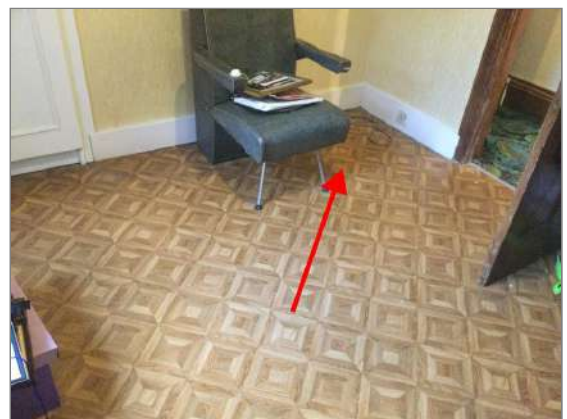
*Photo - 102 The flooring in the second left hand bedroom was noted to be sloping*

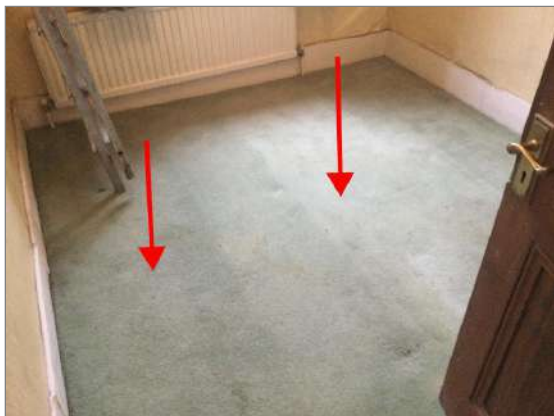
*Photo - 103 Floorboards were noted to deflect when traversed in the third left hand bedroom*

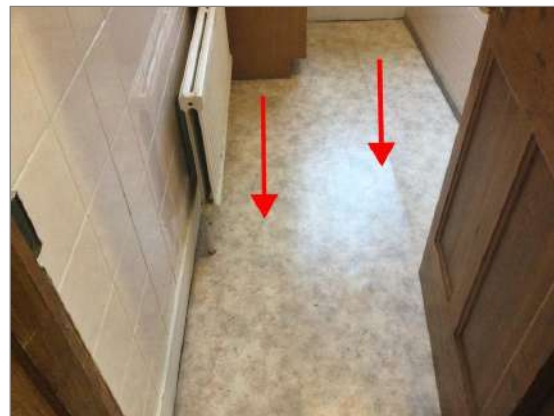
*Photo - 104 Floorboards were noted to deflect when traversed in the first floor bathroom*

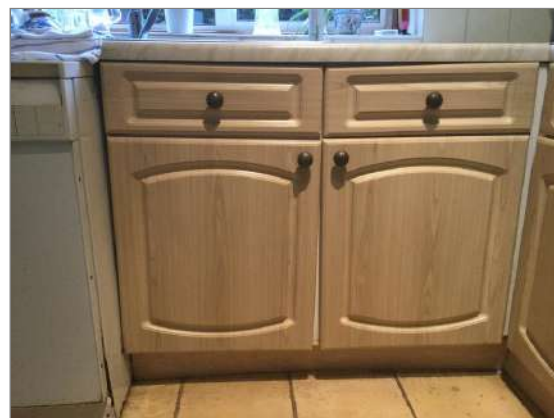
*Photo - 110 The cupboard doors were noted to have dropped on their hinges*

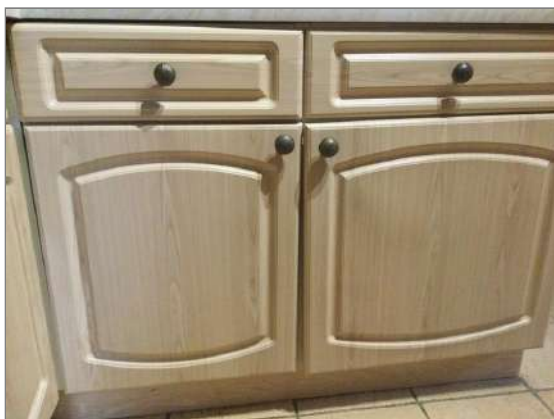
*Photo - 111 The cupboard doors were noted to have dropped on their hinges*

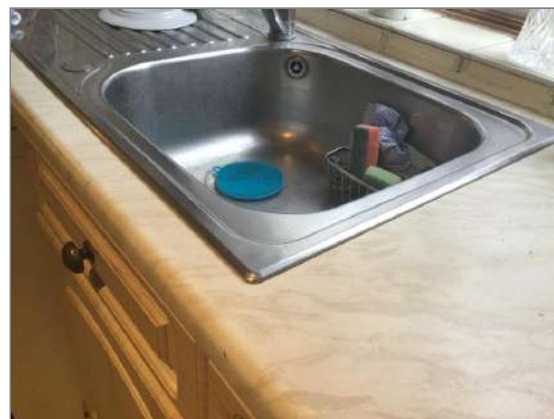
*Photo - 112 The sealant was noted to be missing from around the sink*

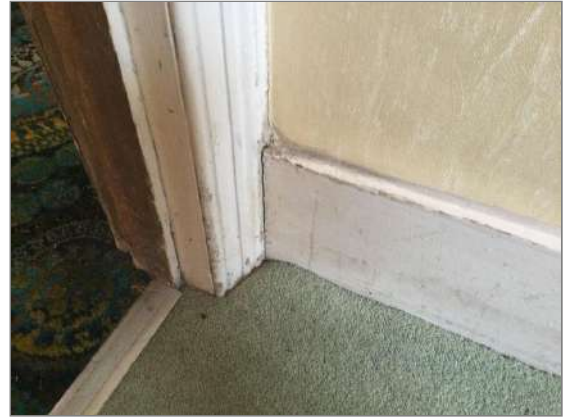
*Photo - 116 Example of shrinkage cracking to the skirting boards*

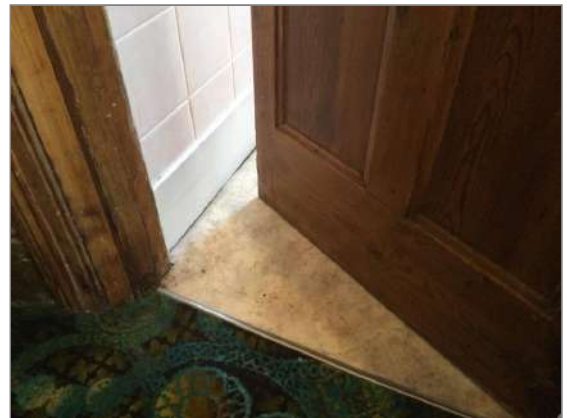
*Photo - 118 The first floor bathroom door was noted to scuff the floor when operated*

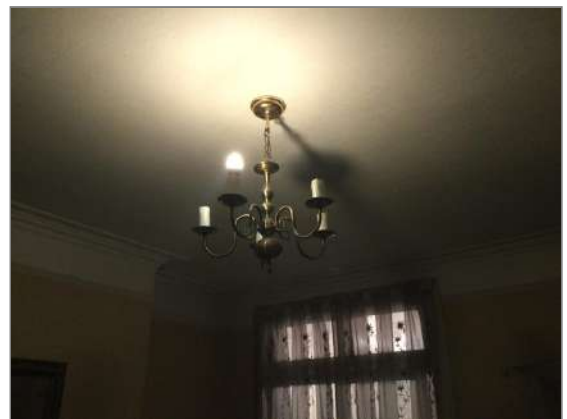
*Photo - 128 Bulbs were noted to be missing in the second living room*

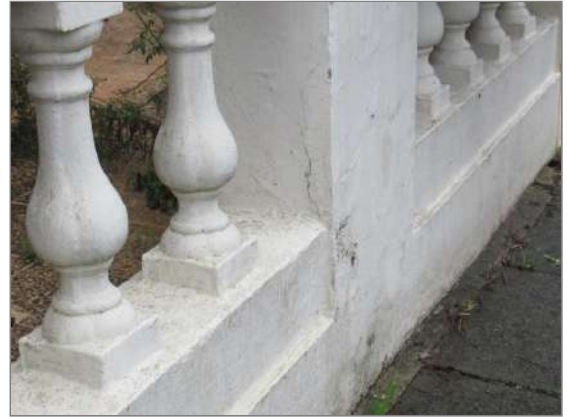
*Photo - 137 Cracks were noted to the front boundary wall*

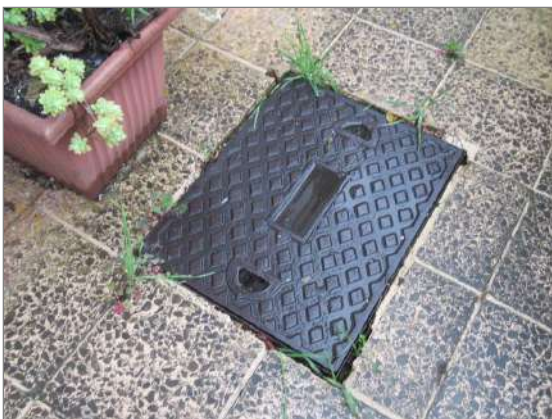
*Photo - 140 The manhole cover was noted to rock when traversed on the front elevation*

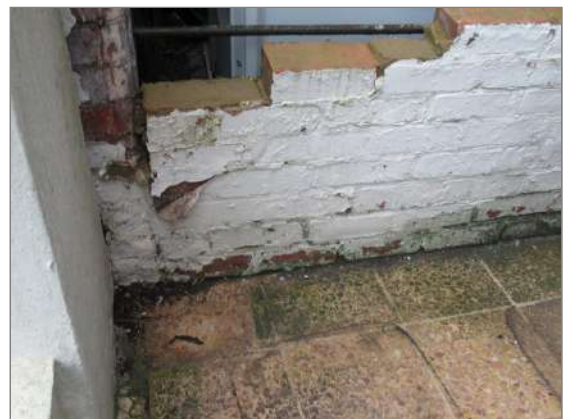
*Photo - 141 The front left-hand boundary wall was noted to be leaning and defective*

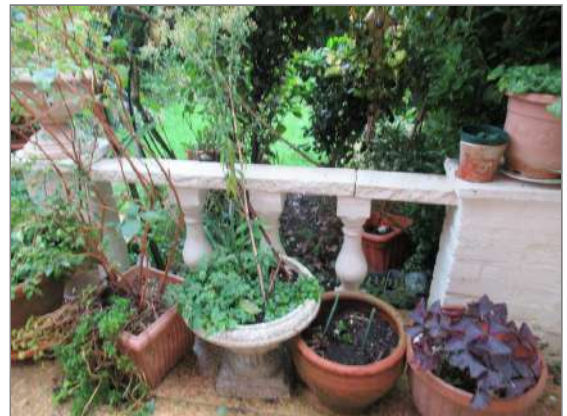
*Photo - 145 A crack was noted to the coping stone on the rear garden wall*

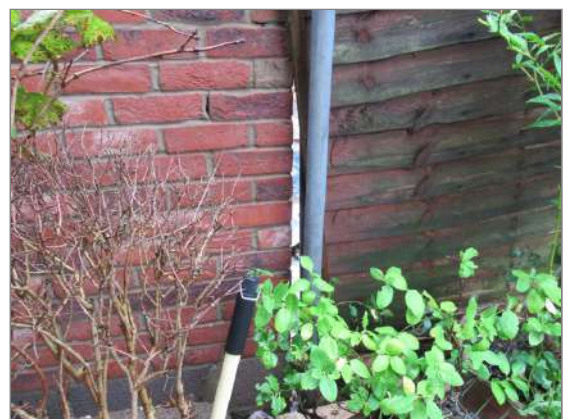
*Photo - 147 The rear left-hand boundary fence was noted to be defective*

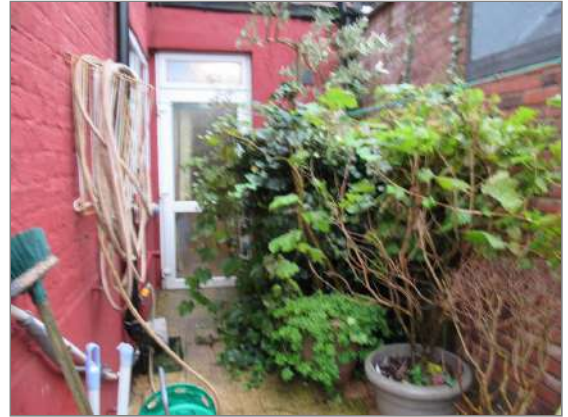
*Photo - 149 Overgrown shrubbery was noted to the rear of the property*
