Snagging List

123 Forever Street
London
N12 8AB

4th July 2024

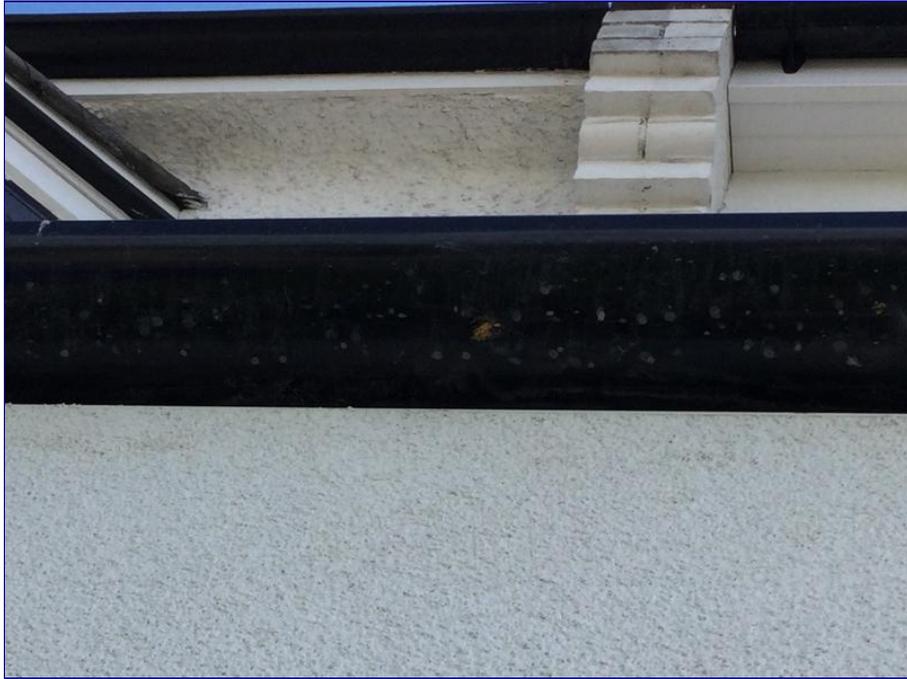
Photo 1

Item	Location	Description	Date Raised	Comments	Defect Owner	Action by Defect Owner Initial	Checked Date	Checked by Initial
1.1	External							
1.1.1	Gutters	Dirt marks to the UPVC gutters above front porch	04-07-2024	Dirt marks to the UPVC gutters above front porch Photo [1]

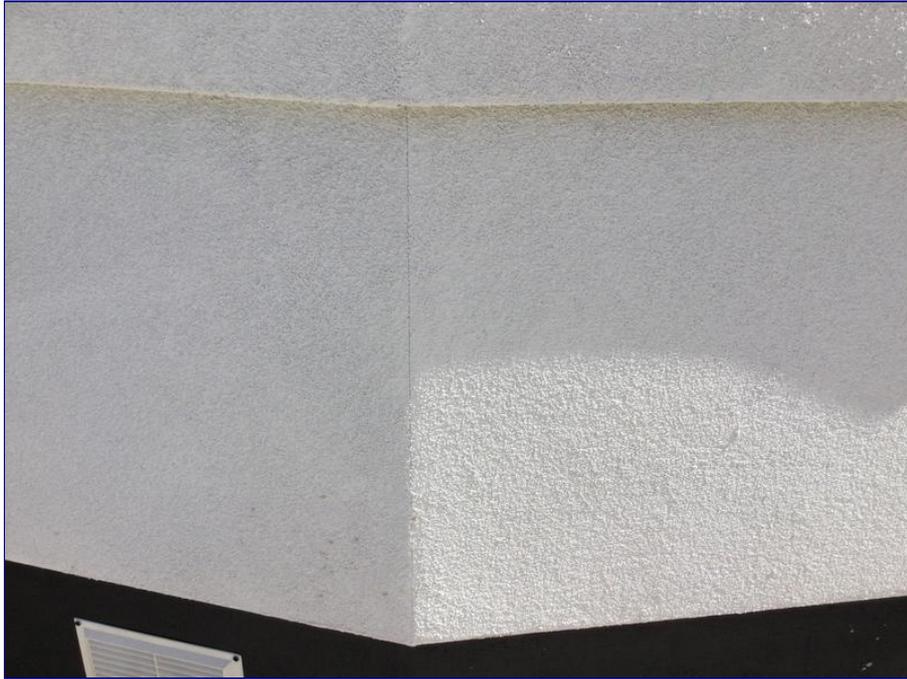
Photo 3

1.1.10	Gutters	Bowing soffit	04-07-2024	Bowing soffit Photo [126]				
1.1.11	Walls	A hairline crack running down the external rendered wall	04-07-2024	A hairline crack running down the external rendered wall Photo [3]

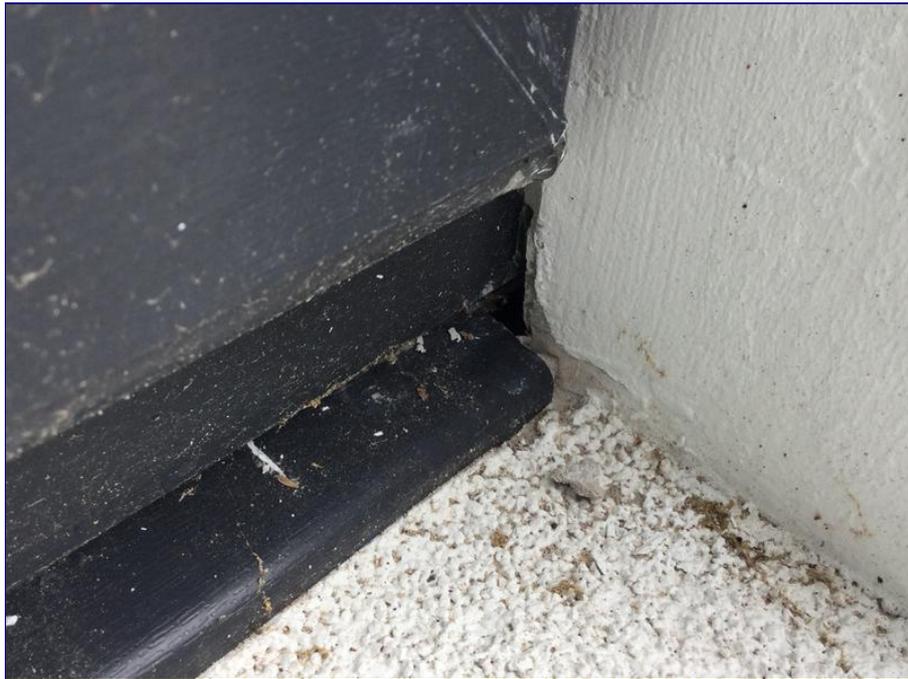
Photo 7

Item	Location	Description	Date Raised	Comments	Defect Owner	Action by Defect Owner Initial	Checked Date	Checked by Initial
1.1.15	Walls	Void between external wall and left bay window	04-07-2024	Void between external wall and left bay window Photo [7]

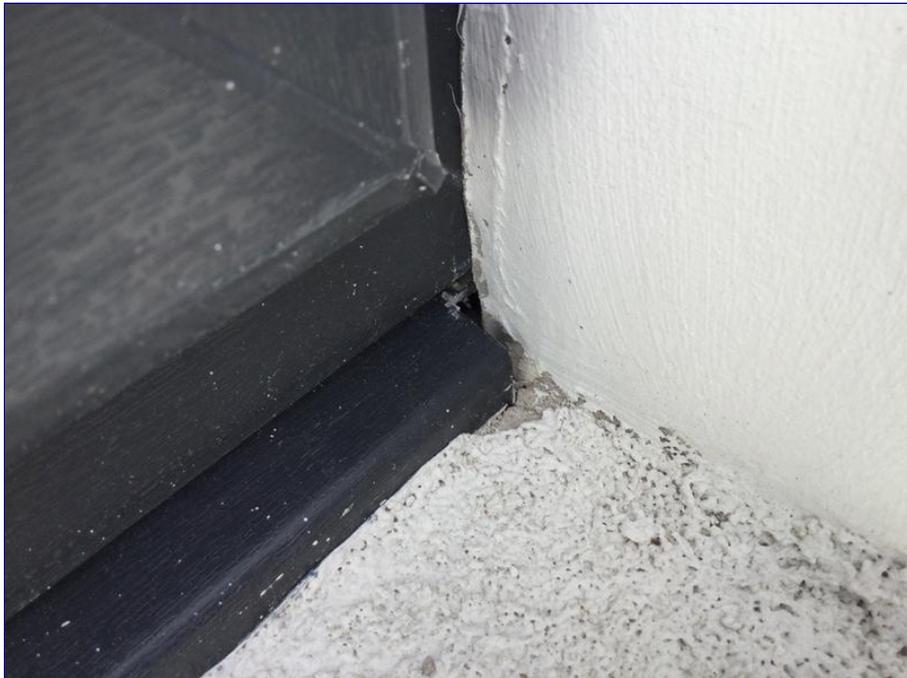
Photo 12

1.1.20	Walls	Void between external wall and right central bay window	04-07-2024	Void between external wall and right central bay window Photo [12]				
1.1.21	Walls	Impact damage was noted to the front elevation wall	04-07-2024	Impact damage was noted to the front elevation wall Photo [13]

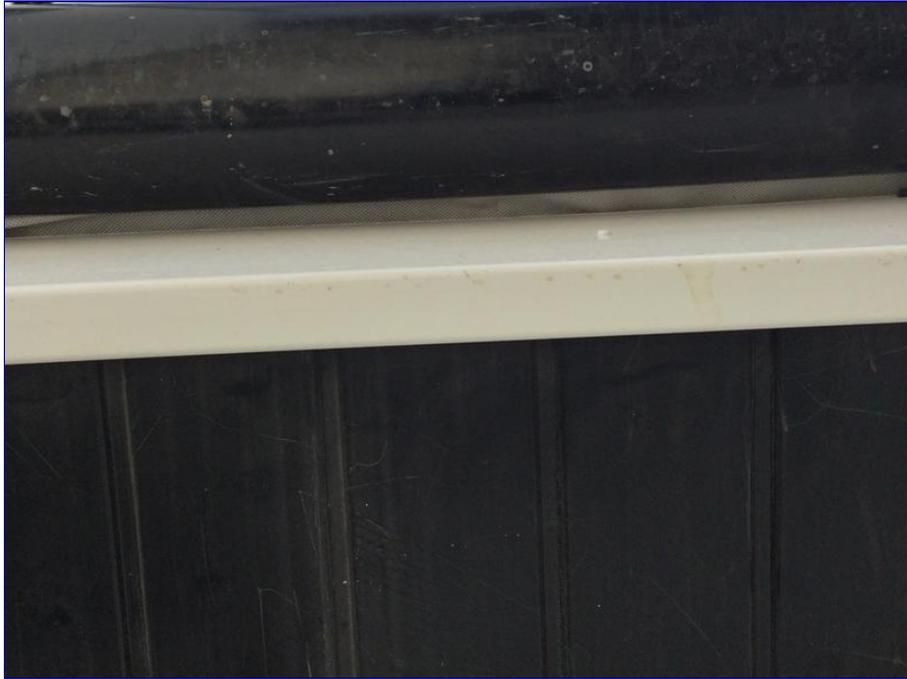
Photo 15

1.1.2	Gutters	Dirt marks to the UPVC gutters to the main roof	04-07-2024	Dirt marks to the UPVC gutters to the main roof Photo [2]				
1.1.3	Gutters	Staining was noted to the fascias to side extension	04-07-2024	Staining was noted to the fascias to side extension Photo [15]

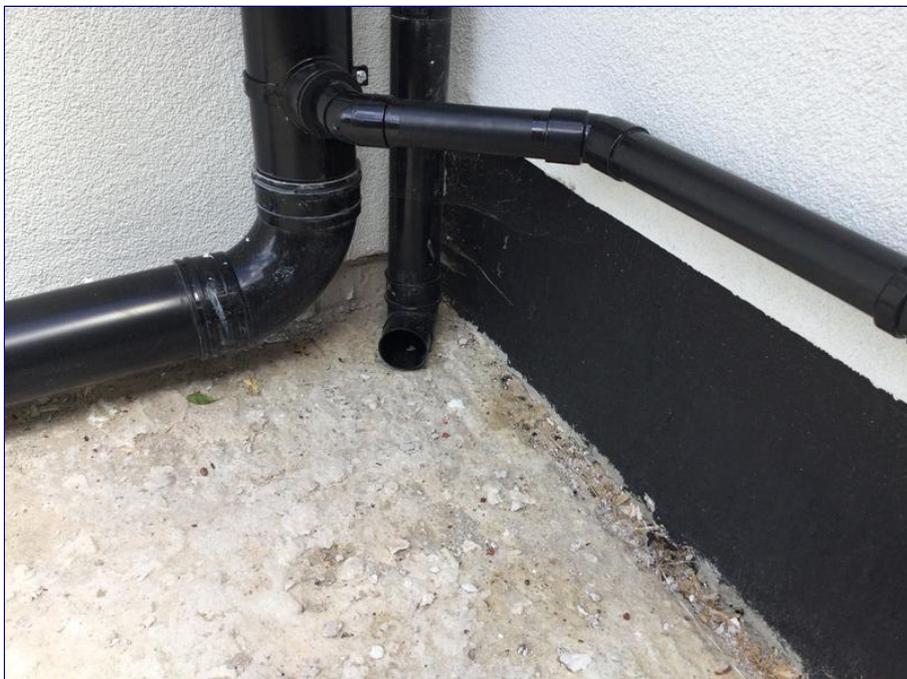
Photo 16

1.1.4	Gutters	No draining build to the downpipe of the side extension	04-07-2024	No draining build to the downpipe of the side extension Photo [16]

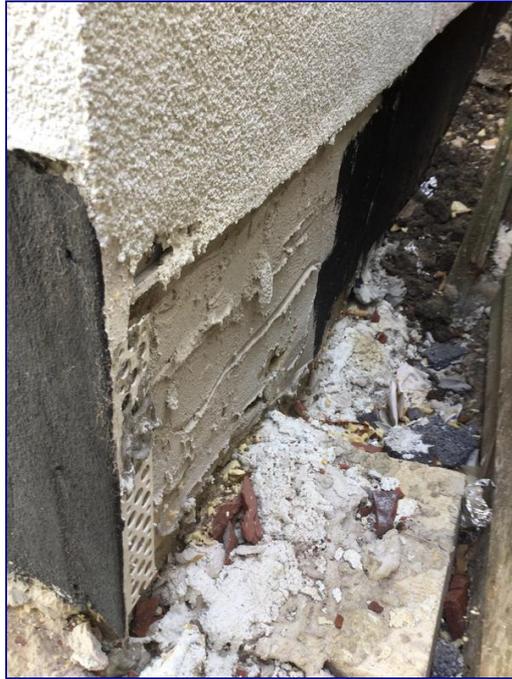
Photo 17

Item	Location	Description	Date Raised	Comments	Defect Owner	Action by Defect Owner Initial	Checked Date	Checked by Initial
1.1.23	Walls	Incomplete render was noted to the side elevation of the side extension	04-07-2024	Incomplete render was noted to the side elevation of the side extension Photo [17]

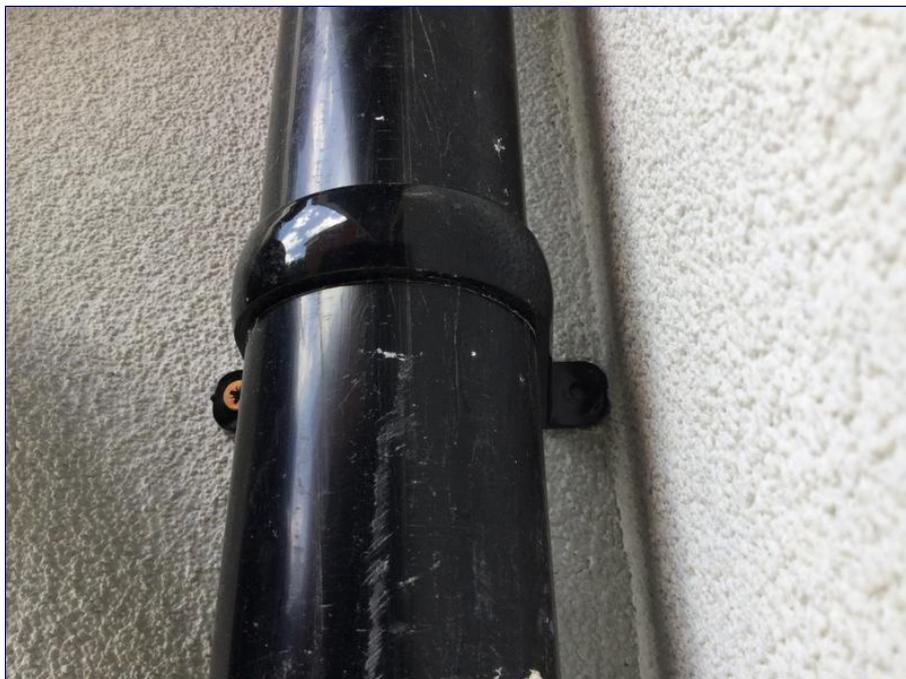
Photo 18

1.1.5	Gutters	Missing screws to the downpipe joints	04-07-2024	Missing screws to the downpipe joints Photo [18]				
1.1.6	Gutters	Missing screws to the downpipe joints	04-07-2024	Missing screws to the downpipe joints Photo [19]

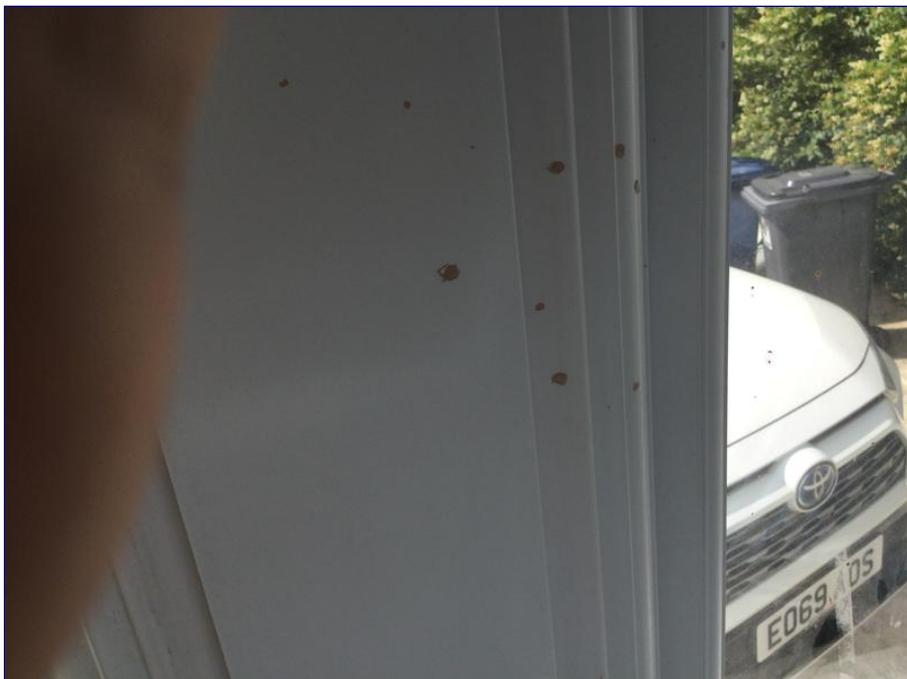
Photo 71

1.7.2	Sitting room	Staining was noted to the windows in the sitting room	04-07-2024	Staining was noted to the windows in the sitting room Photo [71]

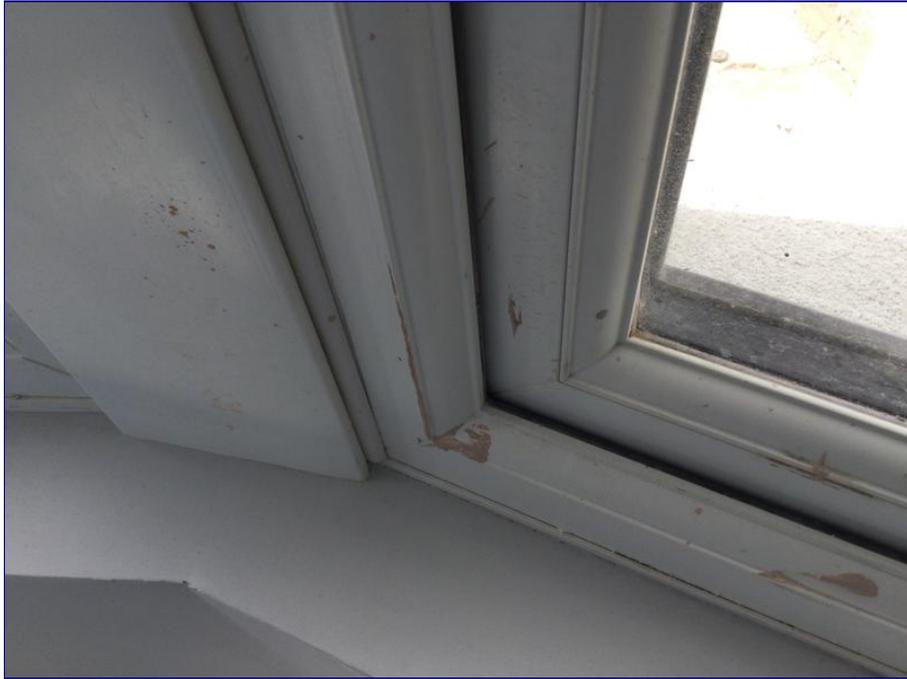
Photo 72

1.7.3	Sitting room	Staining was noted to the windows in the sitting room	04-07-2024	Staining was noted to the windows in the sitting room Photo [72]

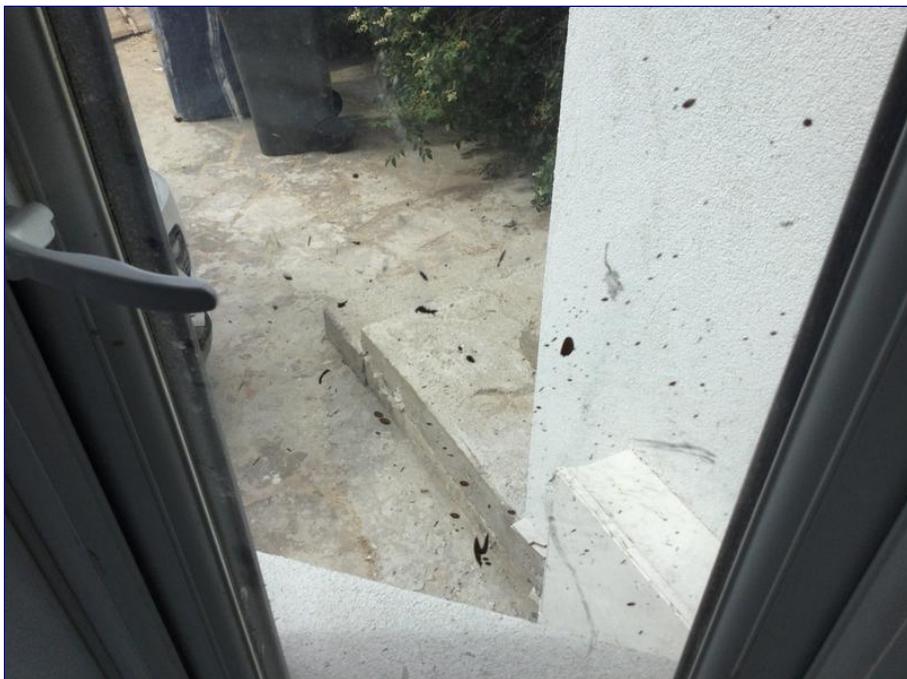
Photo 73

1.7.4	Sitting room	Staining was noted to the windows in the sitting room	04-07-2024	Staining was noted to the windows in the sitting room Photo [73]

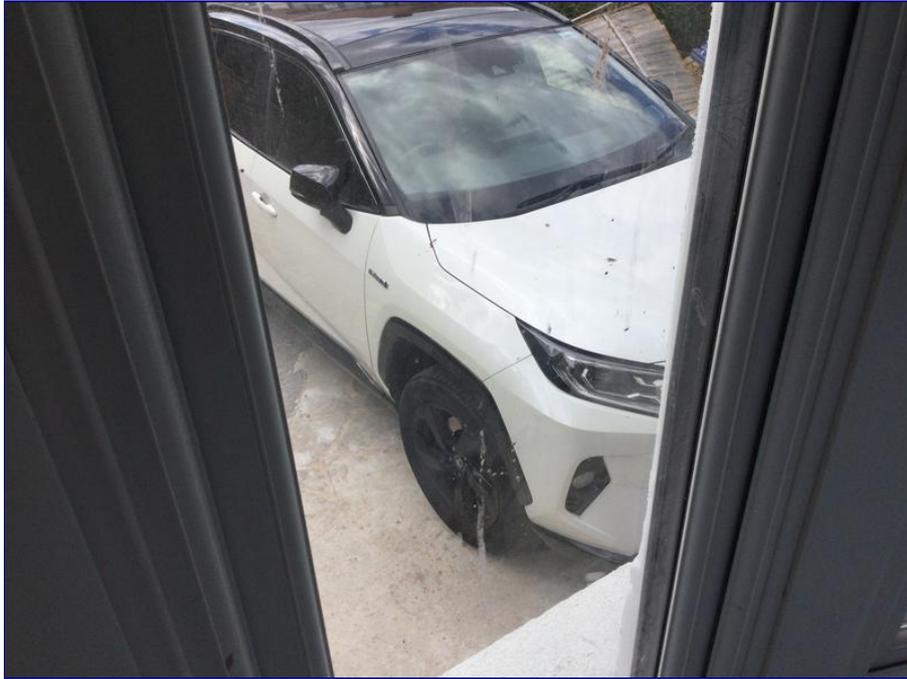
Photo 74

1.7.5	Sitting room	Staining was noted to the double glazed windows in the sitting room	04-07-2024	Staining was noted to the double glazed windows in the sitting room Photo [74]

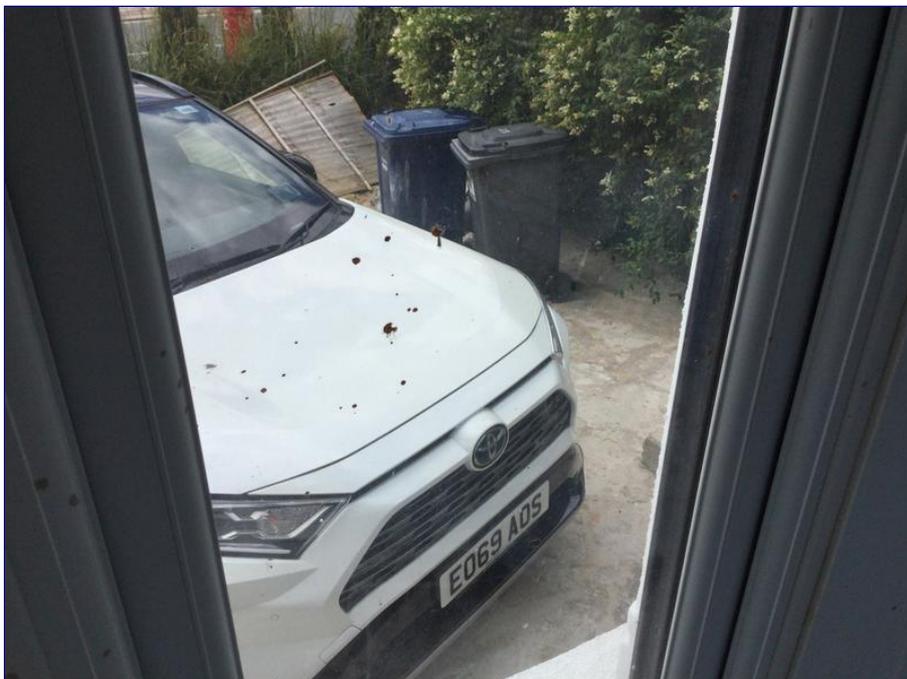
Photo 75

Item	Location	Description	Date Raised	Comments	Defect Owner	Action by Defect Owner Initial	Checked Date	Checked by Initial
1.7.6	Sitting room	Staining was noted to the double glazed windows in the sitting room	04-07-2024	Staining was noted to the double glazed windows in the sitting room Photo [75]

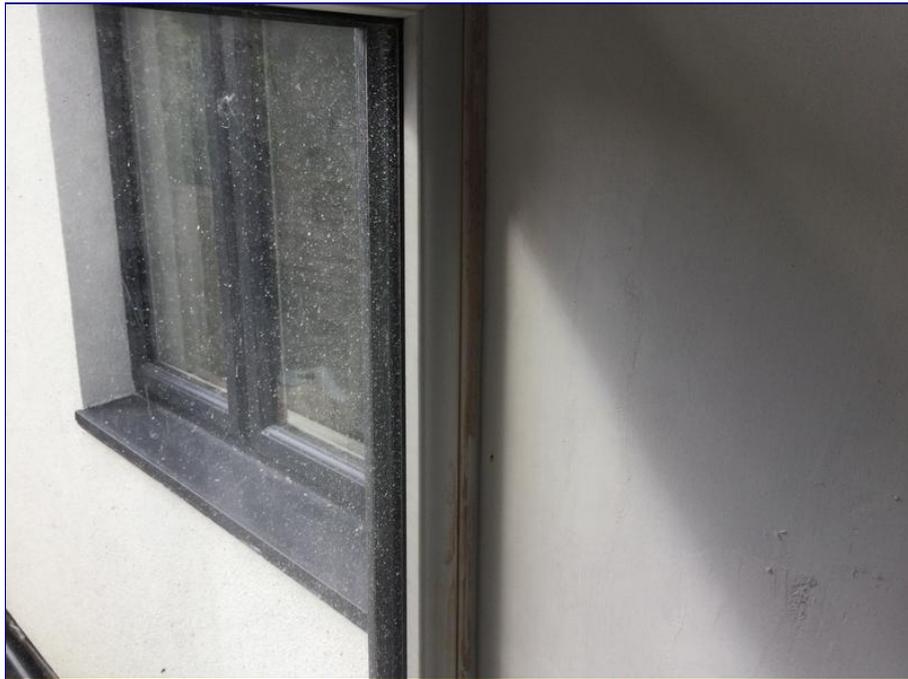
Photo 111

1.7.8	Kitchen	Staining was noted to the windows in the kitchen	04-07-2024	Staining was noted to the windows in the kitchen Photo [111]				
1.7.9	Kitchen	Ill-fitted window sill in the kitchen	04-07-2024	Ill-fitted window sill in the kitchen Photo [112]

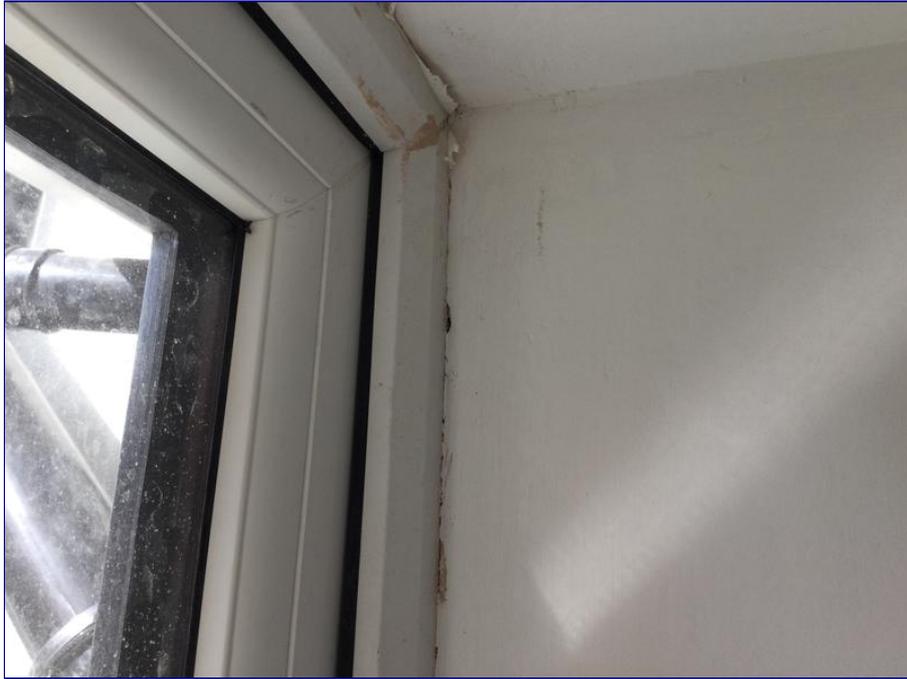
Photo 113

1.7.10	Kitchen	Shrinkage cracking to the wall in the kitchen	04-07-2024	Shrinkage cracking to the wall in the kitchen Photo [113]				
1.7.11	Bedroom four	Cracked paint to window sill in the bedroom.	04-07-2024	Cracked paint to window sill in the bedroom. Photo [165]

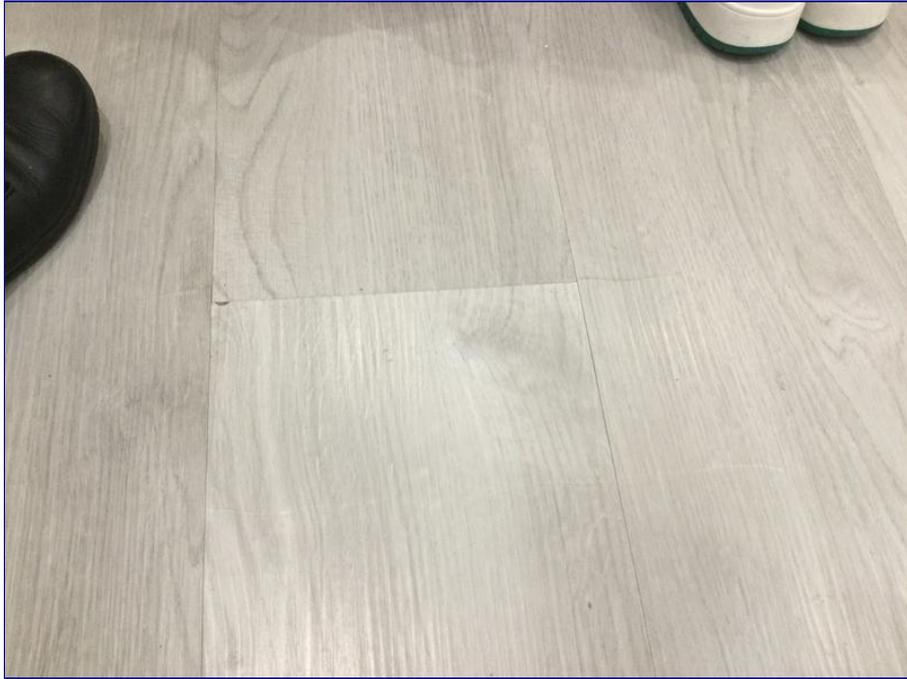
Photo 133

1.8	Flooring							
1.8.1	Upstairs hallway	The vinyl flooring is cracked and lifted	04-07-2024	The vinyl flooring is cracked and lifted Photo [133]				
1.8.2	Upstairs hallway	The vinyl flooring is cracked and lifted	04-07-2024	The vinyl flooring is cracked and lifted Photo [134]

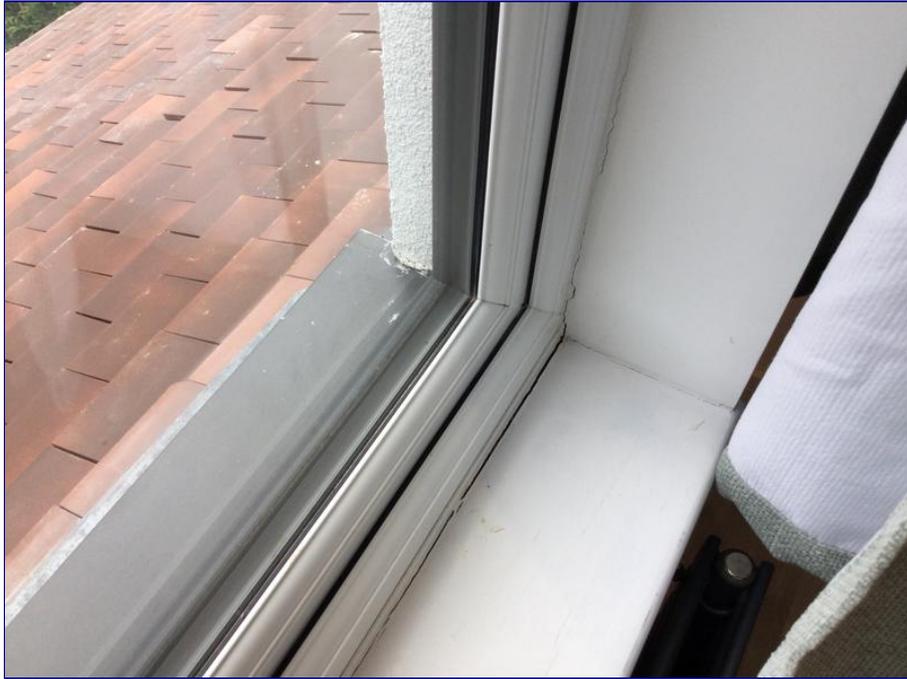
Photo 166

1.7.12	Bedroom four	Hairline crack across the window sill in the bedroom.	04-07-2024	Hairline crack across the window sill in the bedroom. Photo [166]

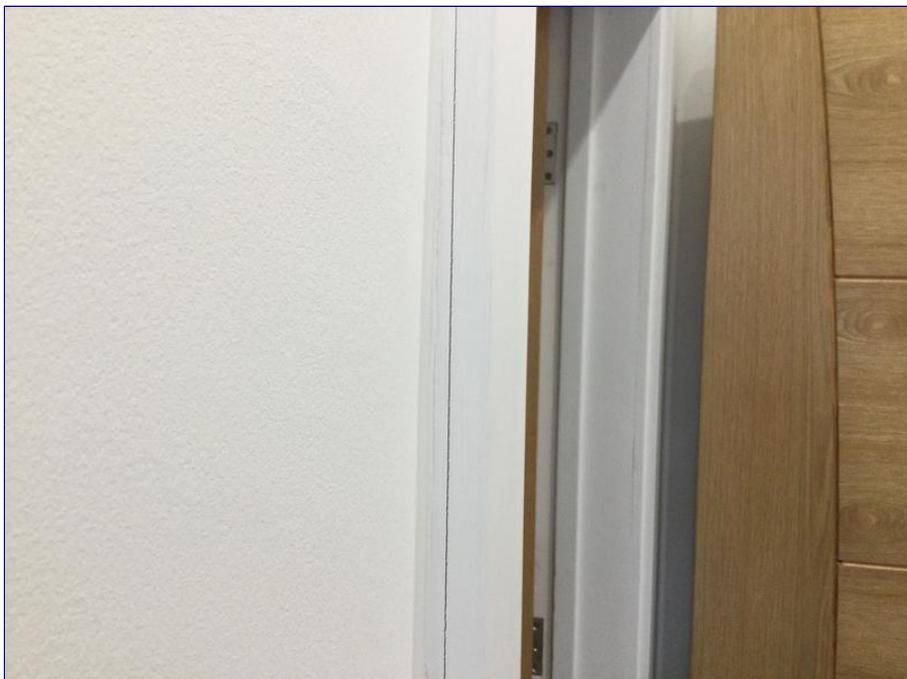
Photo 167

1.7.13	Bedroom four	Hairline crack across the window sill in the bedroom.	04-07-2024	Hairline crack across the window sill in the bedroom. Photo [167]

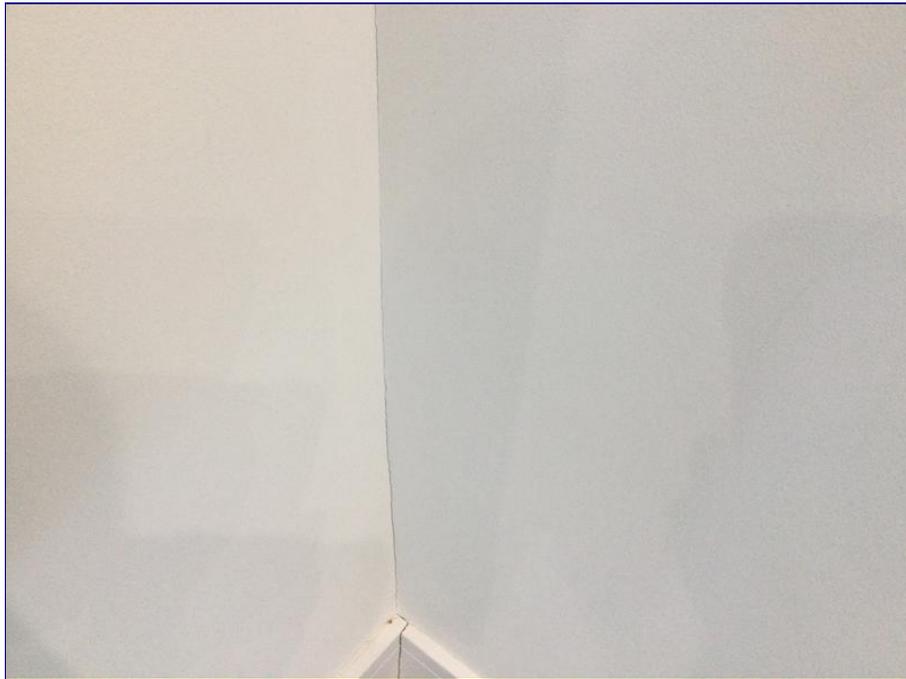
Photo 174

Item	Location	Description	Date Raised	Comments	Defect Owner	Action by Defect Owner Initial	Checked Date	Checked by Initial
1.8.6	Bedroom three	The vinyl flooring is lifted and uneven	04-07-2024	The vinyl flooring is lifted and uneven Photo [152]				
1.8.7	Bedroom three	The vinyl flooring is lifted and uneven	04-07-2024	The vinyl flooring is lifted and uneven Photo [154]				
1.8.8	Bedroom four	The vinyl flooring is lifted and uneven	04-07-2024	The vinyl flooring is lifted and uneven Photo [160]				
1.8.9	Bedroom four	Bedroom flooring not levelled with bathroom floor.	04-07-2024	Bedroom flooring not levelled with bathroom floor. Photo [161]				
1.8.10	Bedroom five	The vinyl flooring is lifted and uneven	04-07-2024	The vinyl flooring is lifted and uneven Photo [174]

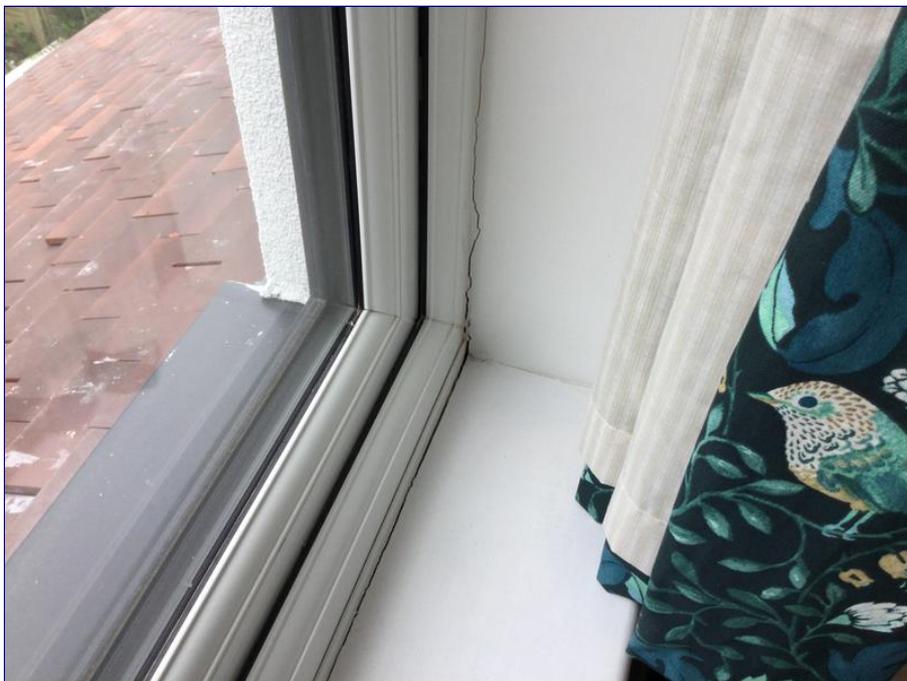
Photo 183

Item	Location	Description	Date Raised	Comments	Defect Owner	Action by Defect Owner Initial	Checked Date	Checked by Initial
1.7.14	Bedroom five	Hairline crack across the window sill in the bedroom.	04-07-2024	Hairline crack across the window sill in the bedroom. Photo [183]

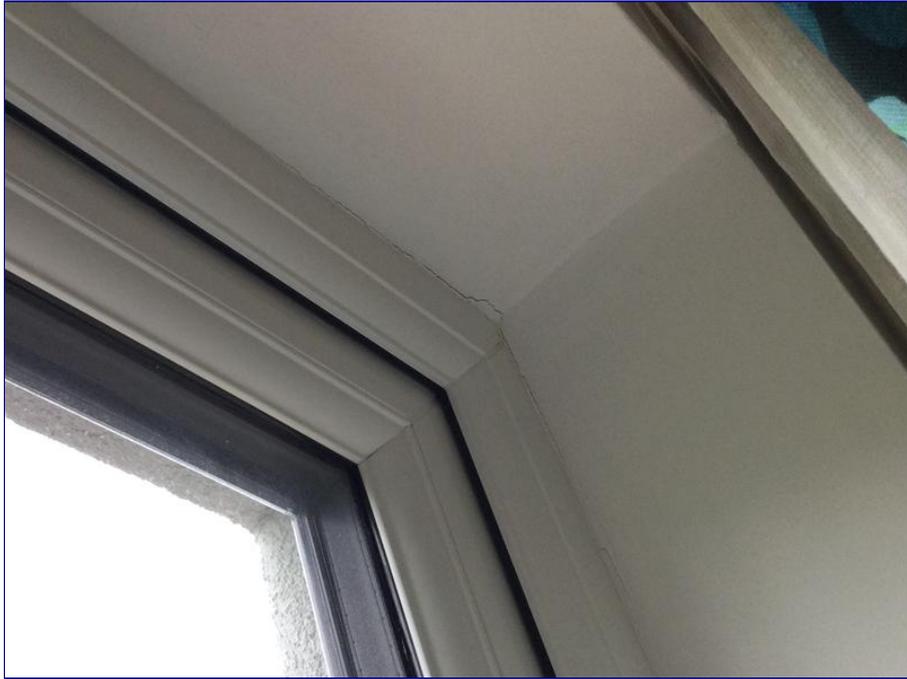
Photo 184

1.7.15	Bedroom five	Hairline crack across the window sill in the bedroom.	04-07-2024	Hairline crack across the window sill in the bedroom. Photo [184]

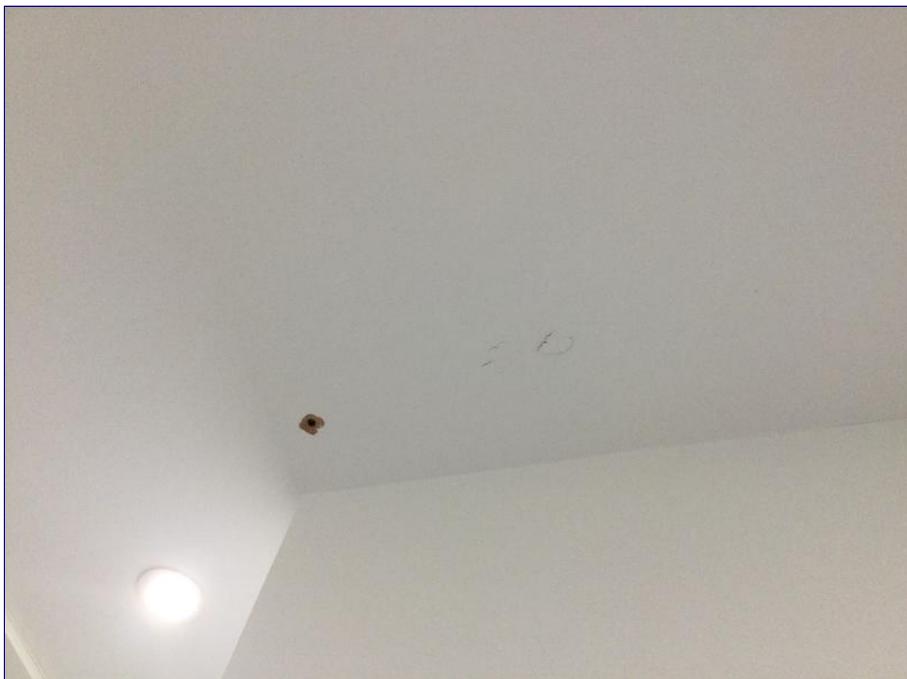
Photo 185

1.7.16	Bedroom five	Hairline crack across the window reveal in the bedroom.	04-07-2024	Hairline crack across the window reveal in the bedroom. Photo [185]
