# Your survey report

6 Leicester Road,  
London,  
N2 8EB

20th October 2023

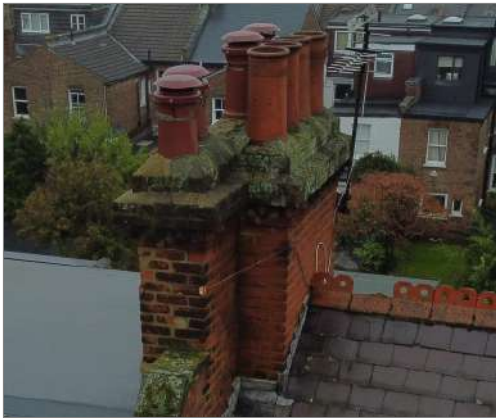
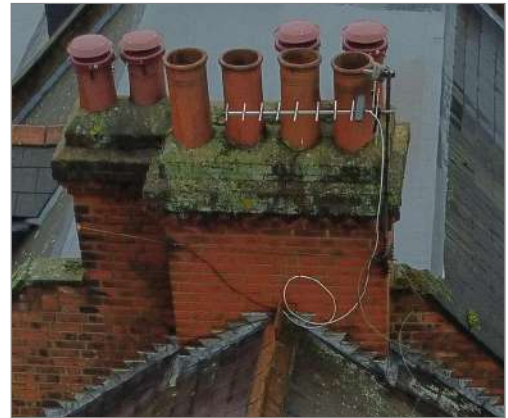
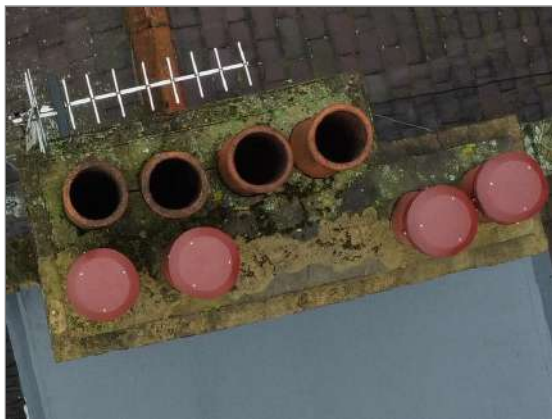
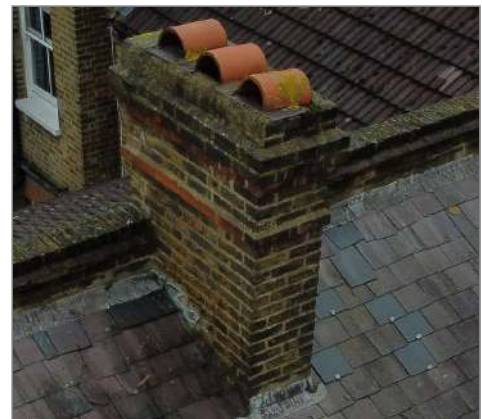
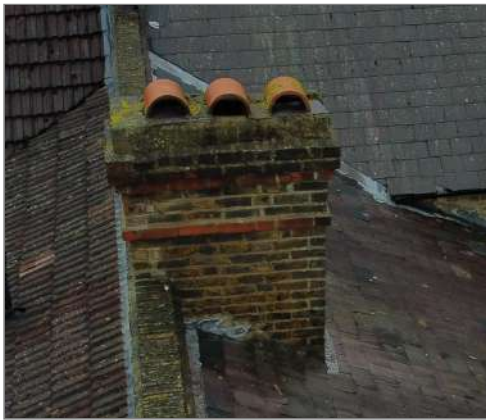
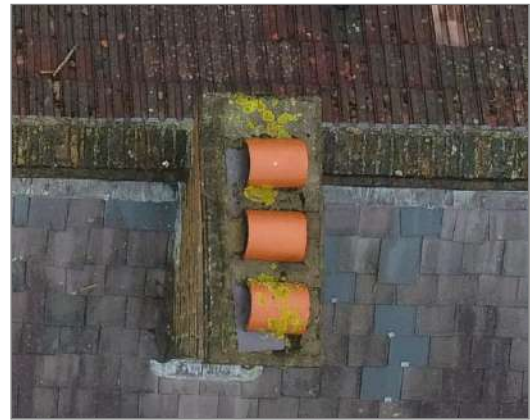
Minor cracking was noted to the flaunching of both chimney stacks. However, this cracking is minimal and is to be expected as the concrete flaunching ages and weathers.

The lead flashings at the base of both chimney stacks are in a general serviceable condition.

Repair cracks to the concrete flaunching on both chimney stacks of the property.

Install chimney cowls to uncapped chimney pots.

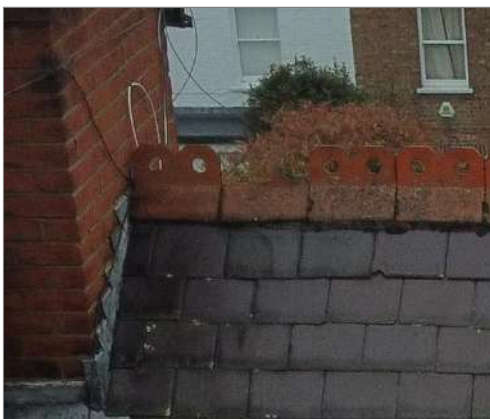
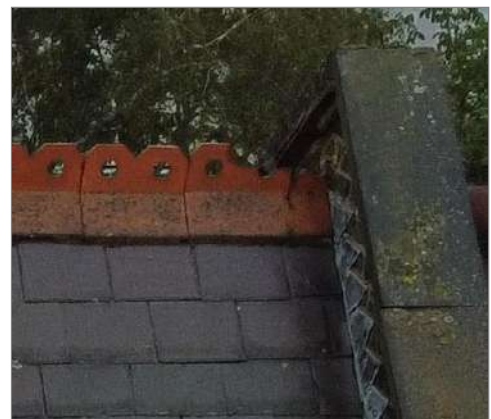
- Broken ridge tiles were noted to the front elevation of the main roof (see photo below).
- A broken tile was noted to the front elevation of the main roof (see photo below).

*Photo - 12 Broken ridge tiles were noted to the front elevation of the main roof*

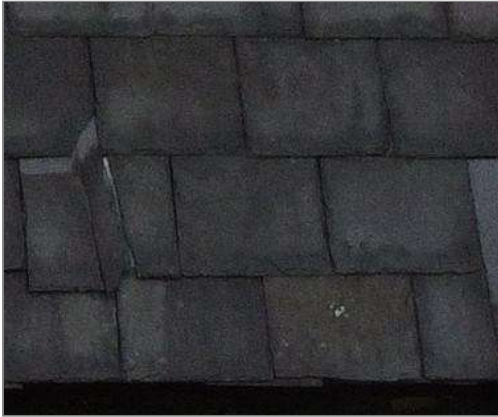
*Photo - 14 A broken tile was noted to the front elevation of the main roof*

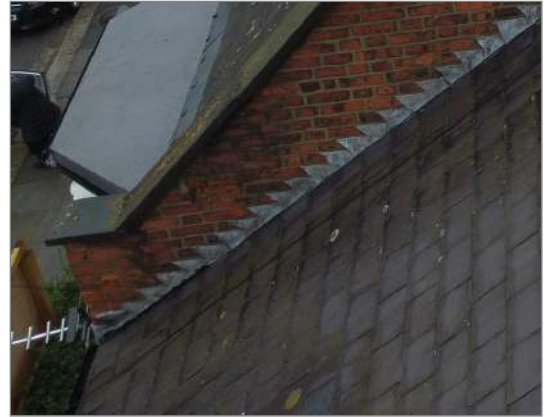
- Damp staining was noted to the front elevation left-hand parapet wall (see photo below).
- Gaps were noted between the tiles on the rear elevation main roof (see photo below). This will allow rainwater ingress to the timber structure of the roof, leading to damp and rot (refer to section 'E1 Roof structure' for further information).

*Photo - 15 Damp staining was noted to the front elevation left-hand parapet wall*

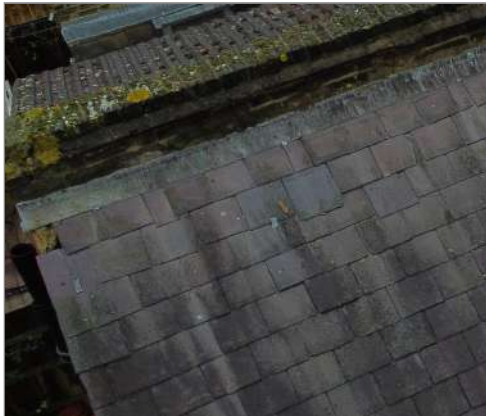
*Photo - 16 Gaps were noted between the tiles on the rear elevation main roof*

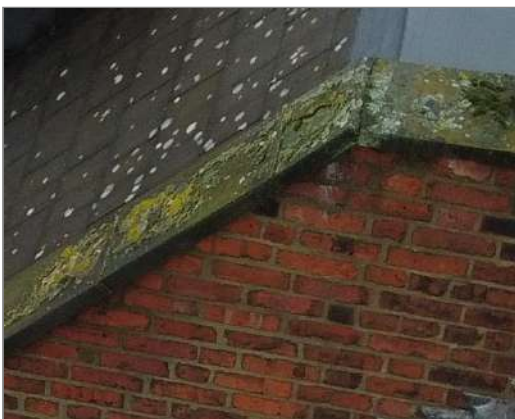
*Photo - 18 Moss growth was noted to the joints of the coping stones of the parapet walls*

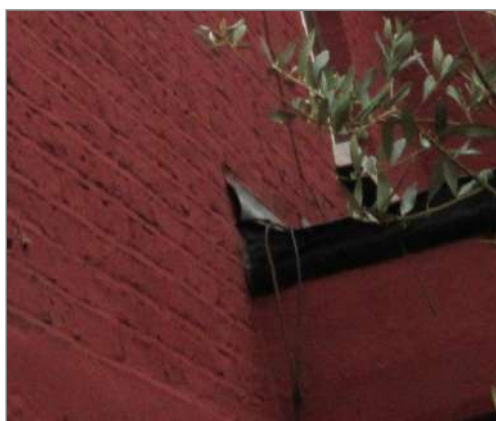
*Photo - 22 Gaps were noted to the lead flashing seals of the flat roof*

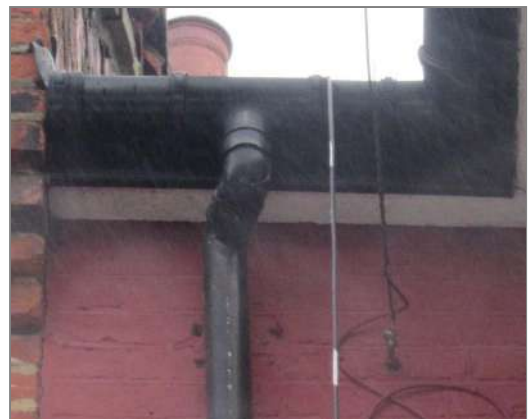
*Photo - 24 Staining was noted to the joints of the down pipe on the front elevation*

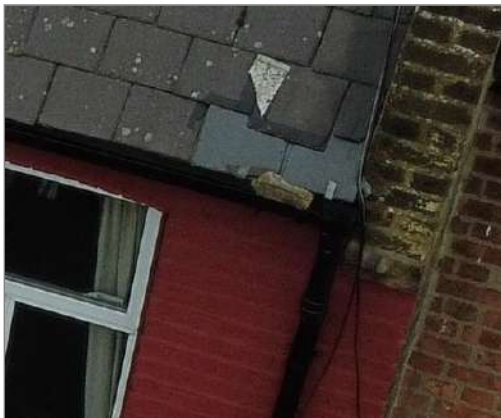
*Photo - 27 Items were noted to be blocking the guttering on the rear elevation*

Climbing plants are prone to causing blockages in gutters and downpipes and should be removed from the area around the facilities on a regular basis.

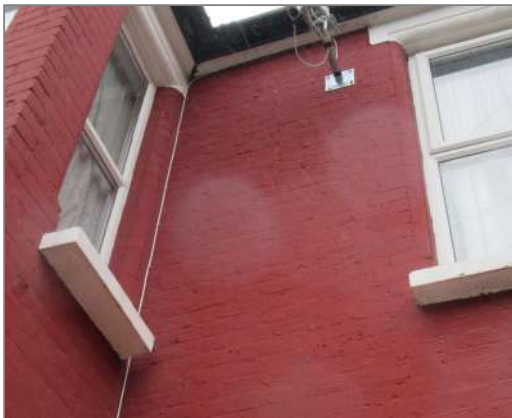
*Photo - 31 Gaps were noted in the mortar pointing on the front elevation*

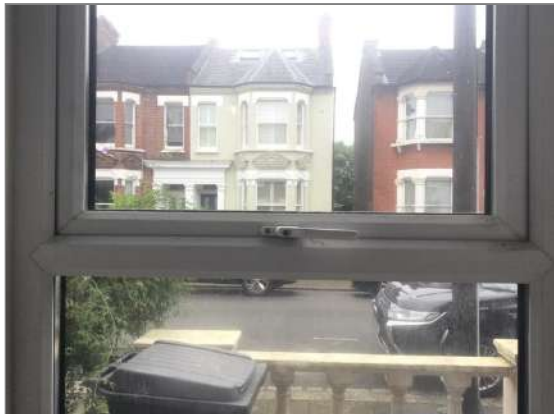
*Photo - 41 The window in the front living room was noted to be stiff to operate*

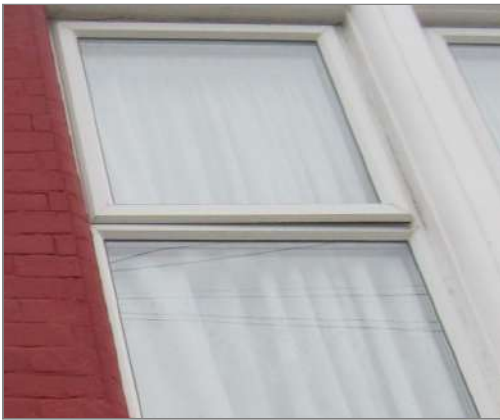
*Photo - 43 The window in the front bedroom was noted to be defective and would not close sufficiently*

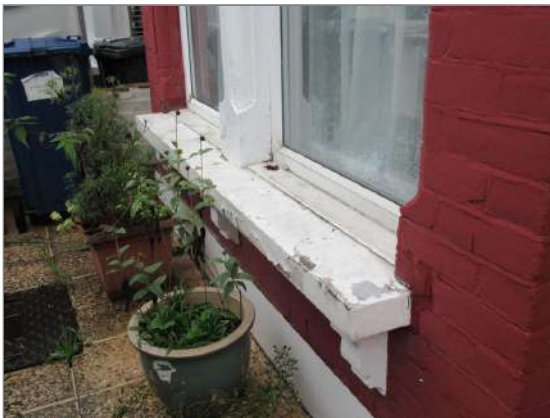
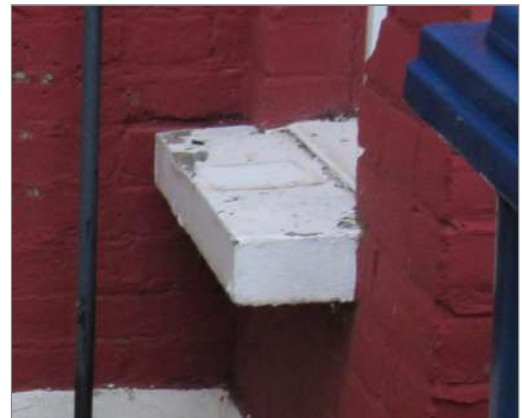
*Photo - 45 Weathering was noted to the external concrete window cills on the front elevation*

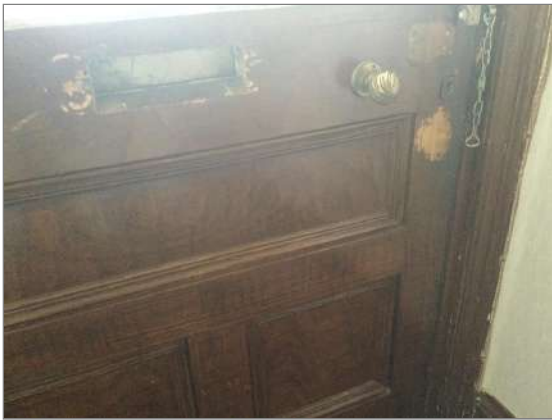
*Photo - 51 The front door was noted to be weathered*

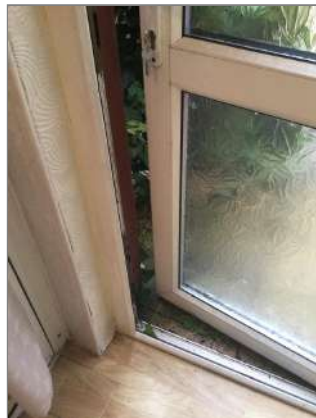
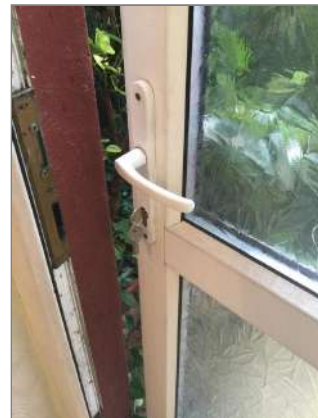
*Photo - 53 The rear side door was noted to be defective when operated*

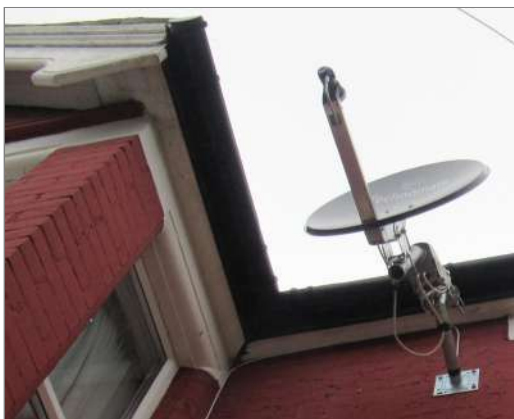
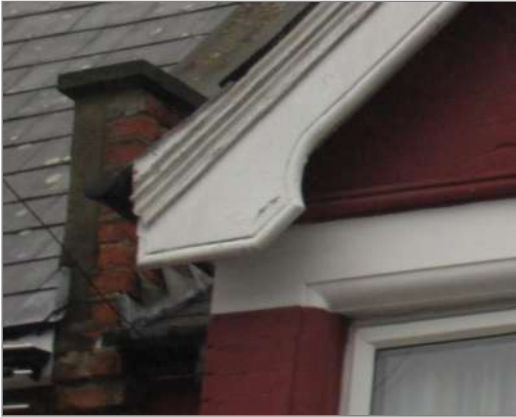
*Photo - 59 Weathering was noted to the front elevation soffit and fascia boards*

Redecorate the front elevation soffit and fascia boards with an exterior weatherproof paint as necessary.

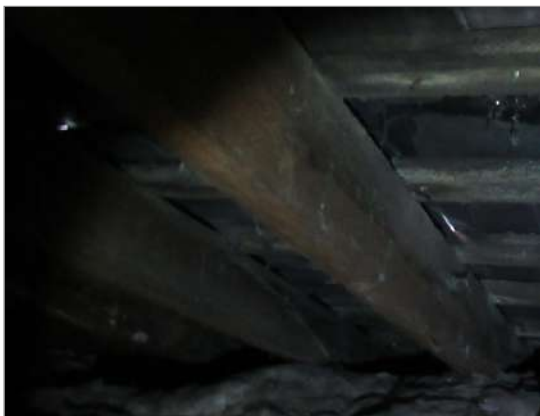
*Photo - 66 Gaps were noted to the roof covering*

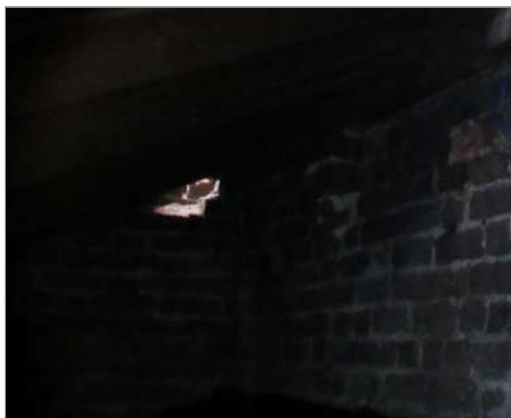
*Photo - 68 A hole was noted to the wall in the roof space*

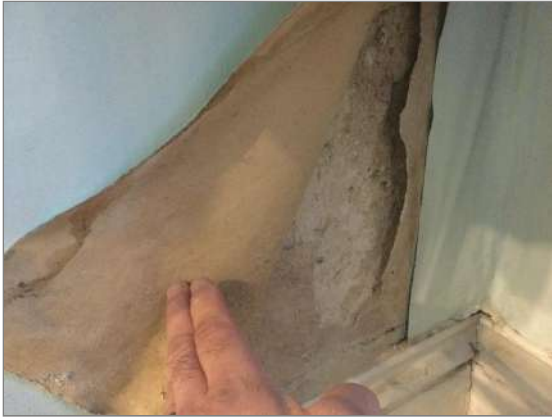
- Damp and high moisture meter readings were recorded on the wall in the front bedroom (see photo below). This is likely caused by penetrating damp due to the condition of the walls on the front elevation (refer to section 'D4 Main walls' for further information).

*Photo - 81 Damp was noted to the walls in the front bedroom*

Walls with high moisture meter readings due to penetrating damp - Once the defects identified with the guttering and main walls have been completed (refer to section 'D3 Rainwater pipes and gutters' and 'D4 Main walls' for further information). The walls will then dry out naturally with time.

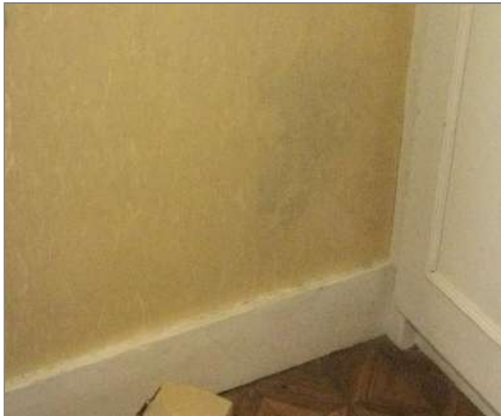
- Damp and high moisture meter readings were recorded on the wall in the second left-hand bedroom (see photo below). This is likely caused by penetrating damp due to the condition of the walls and guttering on the rear elevation (refer to section 'D4 Main walls' and 'D3 Rainwater pipes and gutters' for further information).

*Photo - 83 Damp was noted to the wall in the second left-hand bedroom*

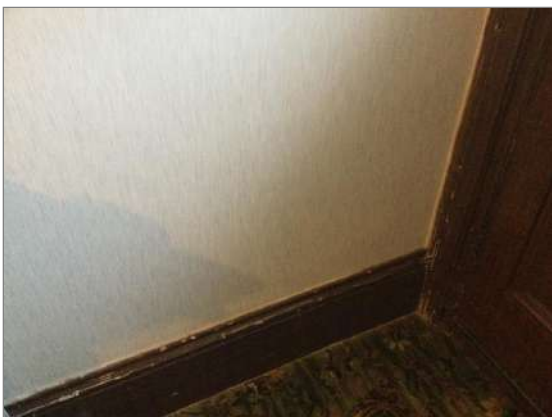
- High moisture meter readings were recorded on the wall adjacent to the front door (see photo below). This is likely caused by suspected rising damp due to the absence of any DPC, or penetrating damp caused by the bridging of moisture from the render at the base of the front elevation walls (refer to section 'D4 Main walls' for further information).

*Photo - 85 High moisture meter readings were recorded on the wall adjacent to the front door*

Walls with high moisture meter readings due to suspected rising damp - Further investigation will be needed to identify the extent of the rising damp and the cost of any remedial works.

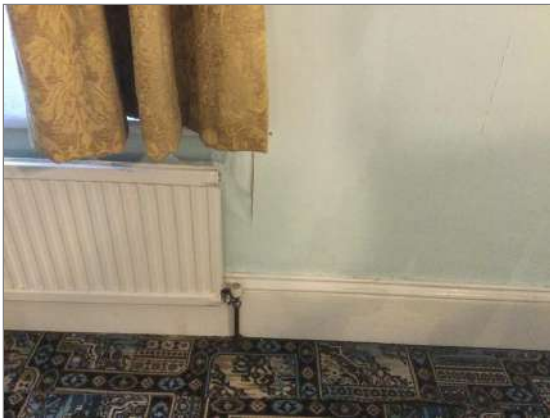
*Photo - 87 High moisture meter readings were recorded on the wall in the front bedroom*

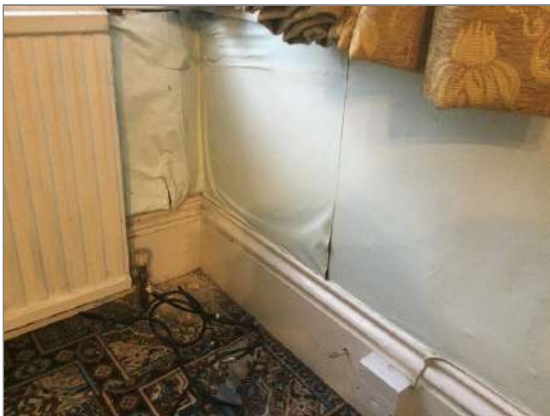
*Photo - 89 High moisture meter readings were recorded on the wall in the front bedroom*

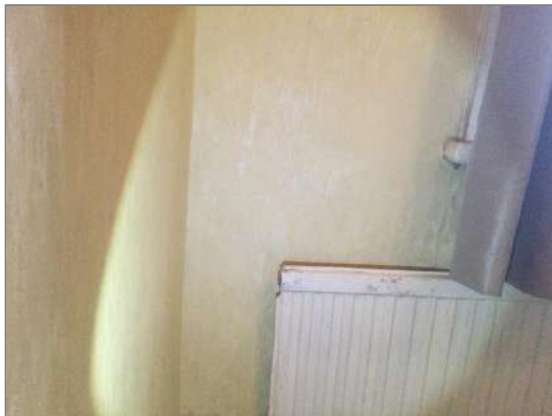
- Damp and high moisture meter readings were recorded on the wall in the third left-hand bedroom (see photo below). This is likely caused by penetrating damp due to the condition of the walls and guttering on the rear elevation (refer to section 'D4 Main walls' and 'D3 Rainwater pipes and gutters' for further information).

*Photo - 95 High moisture meter readings were recorded on the wall in the third left-hand bedroom*

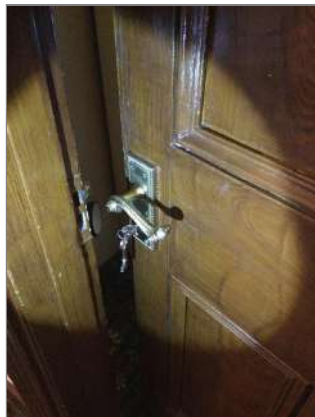
*Photo - 113 The second living room door does not engage with latch when closed*

All door hinges and locks should be regularly lubricated. Internal timbers should be inspected regularly for evidence of bowing or distortion, woodworm and other defects.

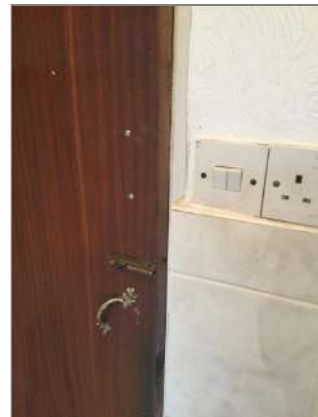
*Photo - 114 The rear shower room door does not shut and scuffs the frame when operated*

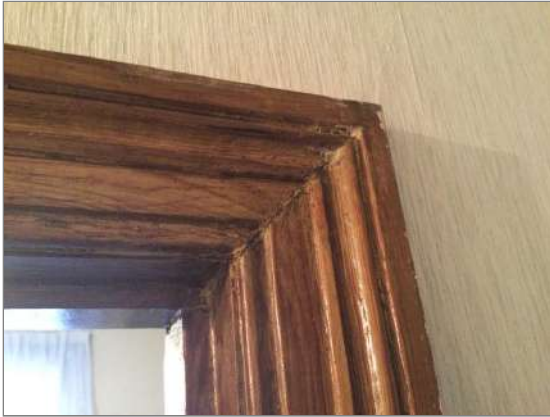
*Photo - 115 Example of shrinkage cracking to the timber architrave*

Fill and redecorate shrinkage cracks as necessary

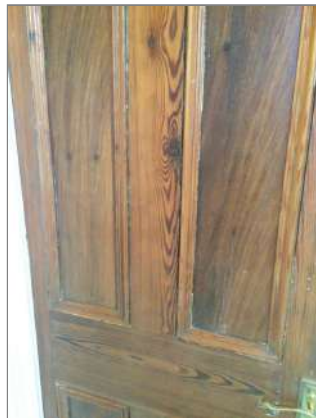
*Photo - 117 Shrinkage cracking was noted to the timber door of the third left hand bedroom*

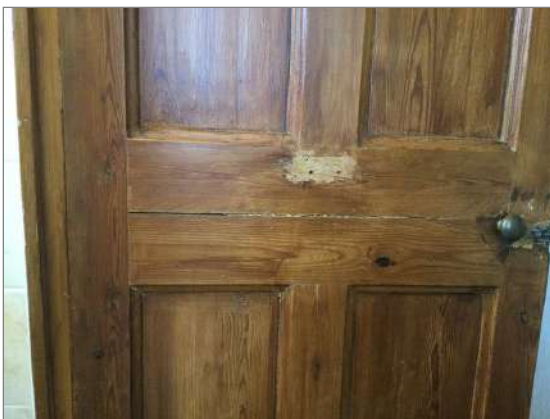
*Photo - 119 Shrinkage cracking was noted to the first floor WC timber door*

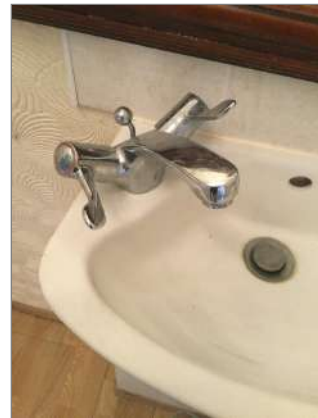
*Photo - 121 The tap on the rear left shower room sink was noted to be loose*

Maintain, repair or replace units as necessary.

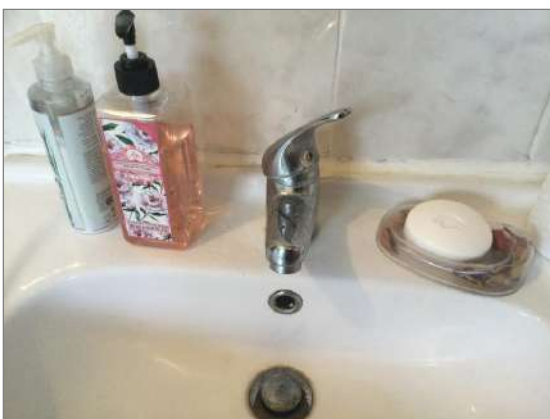
*Photo - 124 Cold water was unavailable from the rear shower room tap when operated*

Investigate the issue with the flow of cold water to the tap in the rear shower room and repair as necessary.

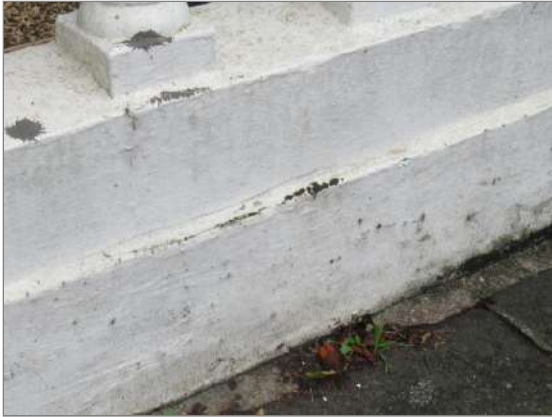
*Photo - 136 Cracks were noted to the front boundary wall*

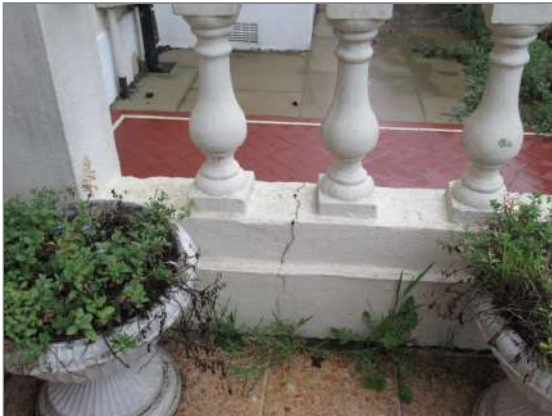
*Photo - 138 Cracks were noted to the front right-hand boundary wall*

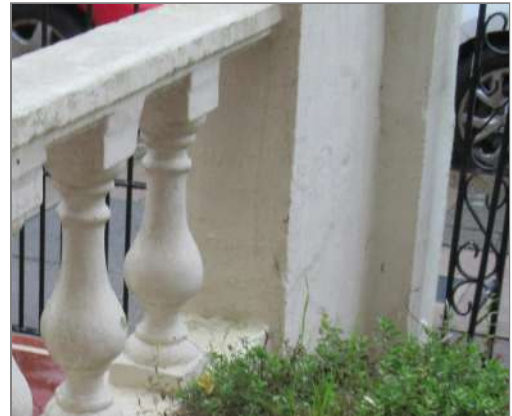
*Photo - 139 Cracks were noted to the front right-hand boundary wall*

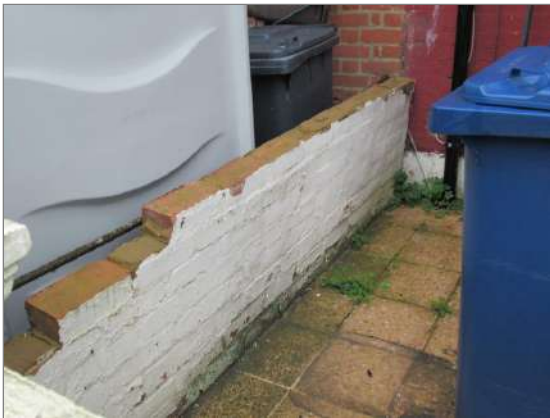
*Photo - 142 The front left-hand boundary wall was noted to be leaning and defective*

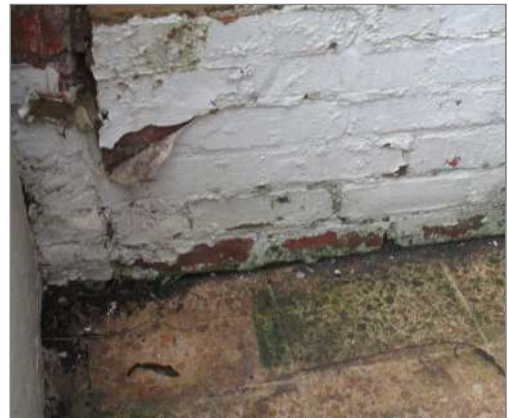
*Photo - 143 Damp was noted to the front left-hand boundary wall*

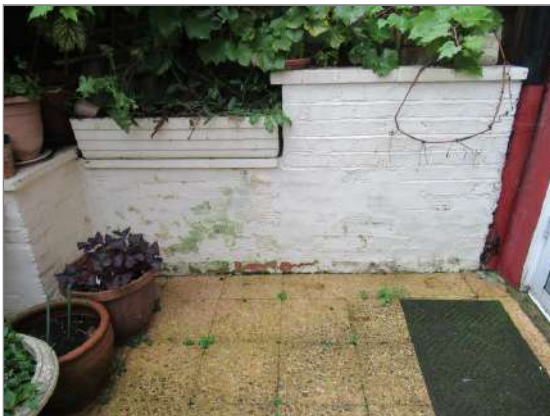
*Photo - 144 Damp was noted to the rear right-hand boundary wall*

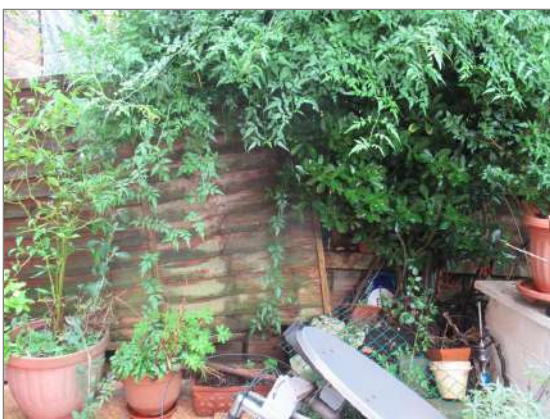
*Photo - 146 The rear left-hand boundary fence was noted to be defective*

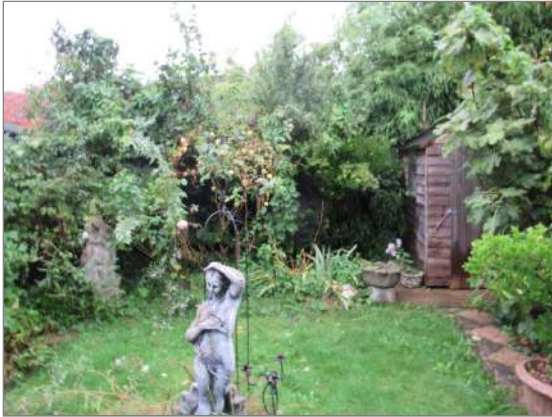
*Photo - 148 Overgrown shrubbery was noted to the rear of the property*

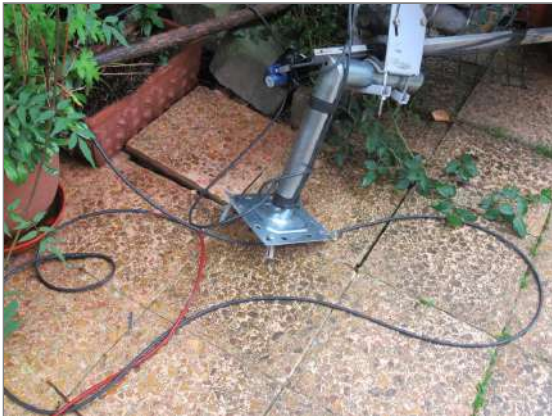
*Photo - 150 Paving slabs were noted to be loose on the rear pathway*

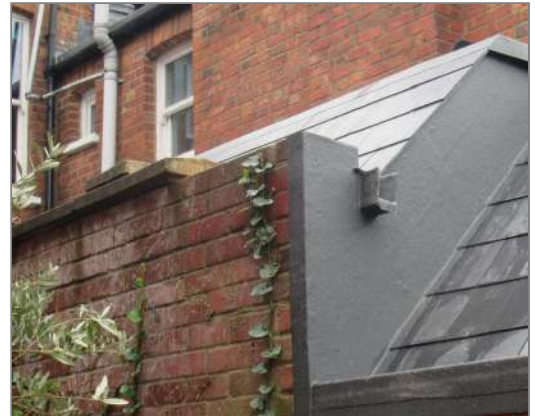
*Photo - 151 A coping stone was noted to be removed from the rear right-hand boundary wall*

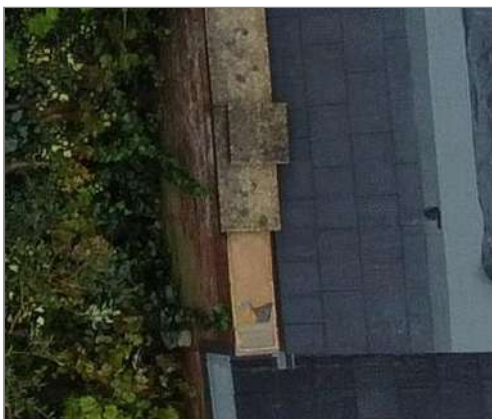
*Photo - 152 A coping stone was noted to be removed from the rear right-hand boundary wall*
