# BUILDING SURVEY REPORT

**PROPERTY**       1 Example Street  
London  
A1 2BC

**SURVEY DATE**   6 May 2021

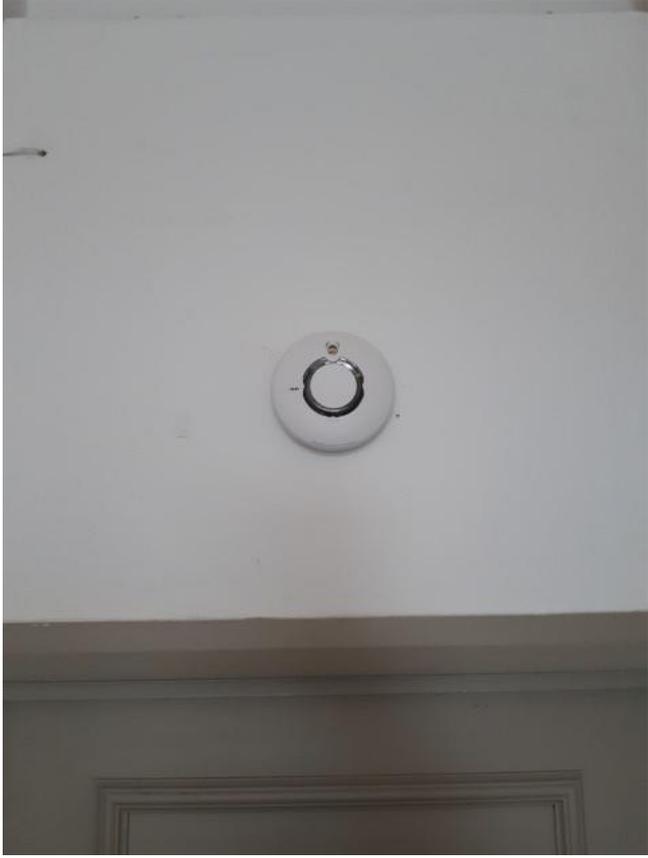
<p style="text-align: center;">Smoke detector to communal hallway</p>
<b>Safety Glass</b>	No issues were noted by the Surveyor.
<b>Lead Pipes</b>	<p>A visual inspection was carried out, however pipes buried within walls or beneath the ground were not inspected.</p> <p>No issues were noted by the Surveyor.</p>
<b>Risk of Falls</b>	<p>Window cill heights: No Issues noted.</p> <p>Trip Hazards: A trip hazard exists at the transition from the hallway to the small bedroom. It was also noted that the decorative floorboards in the small bedroom were not secured to the floor and could be lifted up, thus creating a hazard. These decorative floorboards should be made secure.</p>

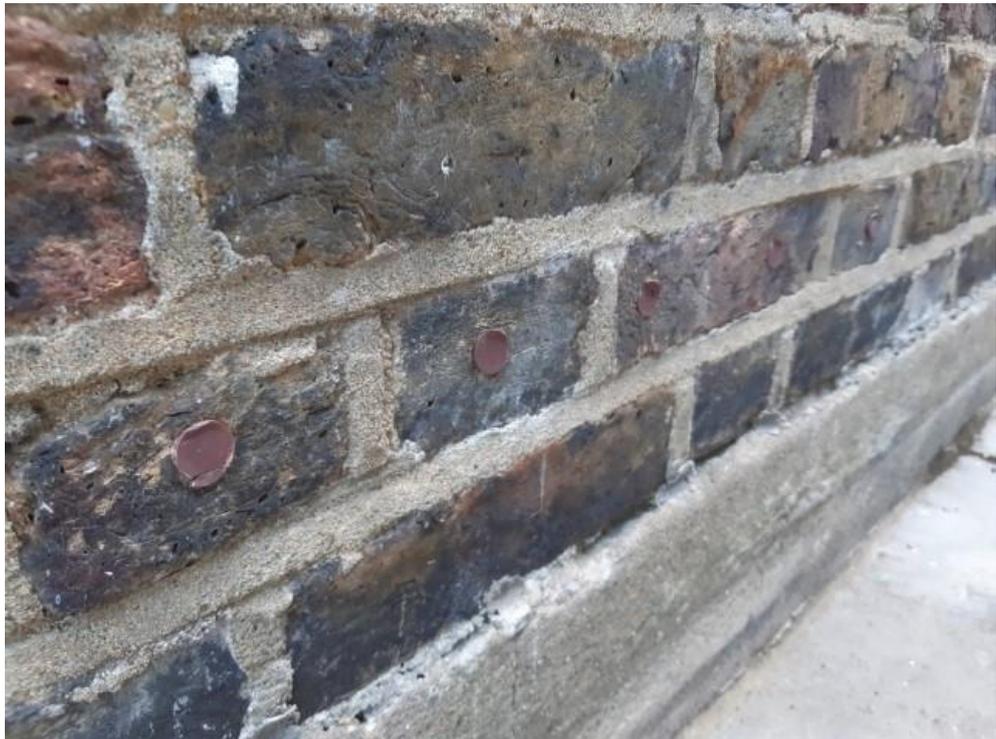
Chemical injected damp proof course to rear elevation

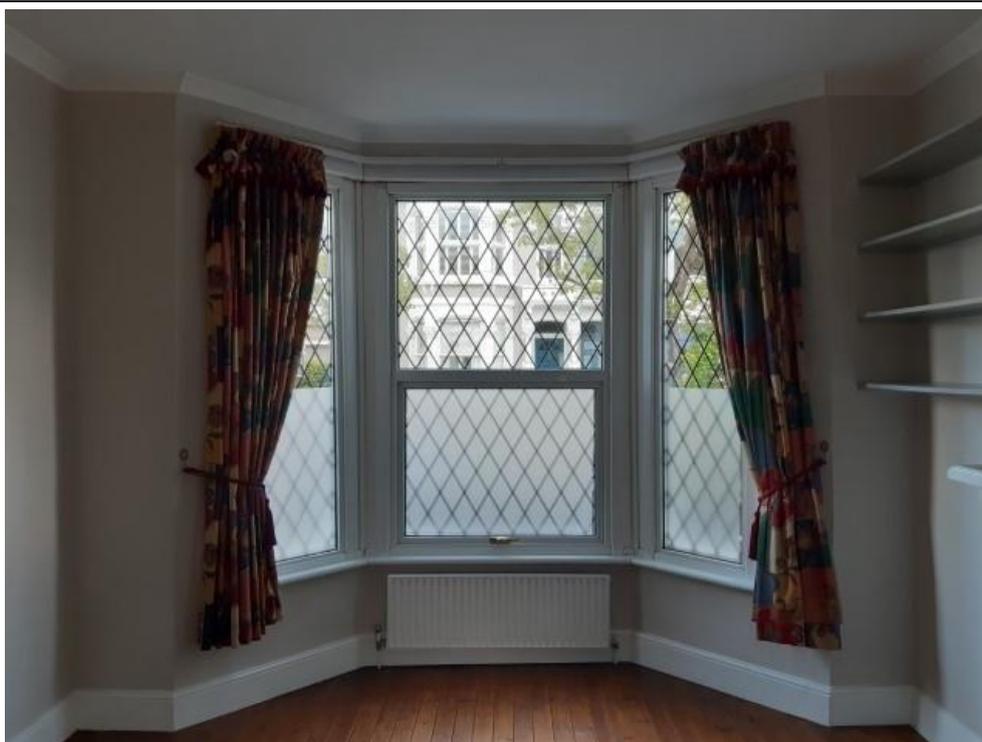
<p><b>Condition</b></p>	<p>No significant defects were noted, all doors operated effectively on opening and closure. All locks functioned correctly except for the lock on the back door, which I struggled to lock. The back door did lock after several attempts.</p> <p>Windows The uPVC windows are dated and due for renewal. However, the frames are in overall serviceable condition. It is recommended that the agent is asked if keys to the windows are present as this will be an additional cost upon purchase of the property.</p> <p>Internal sill heights were compliant with the current legal safety limits. Due to a lack of keys, we were unable to confirm if all handles operated satisfactorily.</p> <p>Due to the old construction of all glazing units (approximately 1990), they have no thermal e-coating on the internal faces to reflect some heat back into the property. New uPVC windows would increase the thermal efficiency of the property. If the windows are to be renewed then they should be installed by a FENSA certified window fitter and FENSA certification for all new windows and doors sets provided on completion.</p> <p>It should be noted that the design of the windows in both bedrooms prevent easy exit in the event of a fire.</p> <p>Failed sealed glazing units There are failed sealed glazing (blown) units in some of the windows. This occurs when the seal around the edge of the window unit fails, allowing moisture laden air to enter between the panes of glass. This is identified by misting of the glass on the inside faces of the sealed unit, and the formation of crystals around the inside of the seal of the unit. Once the seal on a unit has failed it cannot be repaired and the window unit (though not always the frame) needs to be replaced.</p> <p>Atmospheric moisture levels in certain weather conditions and external dirt can disguise evidence of other blown double-glazed units. However other weather conditions may highlight the presence of more failed units.</p> <p>Under normal circumstances sealed double glazed units can be expected to last around 20 years before the seals begin to fail. This can occur more quickly where windows are in exposed or vulnerable situations. It is estimated that most of the windows currently fitted are approximately 35 years old.</p>

Living room window

<p><b>Action Required</b></p>	<p>Failed sealed glazing units require replacement. It should also be considered that, where some sealed units within a window have failed, others may also fail in due course.</p> <p>Normal maintenance of frames, hinges and locks is required.</p> <p>As the windows are approaching the end of their life, it would be prudent to upgrade/renew the windows and install units that allow easy exit in the event of a fire.</p> <p>Be aware that previous owners may have distributed multiple sets of keys for the windows and doors to individuals not known to you. When purchasing a property, you should consider the cost of replacing all of the door and window locks as soon as possible after you take up occupation. When doing this you should consult your insurers to ensure that you meet their requirements for security, and obtain any discounts that may be available by improving the security of the property.</p>

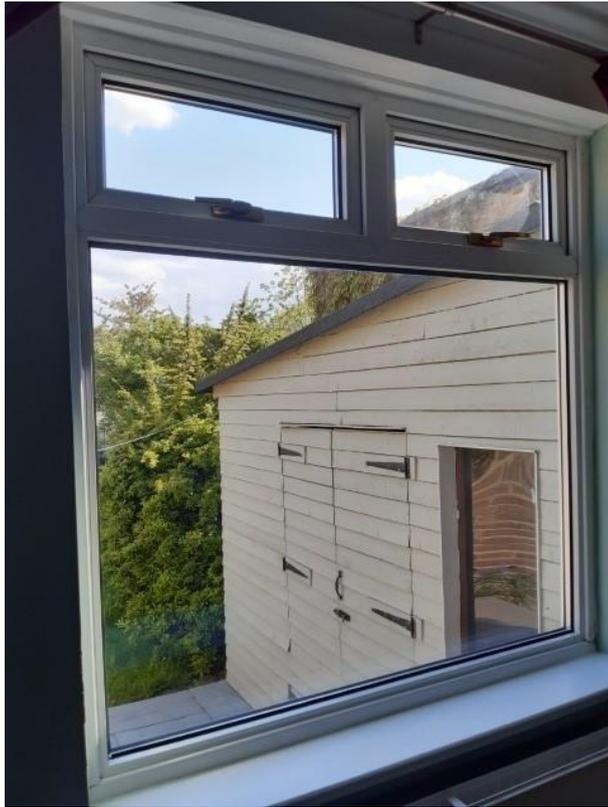
Window to master bedroom

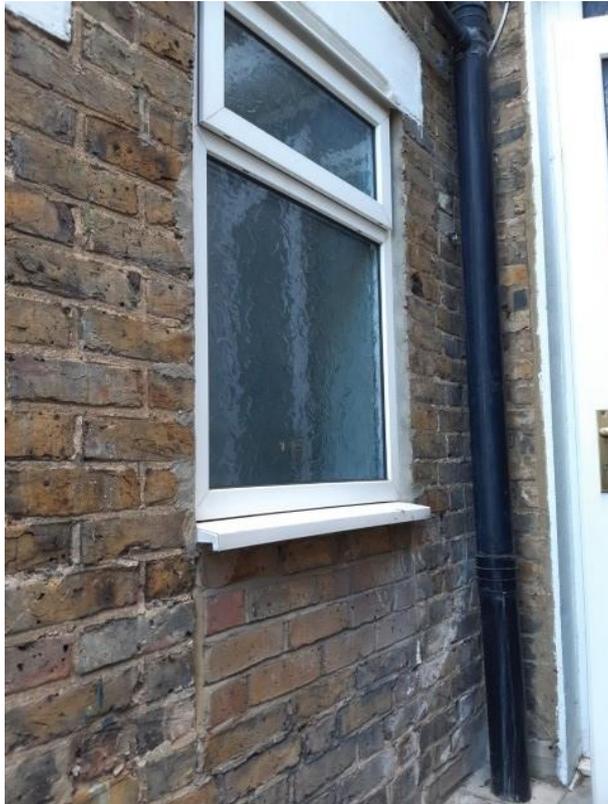
Raised window cills

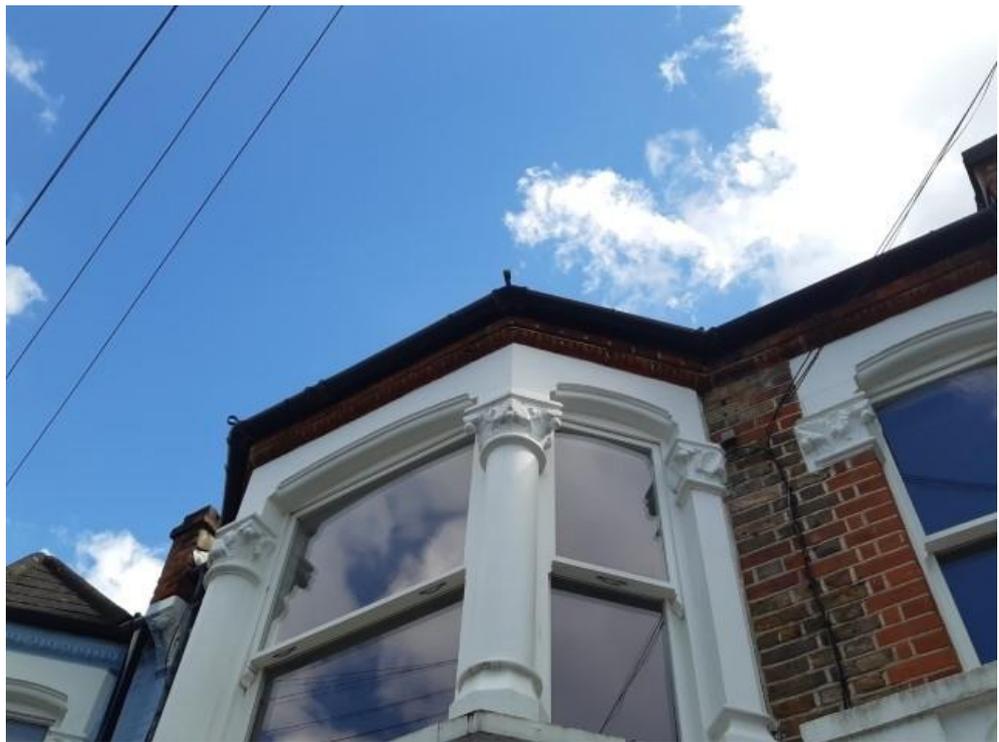
<b>Condition</b>	<p>There are areas where peeling paint is visible to most parts of the gutter boards and the edging boards. Some redecoration is now required or consideration given to replacing all boards noted and soffit boards with modern uPVC equivalents.</p>		
<b>Action Required</b>	<p>Regular maintenance will be required especially to the rear elevation which faces south. This section of the property will receive most of any inclement weather and the heat of the sun.</p>

Timber barge board to front elevation

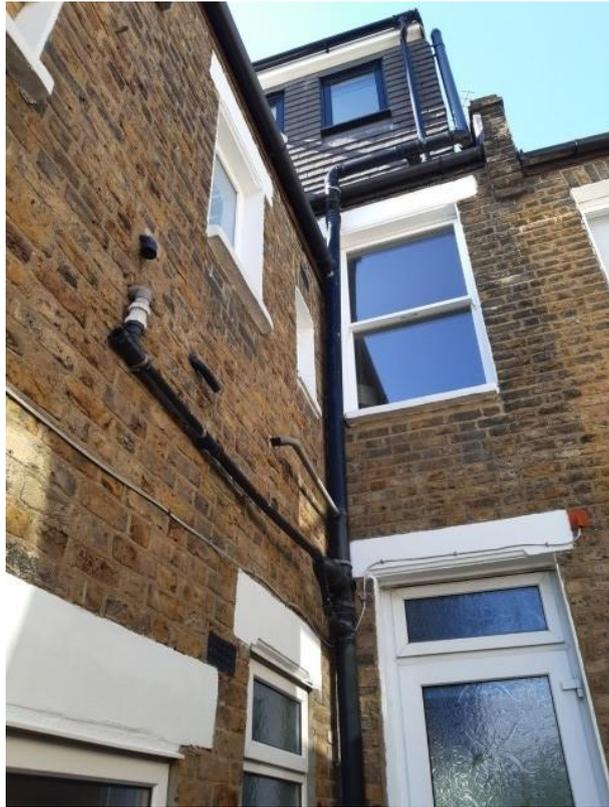
Timber barge board and uPVC soffit & fascia to rear elevation

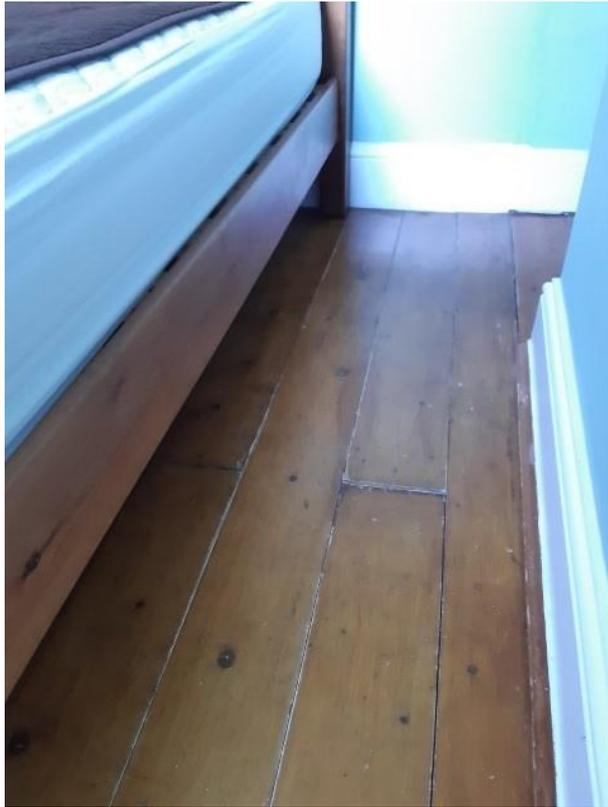
<h2 style="margin: 0;">5.4 Floors</h2>	<b>Condition rating</b>	3
<b>Construction &amp; Type</b>	<p>The floors on the ground floor are of suspended timber construction. The supporting floor joists are believed to span the building from left to right.</p>		
<b>Nature of inspection and Limitations</b>	<p>Floors were examined for sagging, hogging, unevenness, undue springiness and other signs of failure or damage. Fixed floor coverings in most rooms prevented direct examination of the floor surfaces. Tiled floors were examined for any cracked tiles which could indicate movement of the structure.</p>		
<b>Condition</b>	<p>None of the floors were found to be unusually noisy or springy when walked upon, except for the floor in the master bedroom. This suggests that the majority of underlying structures are not affected by significant timber defects.</p> <p>With regards to the floor in the master bedroom, there is a section of floor next to the external wall, which is unusually springy when walked upon. This will need further investigation in order to determine the cause. It should be noted that it is adjacent to the wall which previously suffered from rising damp and as such may be connected to this defect. Floorboards should be removed and an assessment made of the underlying structure by a competent person.</p> <p><b>Ground Floors</b></p> <p>It was noted that there is a slope to the living room floor towards the kitchen door. The floor was found to be secure, hence no further action is recommended.</p> <p>As mentioned in section 3.2, it was noted that the decorative floorboards in the small bedroom were not secured to the floor and could be lifted up, thus creating a hazard. These decorative floorboards should be made secure.</p> <p>As mentioned in section 4.4, air bricks are visible at the base of the external walls. These are present to ensure adequate ventilation to the underfloor voids to minimise the build-up of moisture that can promote the development of rot and other defects in the timbers that support the floors. No evidence of any undue flexing of the ground floor structure was noted, except to the floor in the master bedroom; this indicates that the ventilation levels are adequate. It is however, essential that a free flow of air is maintained through the air bricks.</p> <p>Isolated boards are slightly squeaky, due to being nailed rather than screwed in place. Timber floor construction is prone to misalignment or slight deflection over time, and this is not usually of significance.</p> <p>No undue levels of movement were noted during the survey inspection except for in the master bedroom.</p> <p>Where access was possible to the floorboards no evidence of infestations by wood boring insects (commonly known as woodit is recommended that, should the carpets or coverings be replaced, isolated floorboards should be lifted to assess whether there has been any insect attack to the boards and joists below.</p>

Springy floor to master bedroom - pic 1

<p><b>Action Required</b></p>	<p>Ensure that the air bricks, visible at the base of the external walls, are kept clear to maintain adequate ventilation in the underfloor void. External paving and soil levels should not be allowed to rise above the level of the air bricks.</p> <p>A lack of ventilation can allow moisture levels beneath the floor to become elevated, increasing the risk of the development of moisture related defects such as rot and infestations by wood boring insects (commonly known as woodworm).</p> <p>Further investigation of the floor structure in the master bedroom is recommended, in order to determine the course of the section of springy floor. Floorboards should be removed and an assessment made of the underlying structure by a competent person.</p> <p>The remaining floors in the property should be monitored for any changes that occur in their level or springiness or noise and further investigations carried out should any such changes become apparent.</p>

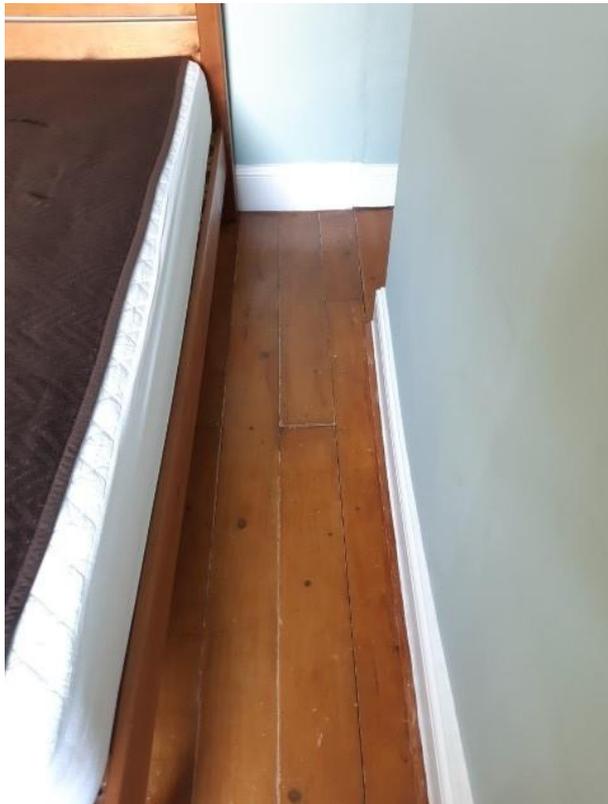
Springy floor to master bedroom - pic 2

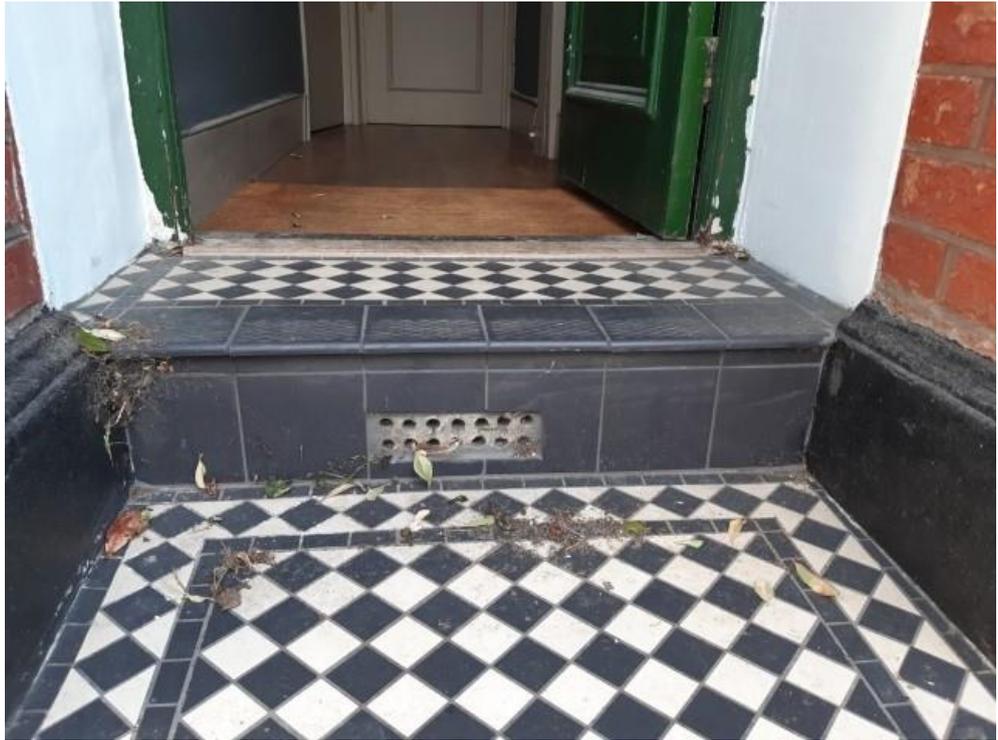
Air brick to suspended timber floor front elevation

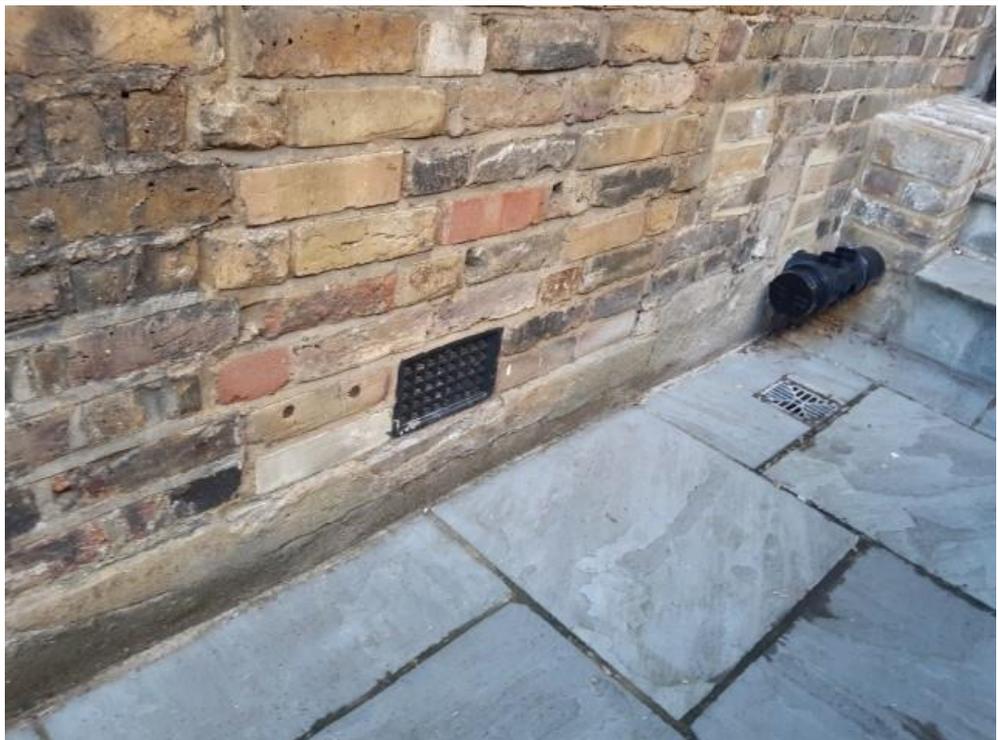
Air brick to suspended timber floor rear elevation

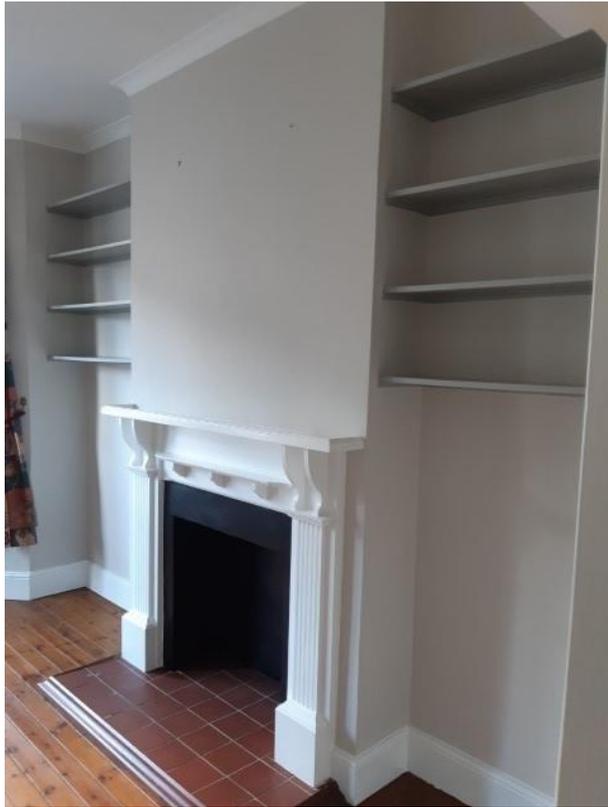
Chiney breast to living room

<b>Action Required</b>	<p>It is recommended that the plasterboard and plaster skim used to block-off the chimney breast in the kitchen is removed and reinstated to improve the final finish of the chimney breast. Adequate ventilation and a ventilation grill should also be installed.</p> <p>In addition, the chimney breast to the living room does not appear to be provided with adequate ventilation.</p> <p>It is important to maintain an adequate airflow, by means of ventilation, through unused chimney flues to prevent the build-up of condensation within the chimney. Hence, ventilation grilles should be fitted to both blocked chimney breasts.</p>

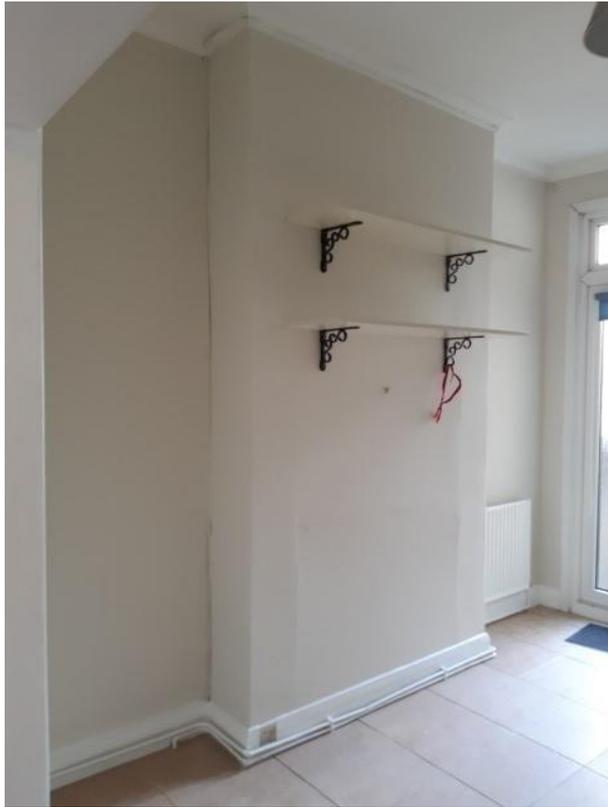
<b>5.5 Chimney Breasts, Fireplaces and Flues</b>	<b>Condition rating</b>	<b>2</b>
<b>Construction &amp; Type</b>	<p>The chimney breasts are of masonry construction. Breasts remain to the living room and to the kitchen.</p> <p>A fireplace remains in the living room; however, this is not operational and has been blocked off. The remaining chimney breast in the kitchen has been blocked off and plasterboard and a plaster skim installed. However, this has been finished in a rather crude manner not befitting the rest of the property.</p>		
<b>Nature of inspection and Limitations</b>	<p>The chimney breasts were examined for indications of dampness, lack of support, failed lining and other defects. It is not possible to investigate the condition or serviceability of chimney flues for use with fixed or open fires during a survey.</p>		
<b>Condition</b>	<p>No significant defects were noted during my inspection and the chimney breasts were found to be structurally sound.</p>

Chimney breast to kitchen - pic 1

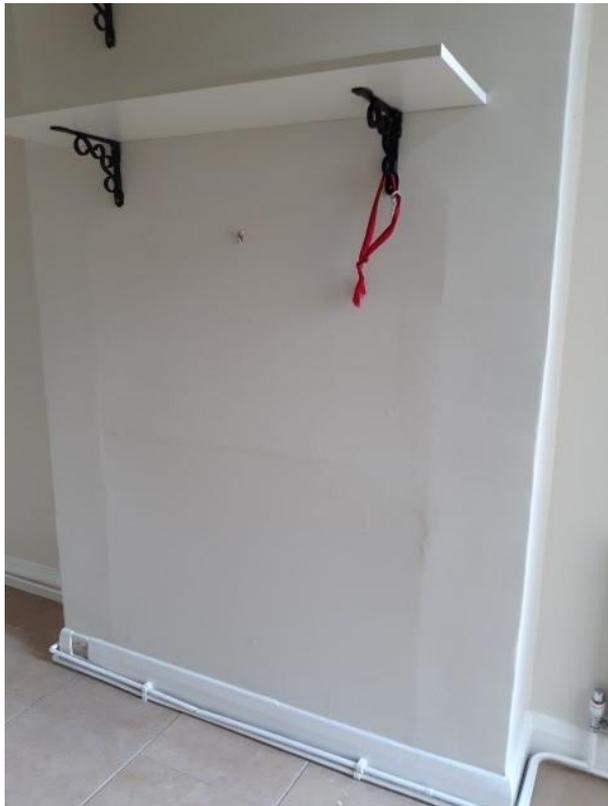
Chimney breast to kitchen - pic 2

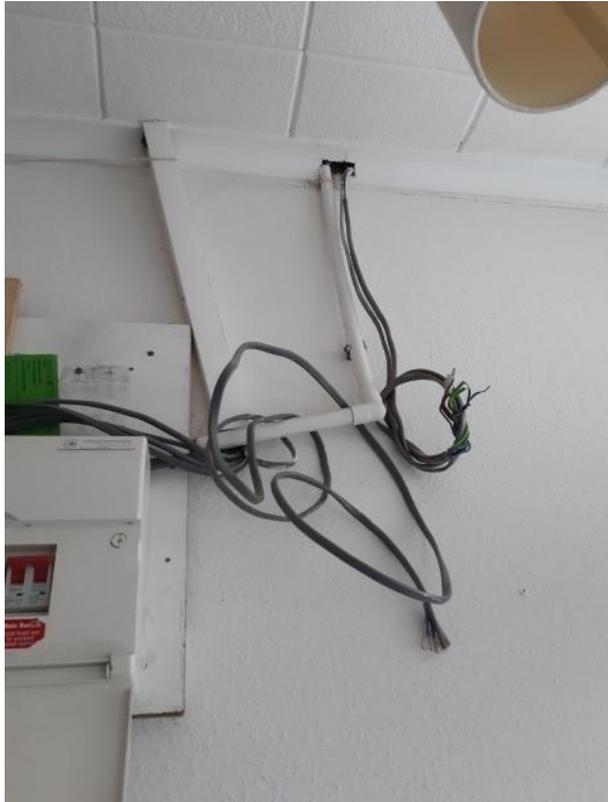
<b>Condition</b>	<p>No evidence was seen of broken, loose or damaged parts of the installation to the ground floor apartment, nor were any obvious amateur alterations or interventions noted.</p> <p>However, there were hanging wires that were not secured correctly. These wires relate to the installation to the first-floor property. This would be of concern to you as they are located within the communal area (next to the consumer unit belonging to the first-floor apartment). These wires should be made safe and boxed in or secured using uPVC trunking.</p> <p>As far as could be seen, the visible wiring to the ground floor apartment is of a modern PVC type, and the nature of the consumer unit suggests that the installation has been upgraded to some extent in recent years, though it cannot be known if this included replacement of the wiring within the walls, floors, ceilings etc.</p> <p>The number of socket outlets in the living room and kitchen was sufficient and also had been upgraded in recent years. However, both bedrooms have less sockets than is generally required for current lifestyles and it is likely that you will wish to have further sockets added. This work should be carried out only by a qualified electrician.</p> <p><b>Observed Issues</b></p> <ul style="list-style-type: none"> <li>- Hanging wires not secured correctly. Located within the communal area, next to the consumer unit belonging to the first-floor apartment.</li> <li>- Low level sockets are located in the small bedroom, the master bedroom, the kitchen and the hallway. You may wish to have these sockets raised for easy operation.</li> <li>- The light in the small bedroom is operated by a pull cord and not a conventional light switch. You may wish to upgrade this to a conventional light switch.</li> <li>- No documentary certification was available to confirm that the electrical installation had been inspected in the last 12 months.</li> </ul>

Hanging wires in communal area

<b>Condition</b>	<p>Hanging wires were noted in the communal area next to the consumer unit belonging to the first-floor apartment. As a result, a red HS has been applied to highlight this defect. These wires should be made safe and boxed in or secured using uPVC trunking. See section 6.1 for further information.</p> <p>Dislodged ceiling tiles were also noted to the communal hallway ceiling.</p> <p>It was also noted that the communal hallway timber floor covering is showing signs of wear and will need to be renewed within the next 3 years.</p>		
<b>Action Required</b>	<p>The purchaser should satisfy themselves as to their likely liabilities for the repair and maintenance of common areas and parts.</p> <p>It would be prudent to understand the inspection and maintenance schedule, and to understand when all shared elements were last inspected in detail and if there are any current works planned.</p>

<p><b>Action Required</b></p>	<p>NAPIT recommends that domestic electrical installations are inspected and tested every 10 years in line with IET (The Institution of Engineering &amp; Technology) Guidance Note 3 covering Electrical Installation Condition Reports (EICR). This guidance also recommends that at any change of occupancy (such as a house sale, or change of tenant) an Electrical Installation Condition Report is carried out to prove the installation to be in a satisfactory or unsatisfactory condition. This report should cover all the fixed wiring and equipment within the property boundaries, including outbuildings.</p> <p>You can get further information from the Electricity Safety First at <a href="https://www.electricalsafetyfirst.org.uk/guidance/safety-around-the-home/">https://www.electricalsafetyfirst.org.uk/guidance/safety-around-the-home/</a></p> <p>Any electrical works carried out should have been completed by a Registered Competent Person (Electrical) and, as such, would have provided a Minor Electrical Installation Works Certificate, or an Electrical Installation Certificate, and in addition a Building Regulation Compliance Certificate where required.</p> <p>At the time of the survey no documentation was seen to verify that an inspection has been carried out within the last 10 years and the installation must therefore be considered to be in a potentially dangerous and unsatisfactory condition. This, along with the hanging wires located in the communal area, is the reason for the HS rating in this section.</p> <p>An electrical installation can look to be in a safe condition, but serious defects may be hidden within the walls or under floors. It is therefore considered to be essential that you commission an inspection and testing of the electrical installation prior to purchase of the property, unless you are provided with verifiable evidence that such an inspection has recently been carried out by a registered competent person.</p> <p>There is no legal requirement on the seller of a house to provide an up-to-date Electrical Installation Condition Report. Whilst it is not unreasonable to ask the seller to provide evidence of the condition of the electrical installation, they are under no obligation to do so.</p>

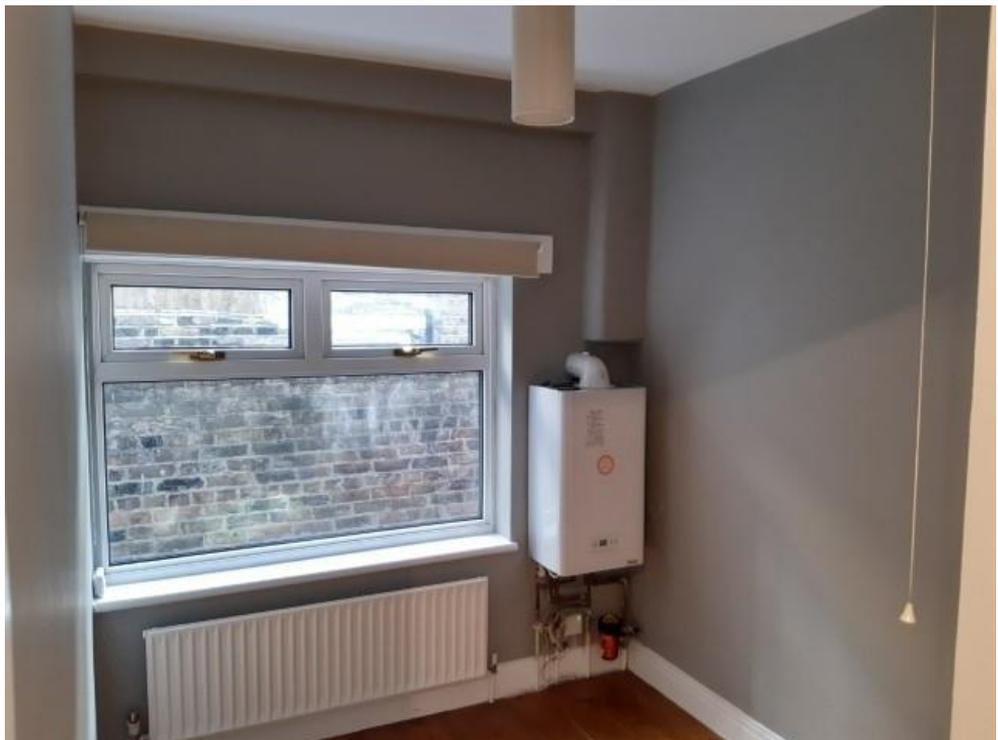
Light cord to small bedroom

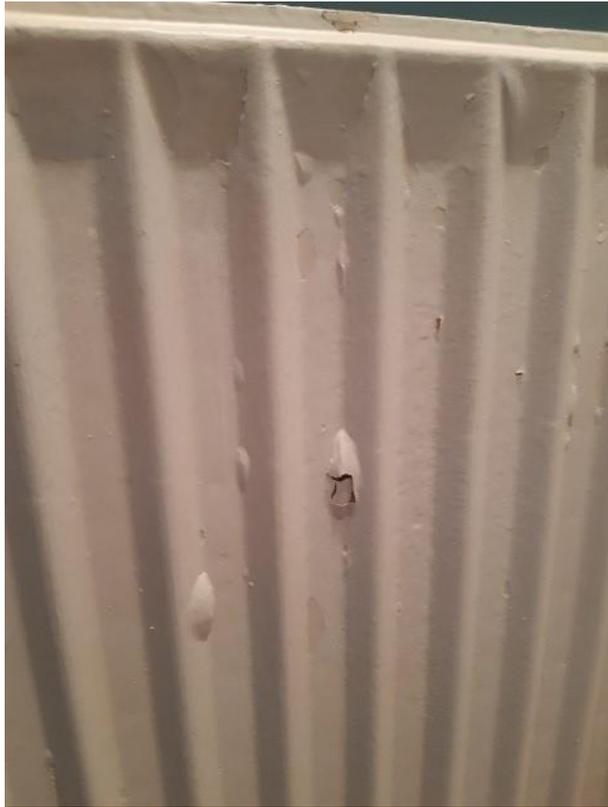
Blistering paint to radiator in hallway - pic 2

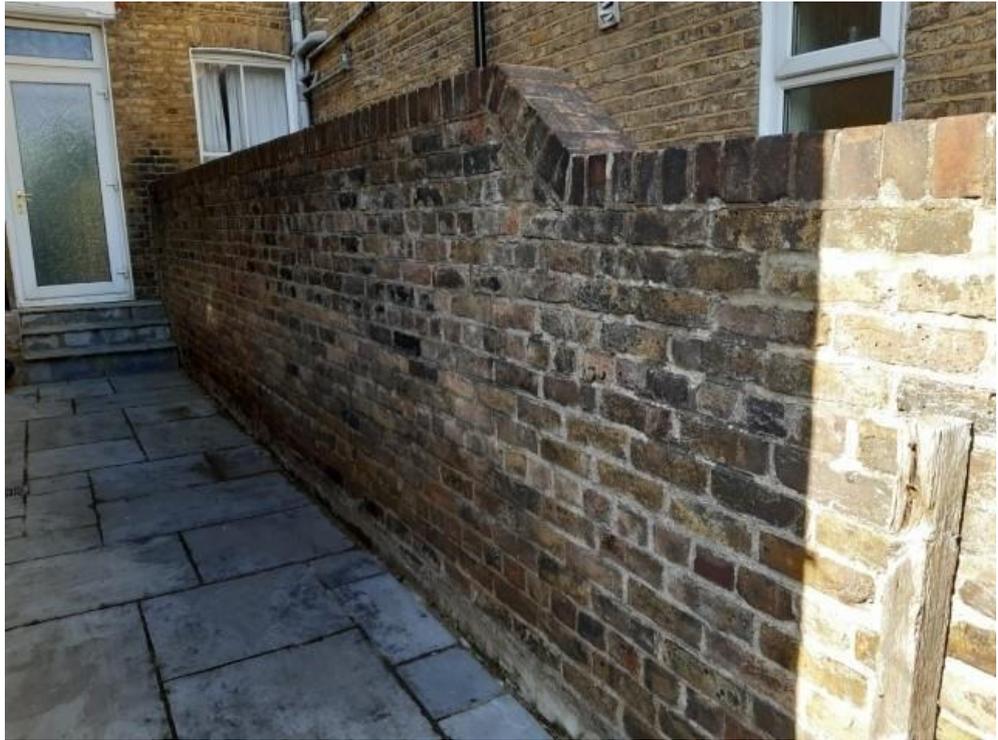
Boundary wall in back garden - pic 1

It was noted that to the rear of the back garden, there exists a garage/shed located on your neighbour's property. The roof drainage from this structure discharges directly onto your boundary wall. This should be rectified by your neighbour so not to adversely affect your boundary wall.

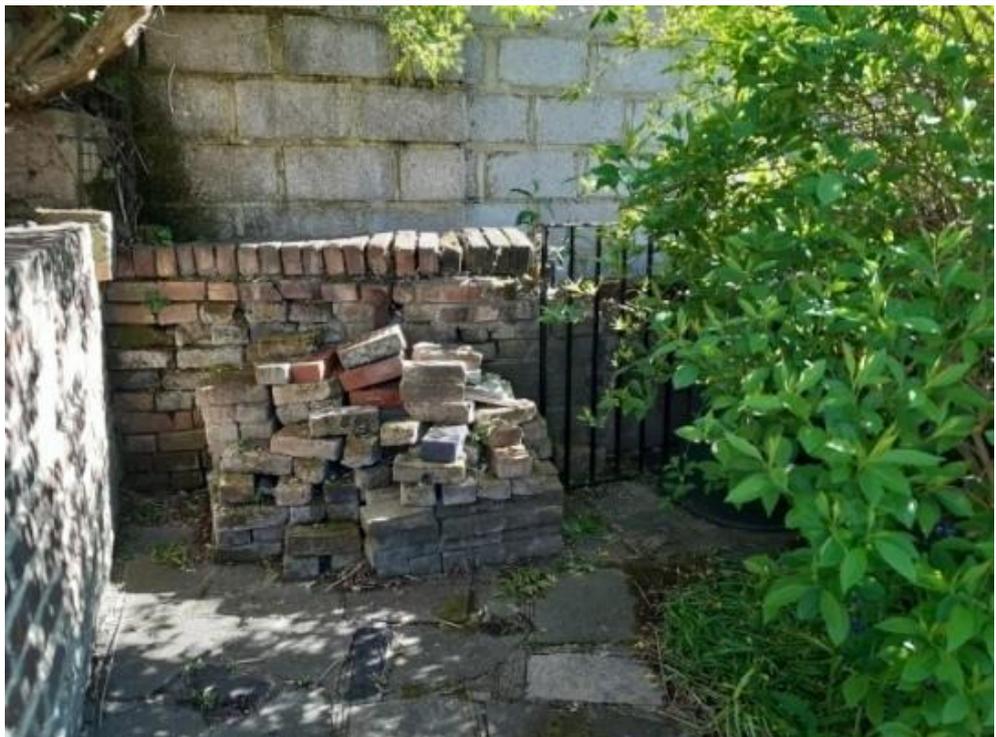
Brick wall to be removed

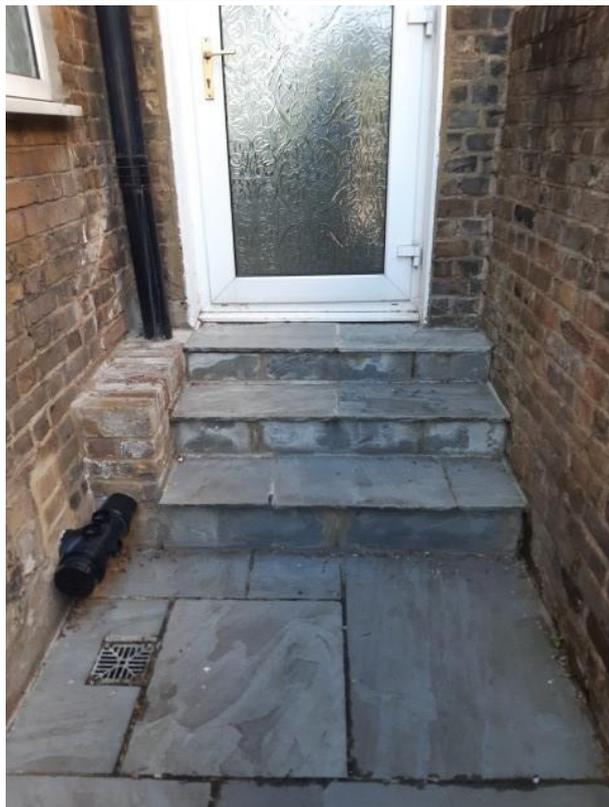
<b>Condition</b>	<p>The gardens are both presented in a maintained condition. There is no evidence of any damage from flooding. No evidence of the presence of Japanese Knotweed was seen during my inspection but you are advised to seek further advice if you believe it may be present or are aware that it is present in premises nearby.</p> <p>There is no indication of the ownership of any of the boundary walls, fences or hedges, and in most cases, this is not specified by the deeds or title documents. Often, responsibility for boundaries to one side or another has been assumed by subsequent owners. You should ask your conveyancer to advise on any indications of ownership included in the title documents.</p> <p>The left-hand side boundary wall located within the rear garden is bowing and there is a bulge apparent to the brickwork. This is due to root growth from the tree located in your neighbour's back garden, which is directly behind the boundary wall.</p> <p>There is a section of wall to the rear boundary which is unstable and needs to be removed.</p> <p>All other boundary fences and walls were found to be in a stable condition.</p> <p>The front gate and both the left and right-side boundary within the front garden are at the end of their life. Both boundaries comprise iron fencing which need replacing.</p> <p>No obvious evidence of subsidence or other unusual ground movement was seen.</p> <p>Paving around the property is generally level and stable.</p> <p>The steps to the back door are finished in flagstone paving. However, the paving used has not been cut down to the correct size and overhangs the steps by approximately 40mm. Over time this will cause the paving to split away from the steps and will eventually lead to the steps becoming hazardous during use.</p>

Steps in back garden

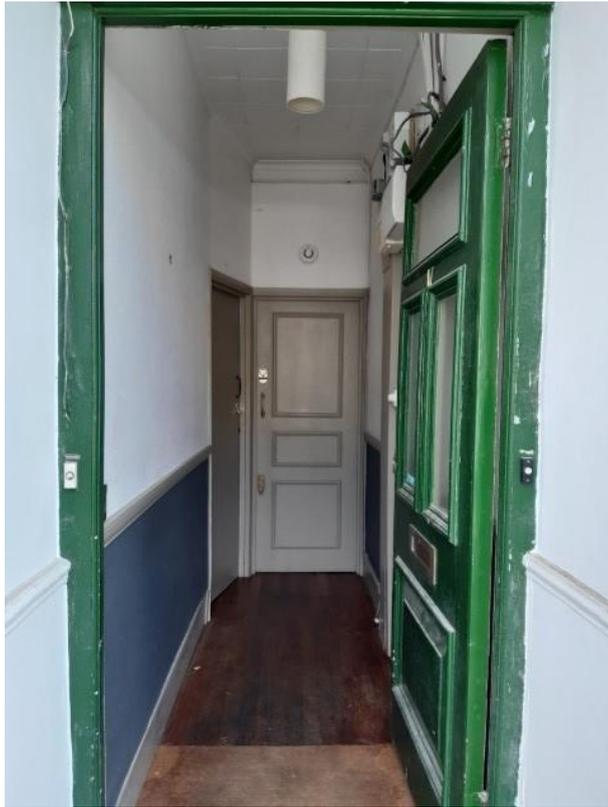
Communal hallway

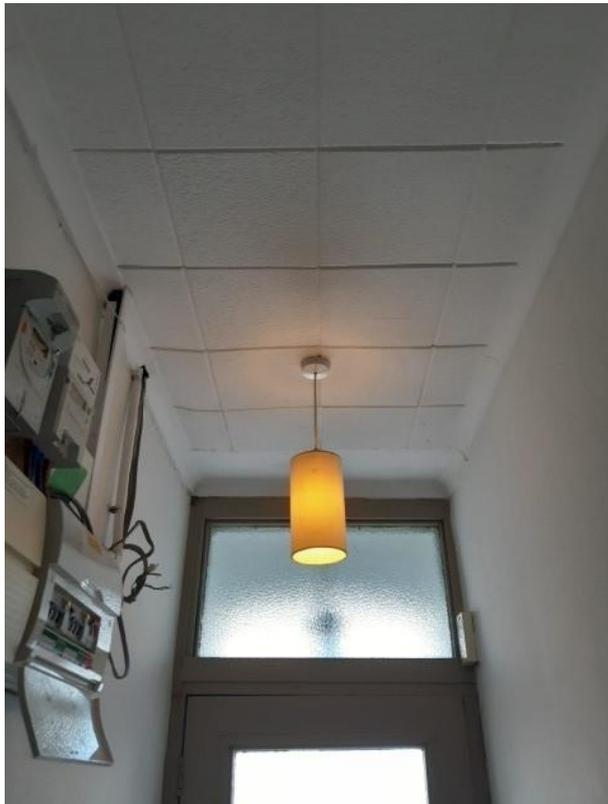
Communal hallway ceiling - pic 1

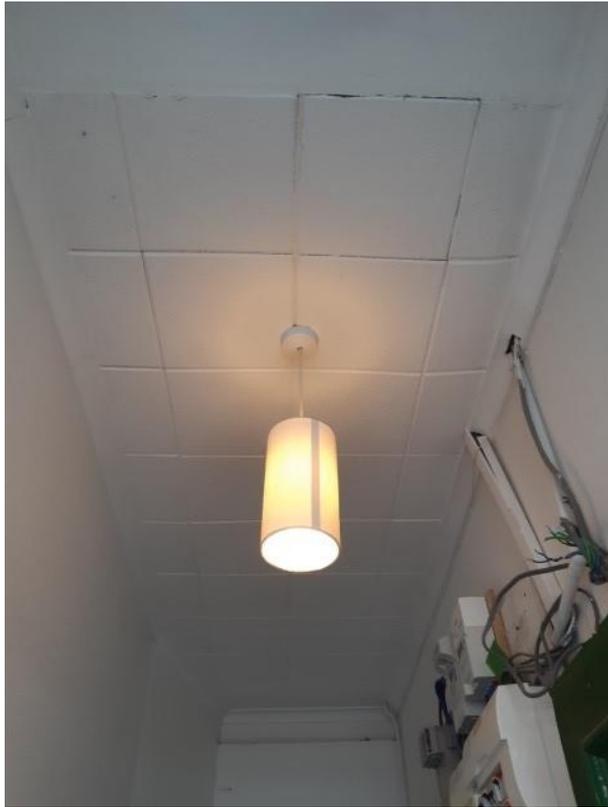
Communal hallway ceiling - pic 2

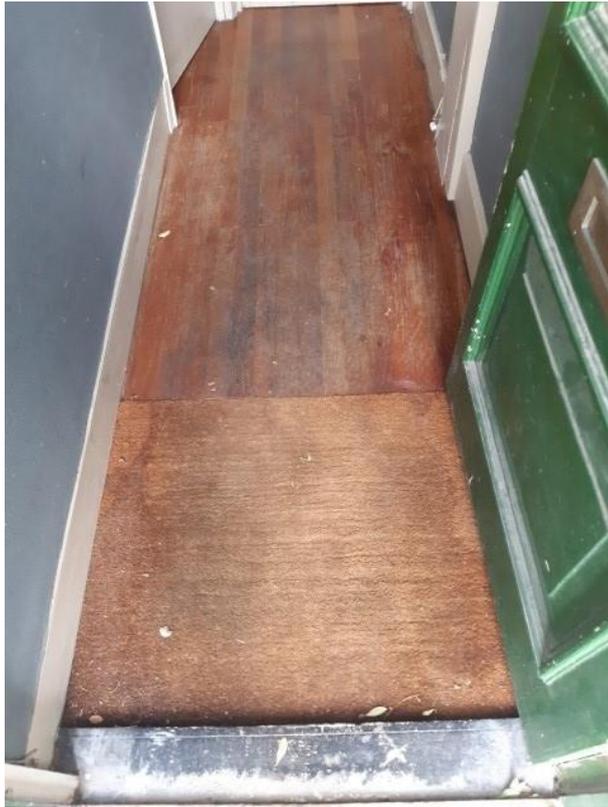
Communal hallway floor

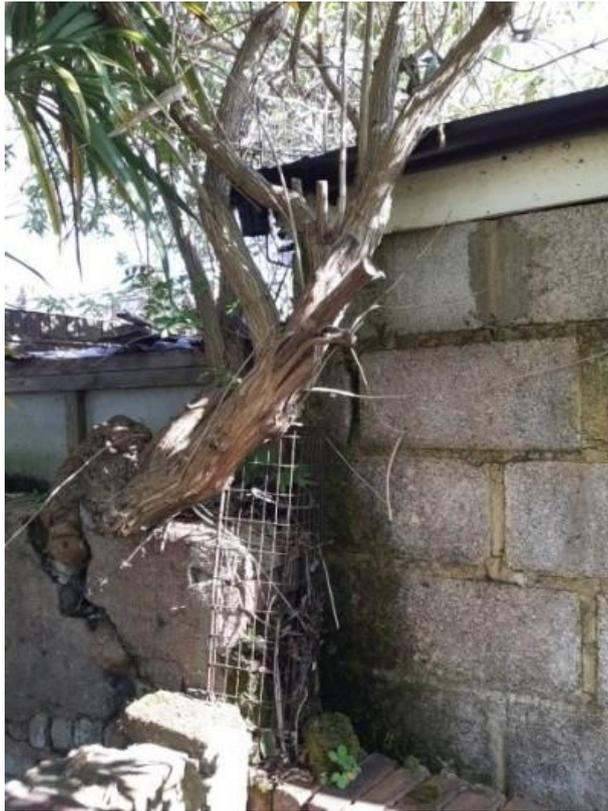
Neighbours rainwater drainage discharging onto boundary wall - pic 2
