Your survey report

Flat 7,
Example Road,
London,
WC1X 7DR

16th March 2022

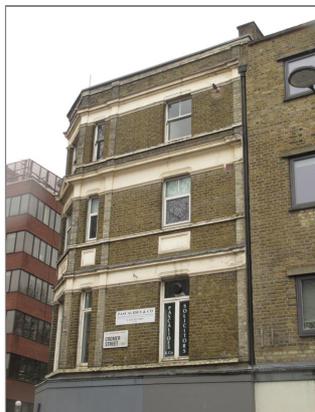
No evidence was seen of excessive staining of the walls or adjacent areas, which might indicate that significant leaks have been occurring.

The rainwater pipes and gutters appear to be in a serviceable condition with no repairs currently needed.

Photo - 4 Rainwater pipes and gutters

Gutters and downpipes should be cleaned and inspected regularly to ensure that they are free from blockages and leaks. If it is noted during any heavy rain, that gutters or downpipe joints are leaking, then these must be fixed as soon as possible to prevent water penetration to the property and damage to the foundations.

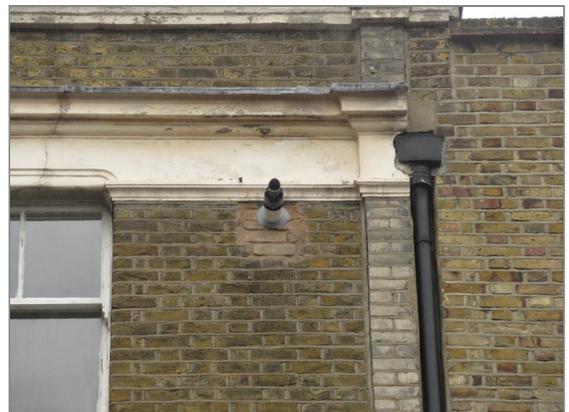
Photo - 5 Close up of rainwater pipe and box section to the rear of the parapet wall at roof level

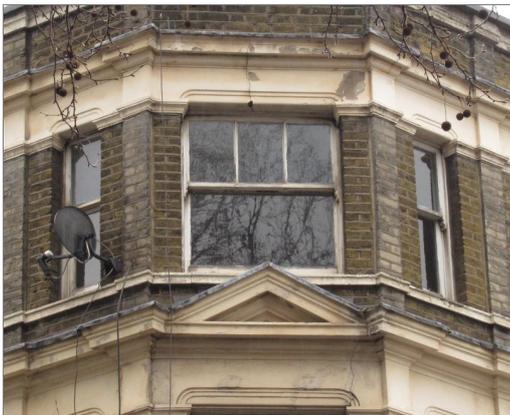
Photo - 10 Front window

You should allow for replacement of all windows in the medium term.

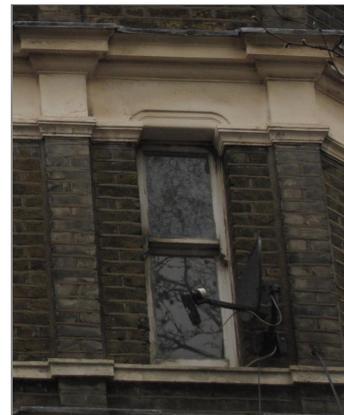
Photo - 11 Left-hand side window

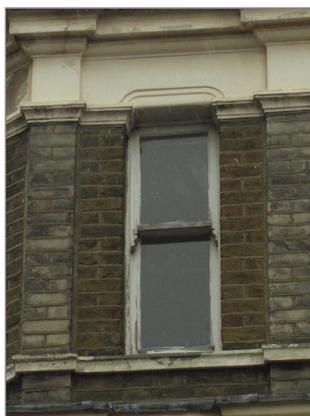
Photo - 12 Right-hand side window No.1

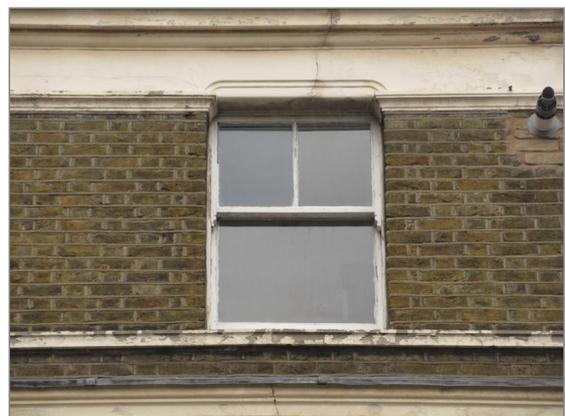
Photo - 13 Right-hand side window No.2

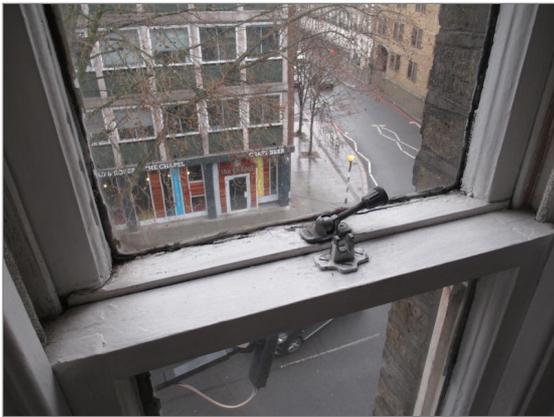
Photo - 14 Hand operated sash window fasteners to windows

Normal maintenance of hinges and locks is required.

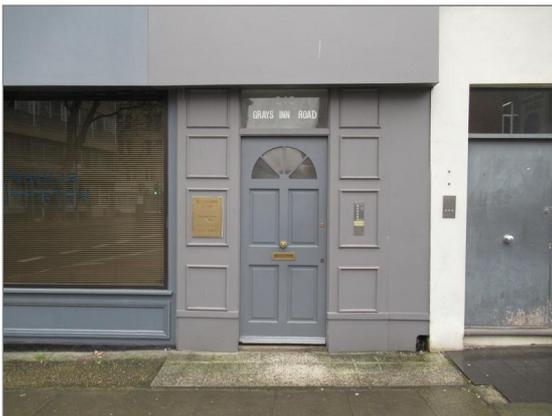
Photo - 22 Communal front door

Normal maintenance of door, frame, hinges and locks is required.

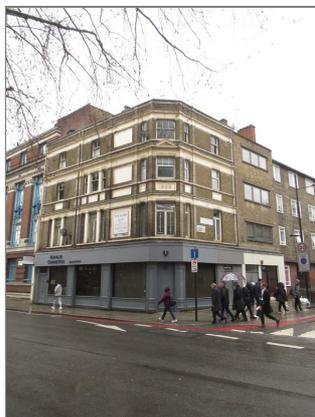
Photo - 23 Building elevation

Repaint areas suffering from weather damage.

Regular maintenance is required.

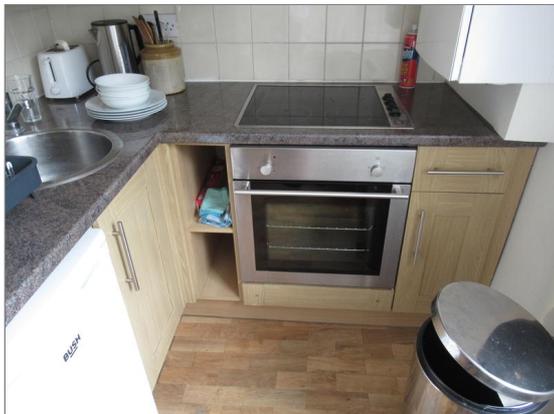
Photo - 50 Kitchen - pic 1

Install extractor fan to control condensation.

Maintain, repair or replace units as necessary.

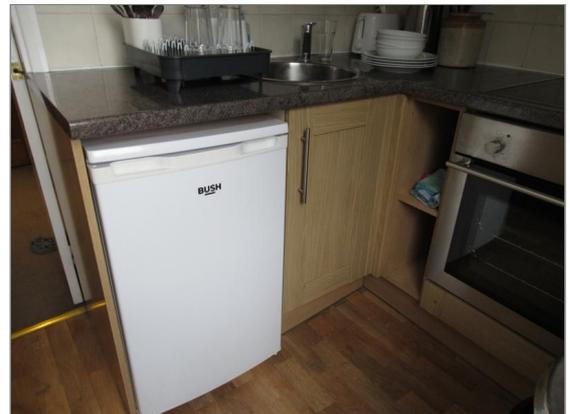
Photo - 51 Kitchen - pic 2

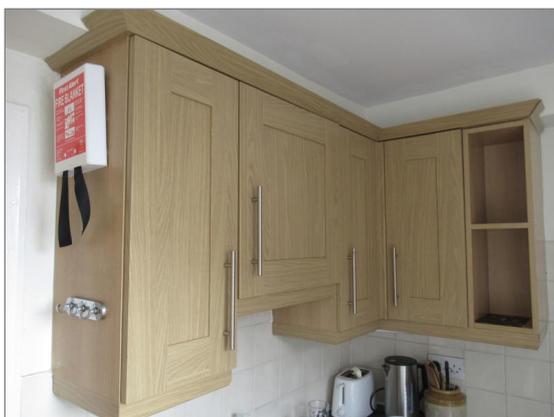
Photo - 52 Kitchen - pic 3

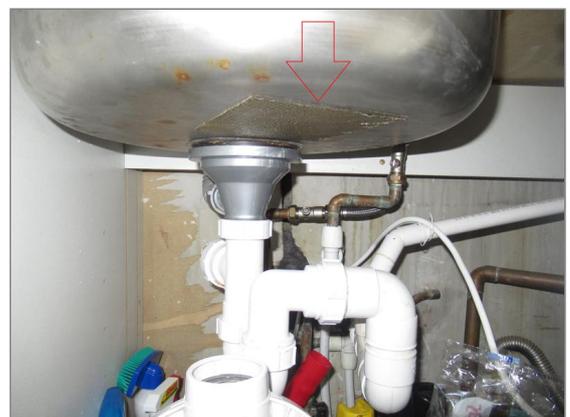
Photo - 53 Damper pad fitted to underside of kitchen sink

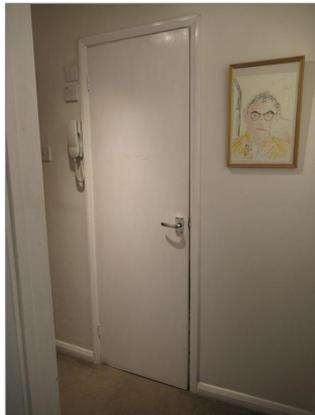
Photo - 54 Bathroom door

Door hinges and locks should be regularly lubricated. Internal timbers should be inspected regularly for evidence of bowing or distortion, woodworm and other defects.

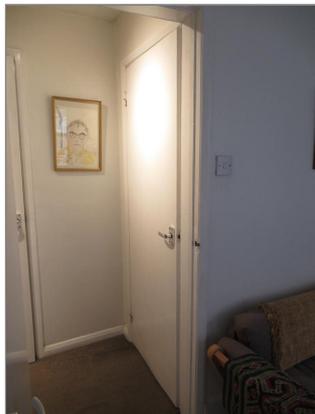
Photo - 56 Kitchen door

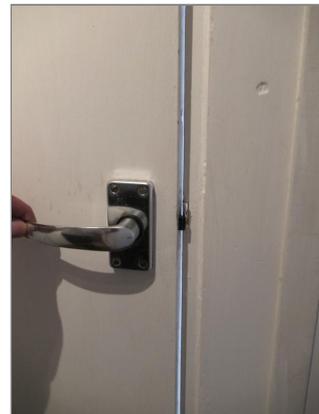
Photo - 57 Latch to kitchen door does not engage when door is closed

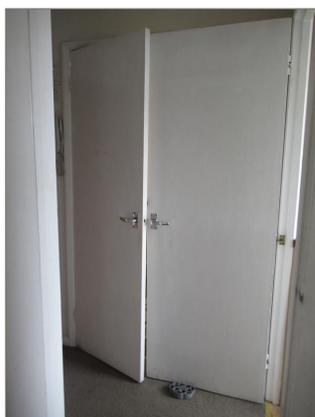
Photo - 58 Bathroom door fouls kitchen door when opened

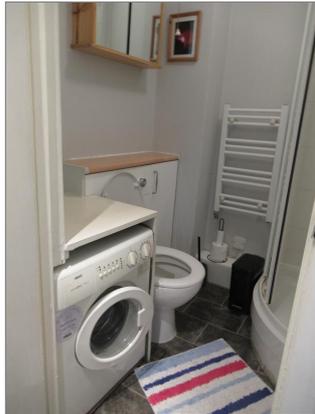
Photo - 61 Bathroom - pic 1

Regular maintenance of all seals to the shower in order to prevent water displacement.

Replace and repair bathroom units and cupboard doors as necessary.

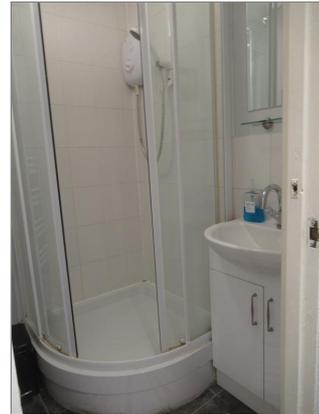
Photo - 62 Bathroom - pic 2

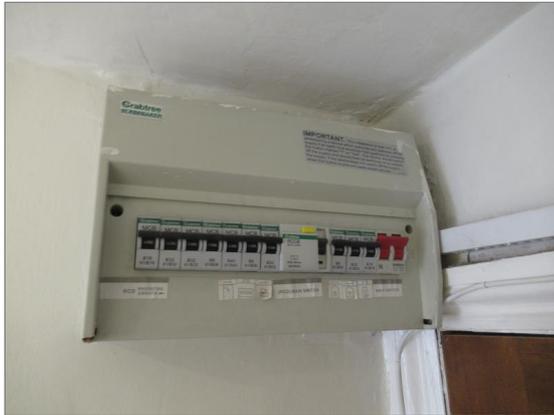
Photo - 65 Consumer unit located in hallway of apartment

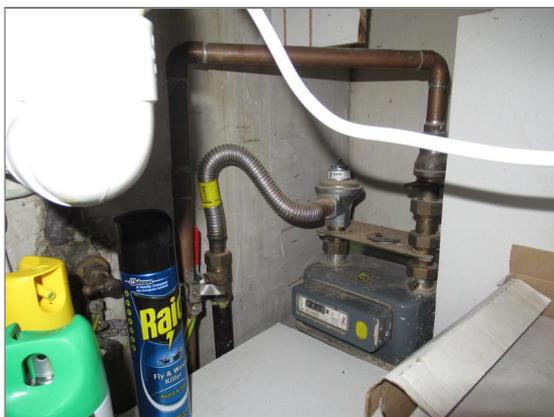
Photo - 68 Gas meter

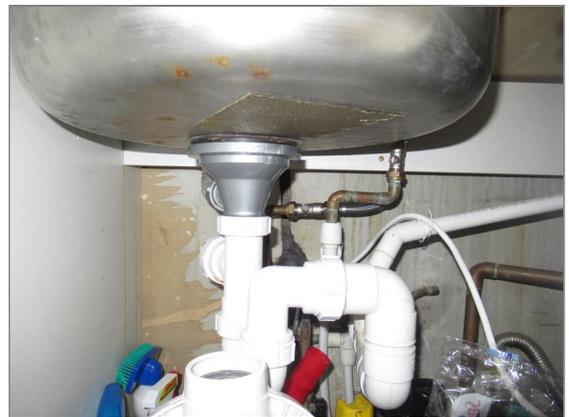
Photo - 70 Stop taps below kitchen sink - pic 2

Check the installation for evidence of leaks or other defects on a regular basis i.e. approximately every 6 months, or sooner. Leaks most often occur at pipe joints and where pipes are subject to movement or physical damage, such as airing cupboards, roof spaces and under sinks.

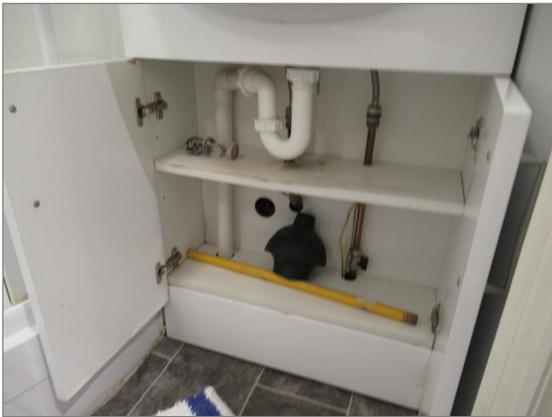
Photo - 71 Stop taps below bathroom hand wash basin

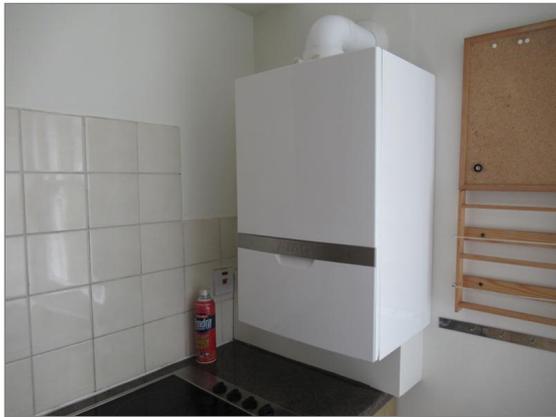
Photo - 72 Combi condensing boiler - pic 1

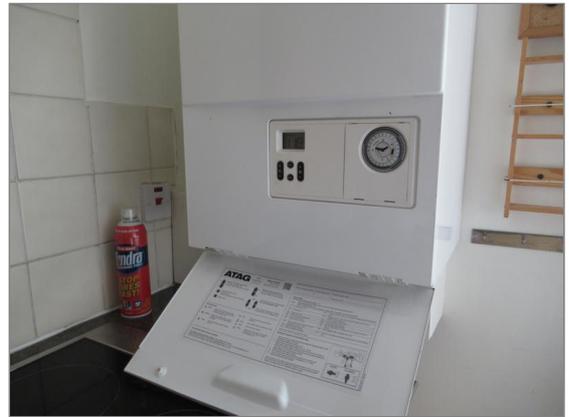
Photo - 73 Combi condensing boiler - pic 2

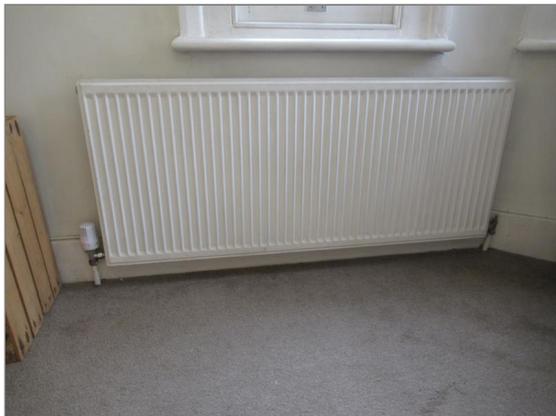
Photo - 74 Radiator in living room

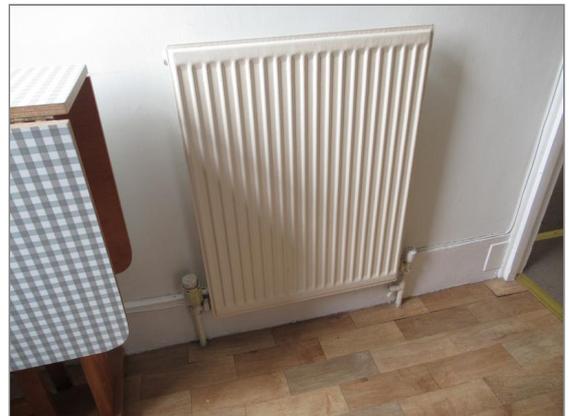
Photo - 75 Radiator in kitchen
