Your survey report

52 Example Avenue,
London,
W9 7DF.

12th April 2022

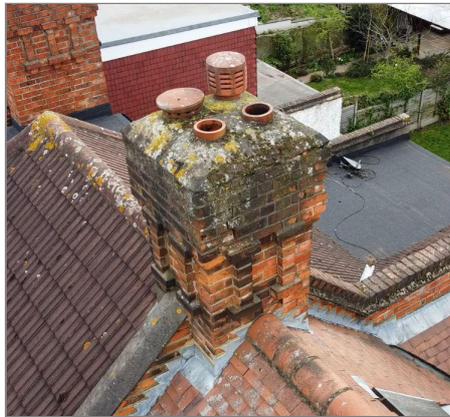
There is missing and weathered pointing evident to the top section of brickwork on the chimney stack. The top section of the chimney will need to be repointed in order to prevent water from penetrating the chimney stack and causing damp to the inside of the property.

The two chimney pots are each missing a cowl and have been left uncapped (see photo below). If any pots are left uncapped then rain can penetrate the flues and damp can appear inside the property on the chimney breasts. Providing fireplaces are regularly used then any penetrating moisture will dry out, however if fireplaces are used infrequently, or there are no fireplaces present, then cowls are necessary to prevent moisture ingress to the flue and vent the chimney breast.

Photo - 2 Chimney to front of property

Install chimney cowls to uncapped chimney pots.

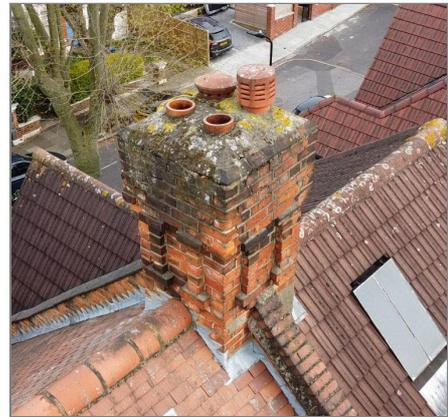
Photo - 3 Chimney to front of property

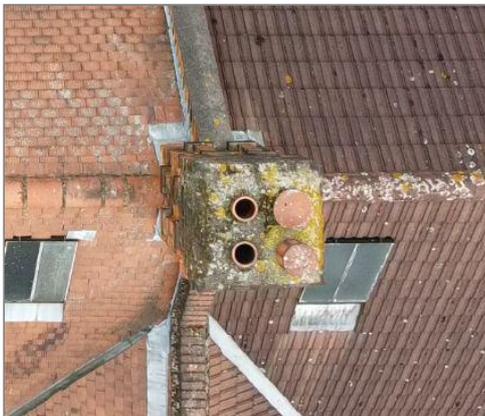
Photo - 4 Chimney to front of property

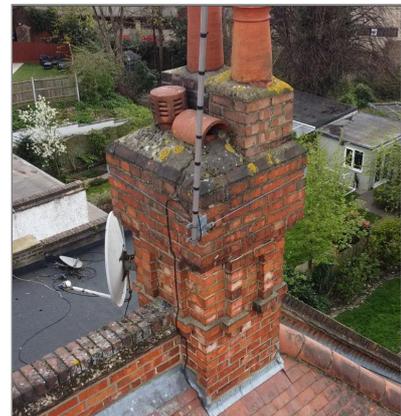
Photo - 5 Chimney to rear of property

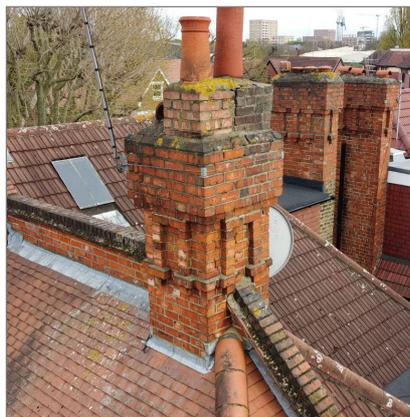
Photo - 6 Chimney to rear of property

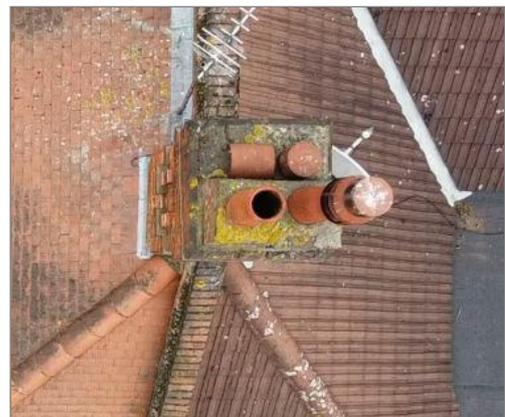
Photo - 7 Chimney to rear of property

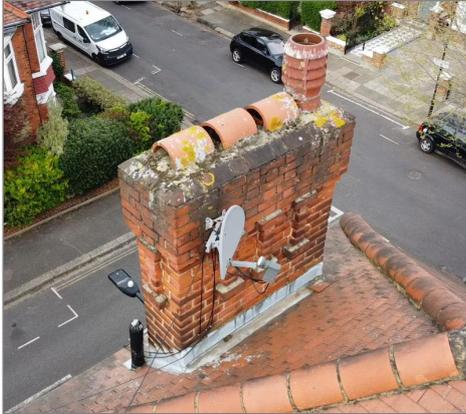
Photo - 8 Chimney to right-hand side of property

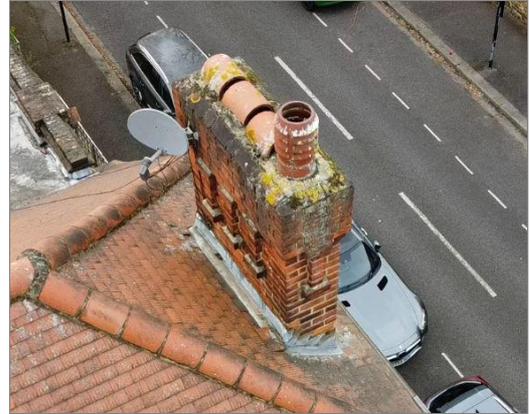
Photo - 9 Chimney to right-hand side of property

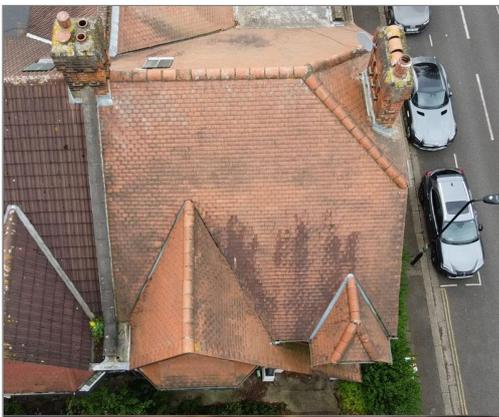
Photo - 11 Roof to front elevation

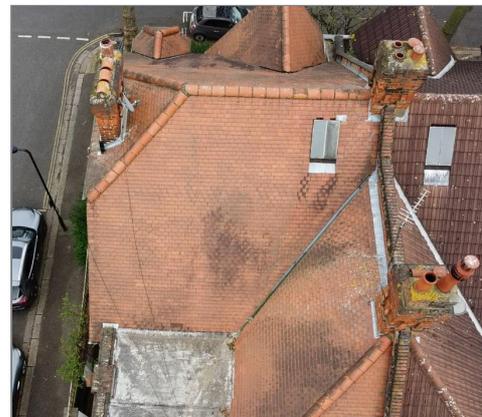
Photo - 12 Roof to rear elevation pic 1

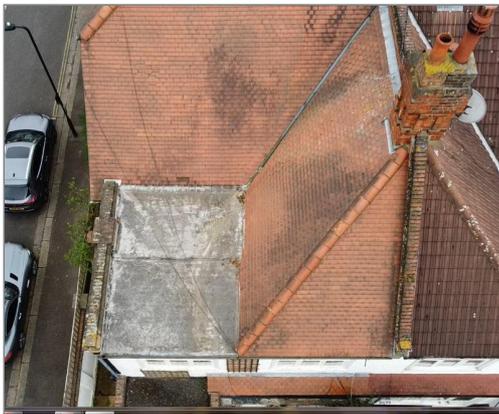
Photo - 13 Roof to rear elevation pic 2

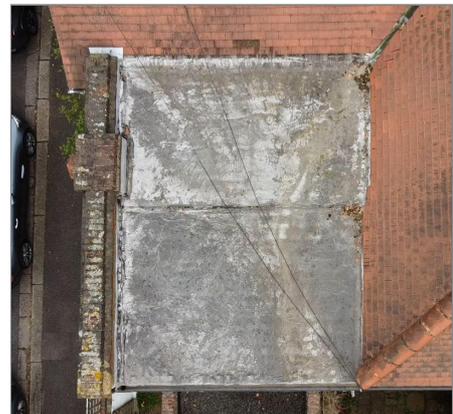
Photo - 14 Flat roof to 1st floor rear elevation

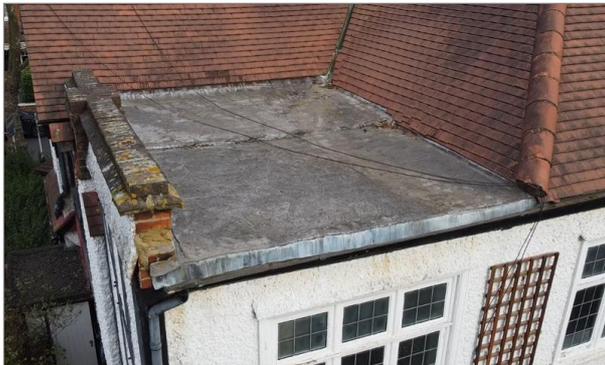
Photo - 15 Flat roof to 1st floor rear elevation

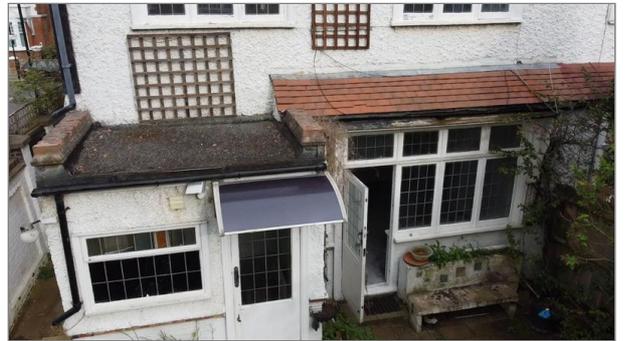
Photo - 16 Flat roof and tiles above window on ground floor of rear elevation

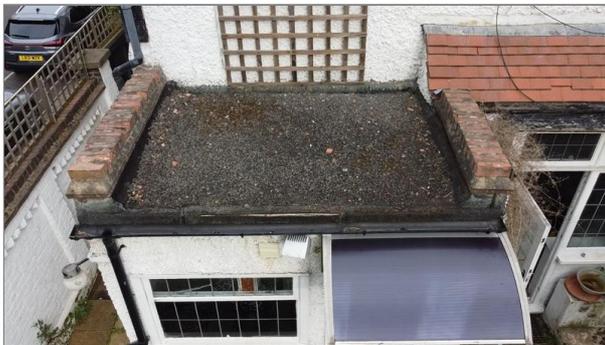
Photo - 17 Flat roof on ground floor of rear elevation

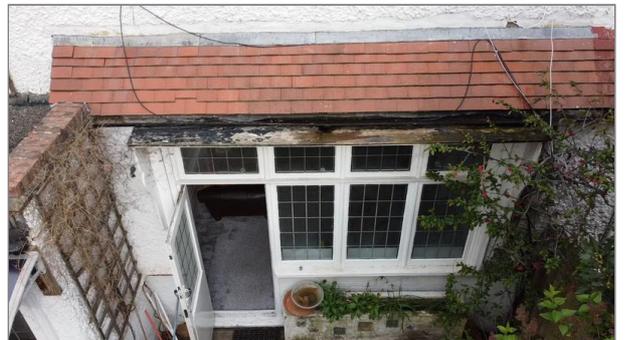
Photo - 18 Tiles above window on ground floor of rear elevation

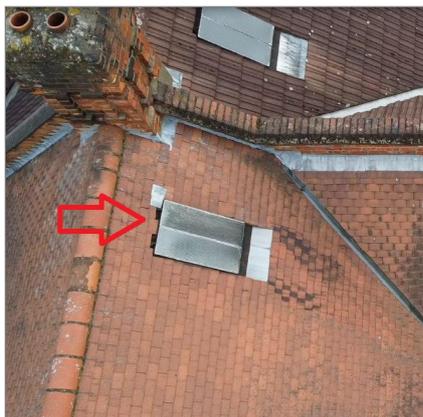
Photo - 19 Section of lead flash missing from top of skylight

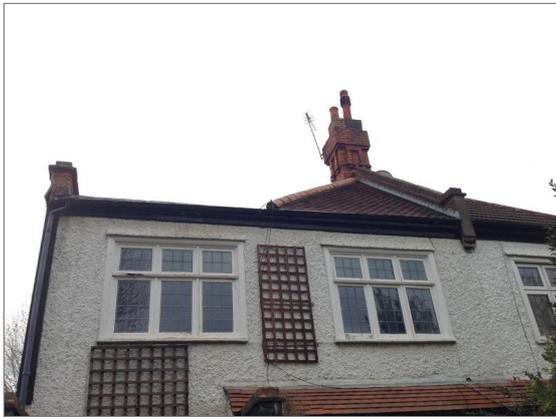
Photo - 20 Cast iron guttering to rear elevation

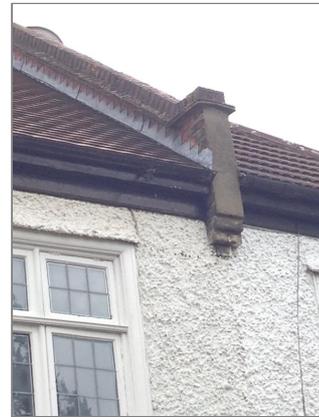
Photo - 21 Leaking joint to cast iron guttering on rear elevation

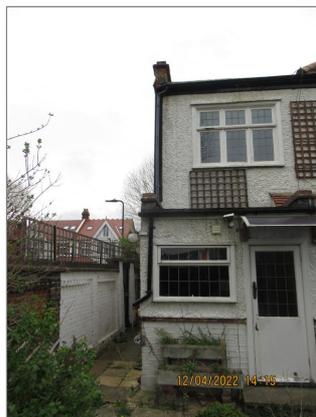
Photo - 24 Downpipe to rear elevation

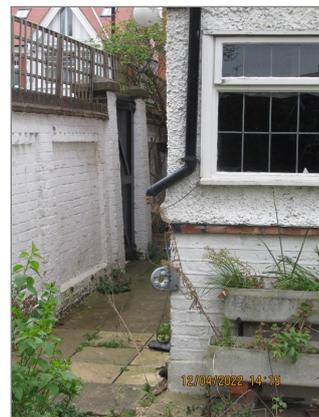
Photo - 25 Section of missing downpipe to rear elevation

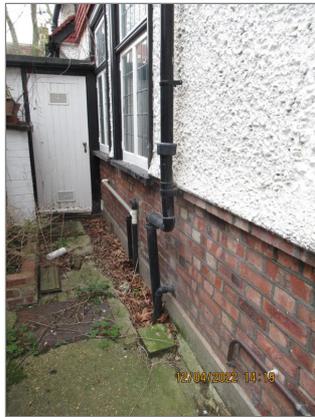
Photo - 26 Leaking joint to downpipe on side elevation

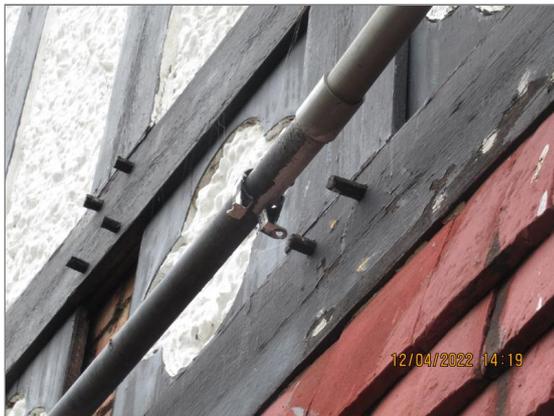
Photo - 28 Broken fixing to wastepipe on side elevation

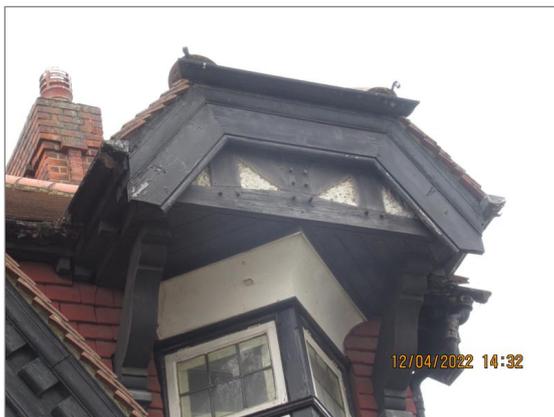
Photo - 30 Cast iron guttering to front elevation

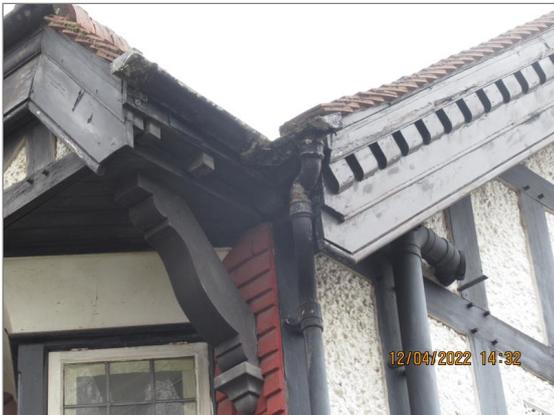
Photo - 32 Leaking joints to cast iron guttering and downpipe on front elevation

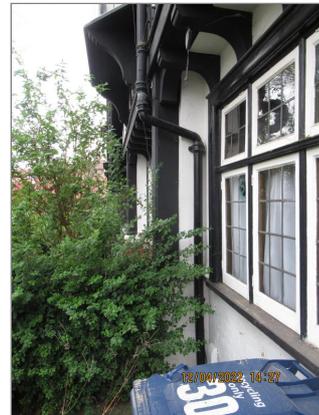
Photo - 33 Leaking joint to cast iron downpipe on front elevation

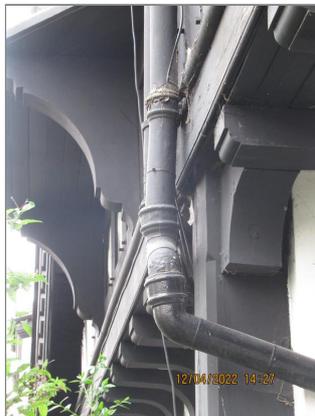
Photo - 34 Leaking joint to cast iron downpipe on front elevation

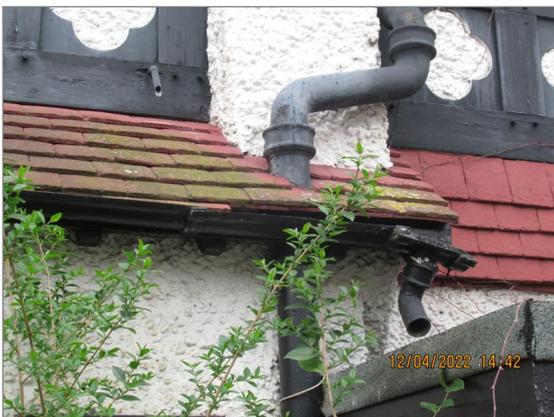
Photo - 36 Damaged guttering and missing downpipe on side elevation

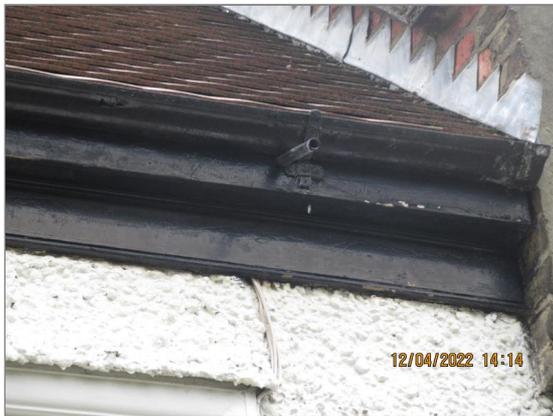
Photo - 40 Dripping overflow pipe at roof level on rear elevation

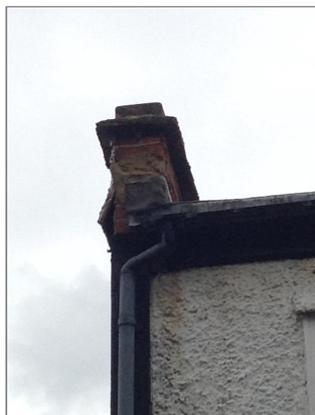
Photo - 49 Damaged brickwork to parapet wall on flat roof of 1st floor rear elevation

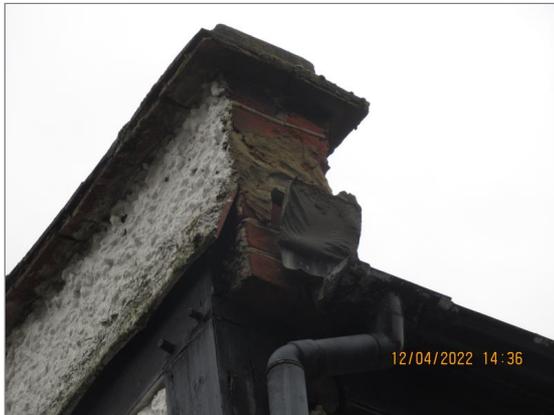
Photo - 51 Detached render panel on parapet wall of flat roof on 1st floor rear elevation

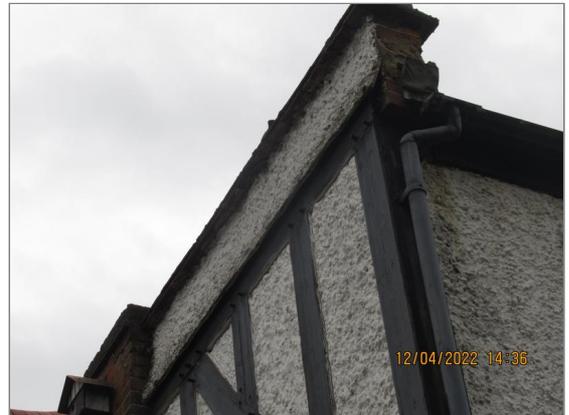
Photo - 52 Detached render panel on parapet wall of flat roof on 1st floor rear elevation

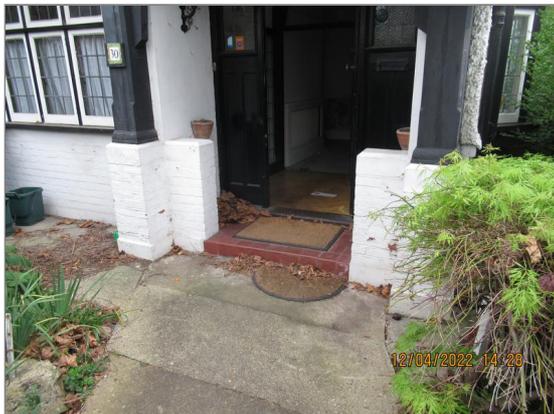
Photo - 53 Damaged/spalling brickwork next to front door entrance

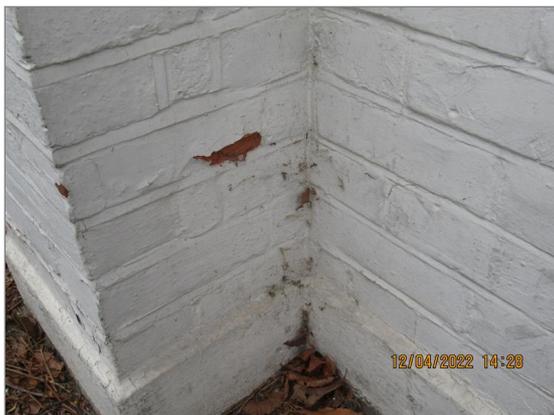
Photo - 55 Damaged/spalling brickwork next to front door entrance

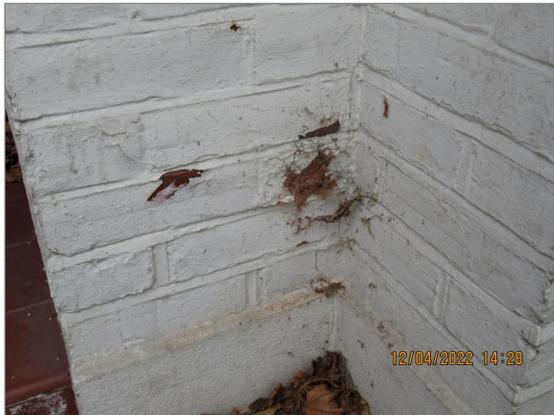
Photo - 57 Damaged/spalling brickwork next to front door entrance

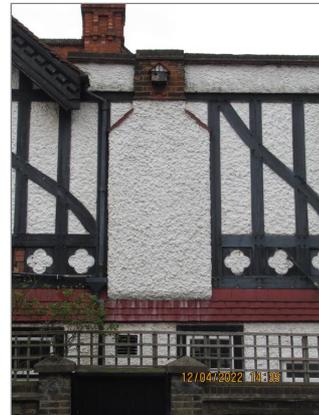
Photo - 58 Damaged/spalling brickwork below bird house on side elevation

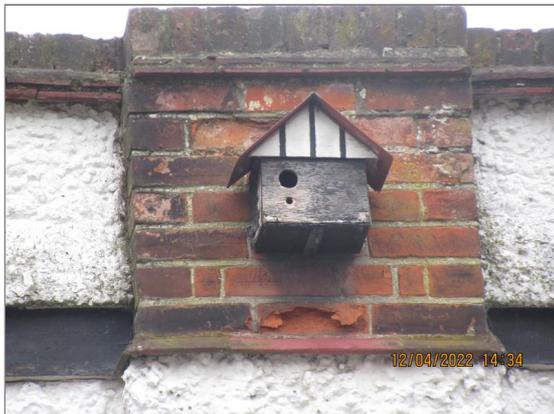
Photo - 59 Damaged/spalling brickwork below bird house on side elevation

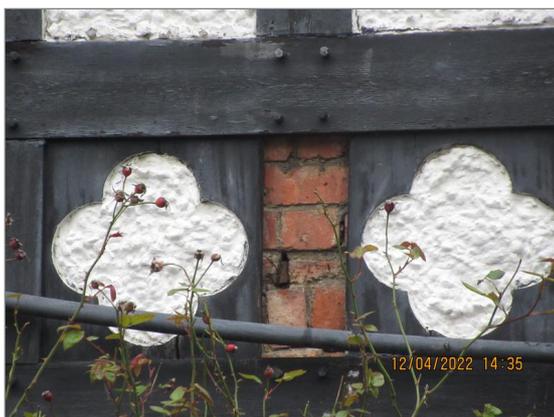
Photo - 61 Gaps and timber in pointing on side elevation

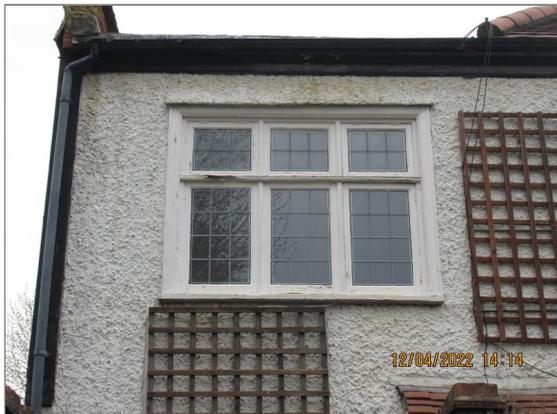
There is minor wood rot present to some timber frames externally (see photos below). This can be repaired by carrying out splice repairs to the timber window frames. Splice repairs involve removing the rotten sections of timber and replacing them with new timber.

Photo - 64 Wood rot to rear bedroom window

Carry out splice repairs to the sections of timber window frames suffering from wood rot.

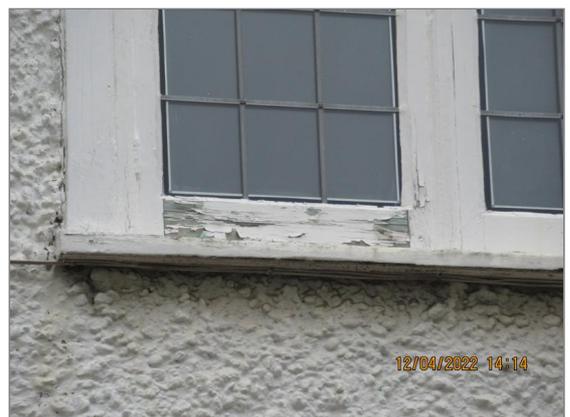
There is peeling paint to a number of timber window frames externally (see photos below). They will require painting immediately in order to protect from the onset of wood rot.

Photo - 67 Peeling paint to rear bedroom window

Paint timber window frames externally in order to protect from the onset of wood rot.

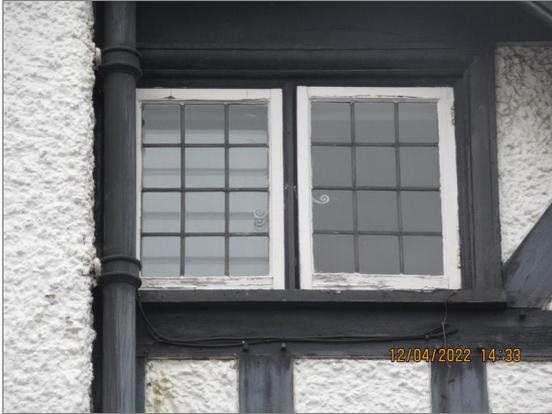
Photo - 68 Peeling paint to side elevation window

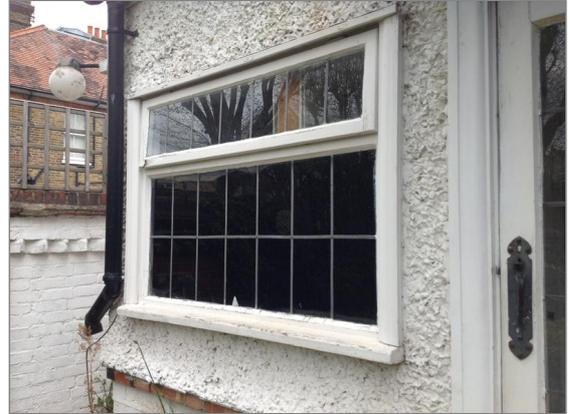
Photo - 69 Peeling paint to rear elevation window

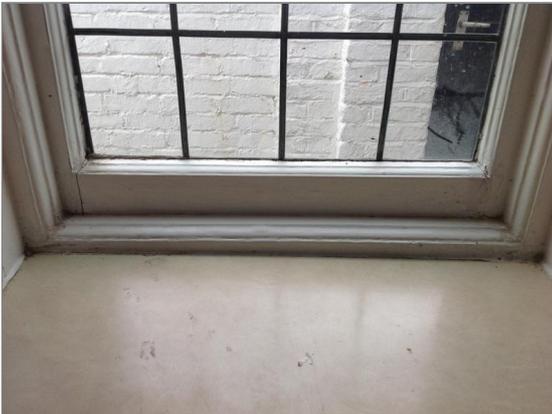
There are minor gaps in some of the timber window frames internally (see photos below). These can be repaired by filling the gaps with wood filler and repainting.

Photo - 70 Minor gaps in timber frames internally

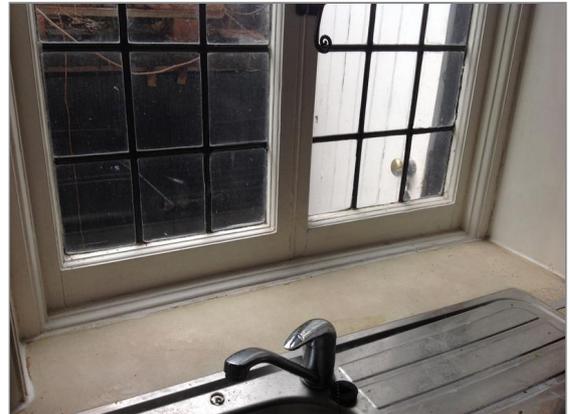
Photo - 71 Minor gaps in timber frames internally

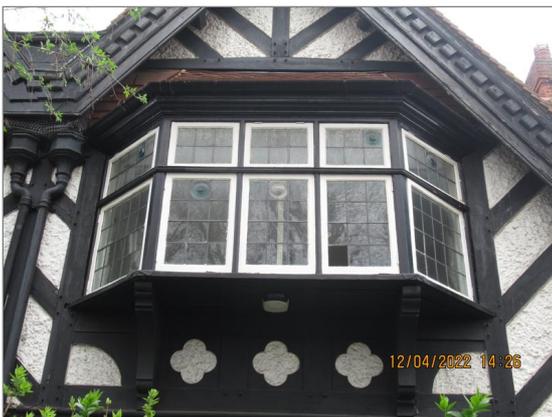
There is a missing glass window pane to the front bedroom window (see photos below).

Photo - 72 Missing glass window pane to front bedroom window

Replace the missing glass window pane to the front bedroom window.

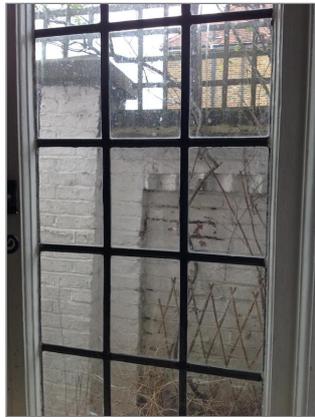
Lead strips are present to the majority of window panes (see photos below). Lead can be hazardous to human health, but in its current location on the external face of the glass window panes, the risk to human health is low.

Photo - 74 Lead strips to window panes

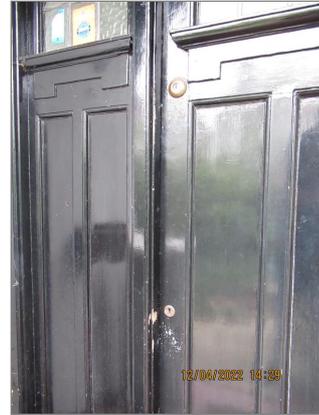
The timber front door is in a serviceable condition. There is some general wear to the paintwork (see photos below), which will need repainting. The door operated normally when opened and closed.

Photo - 76 General wear to paintwork on timber front door

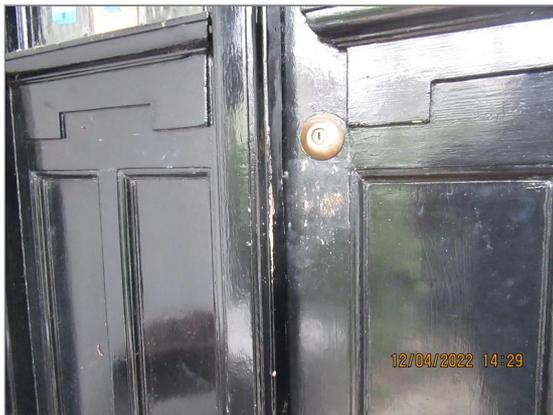
Photo - 77 General wear to paintwork on timber front door

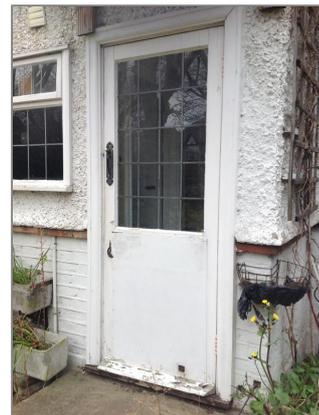
The first back door, located off the toilet/shower area to the left-hand side of the rear elevation, is suffering from weather damage. The paint to the bottom panel of the door is peeling. The timber tread to the door (known as the door threshold) is also rotten. The door is beyond repair and will need replacing.

Photo - 78 Timber back door located off the toilet/shower area needs replacing

Replace both back doors and possibly upgrade to uPVC or GRP doors.

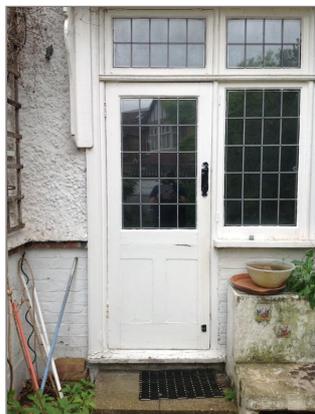
The second back door, located off the living room to the right-hand side of the rear elevation, is also suffering from weather damage. The timber tread to the door (known as the door threshold) is also rotten. The door is beyond repair and will need replacing.

Photo - 79 Timber back door located off the living room needs replacing

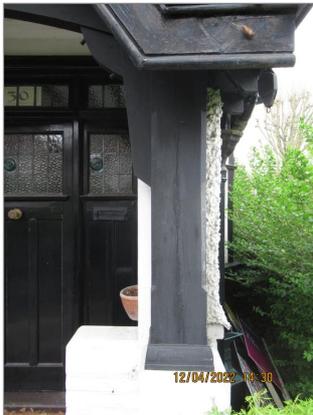
Photo - 84 Spilt in timber of column at front entrance

The splits in the timber of the two columns located at the front entrance of the property, need to be filled with an epoxy resin to prevent water ingress and timber decay.

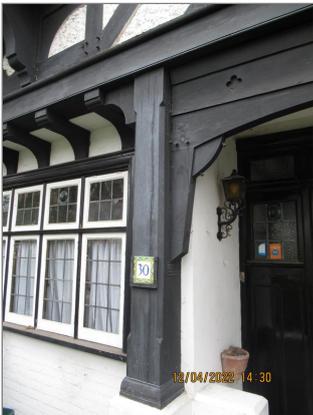
Photo - 85 Spilt in timber of column at front entrance

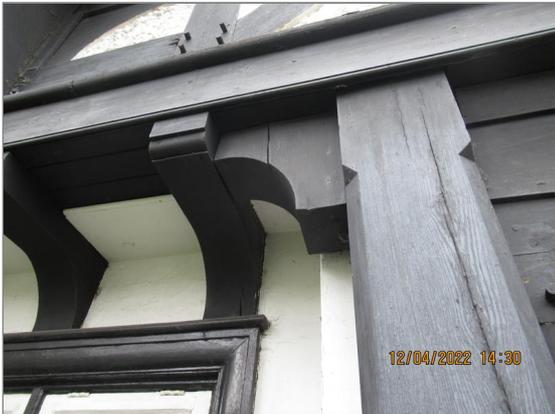
Photo - 86 Spilt in timber next to column at front entrance

The split in the timber next to the column located at the front entrance of the property, needs to be filled with an epoxy resin to prevent water ingress and timber decay.

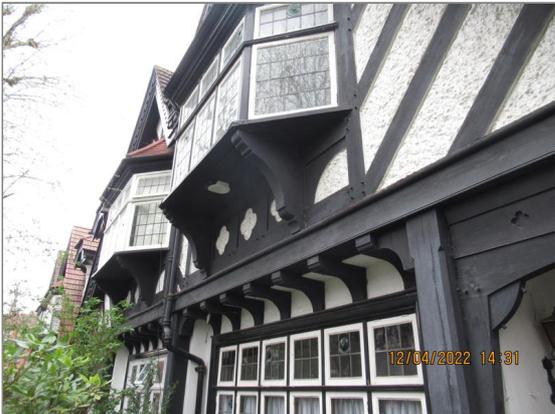
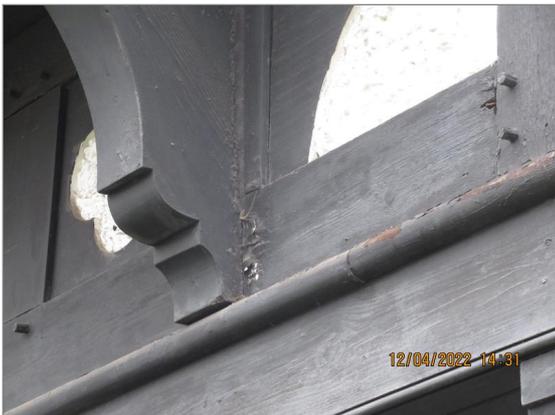
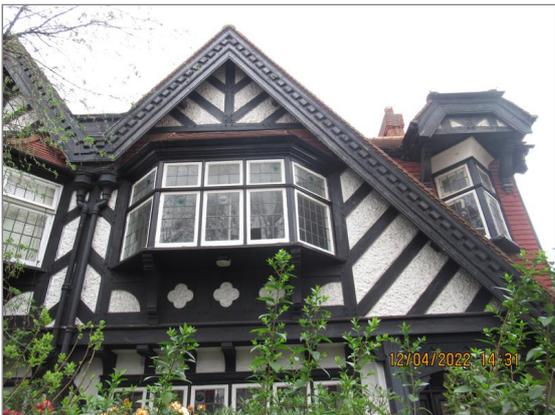
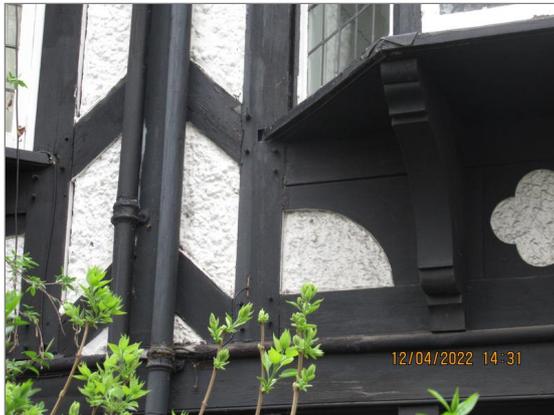
Minor timber damage on front elevation (see photos below).

Photo - 87 Minor timber damage on front elevation

Photo - 88 Minor timber damage on front elevation

Photo - 89 Minor timber damage on front elevation

Photo - 90 Minor timber damage on front elevation

Repair minor timber damage on the front elevation and paint as necessary.

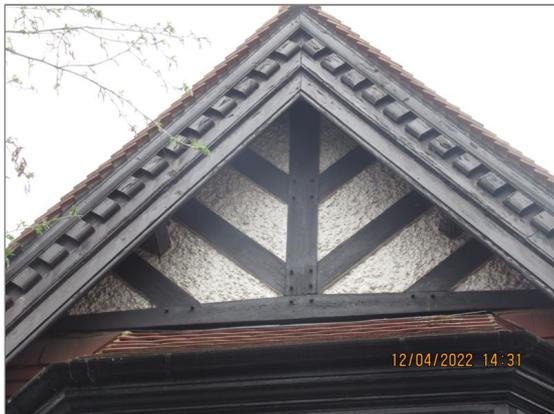
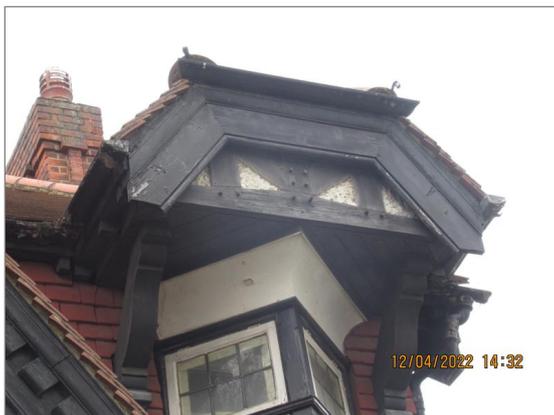
Minor timber damage to bargeboards on front elevation (see photos below).

Photo - 92 Minor timber damage to bargeboard on front elevation

Photo - 94 Minor timber damage to bargeboard on front elevation

Repair minor timber damage to bargeboards on front elevation and paint as necessary.

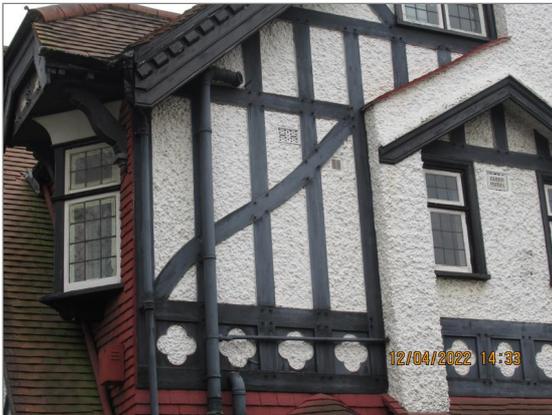
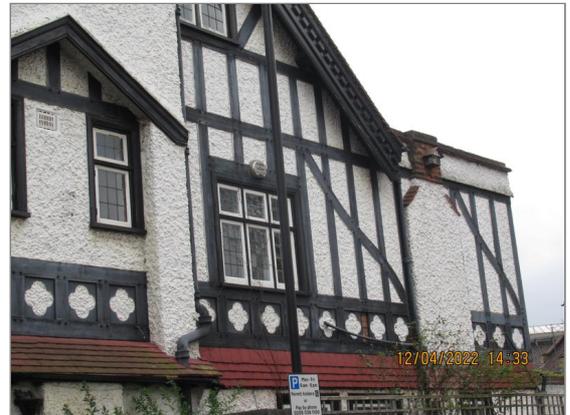
Photo - 96 Timber decorations to side elevation are faded and need repainting

Photo - 97 Timber decorations to side elevation are faded and need repainting

All timbers decorations need repainting in their entirety and wood repairs carried out where necessary.

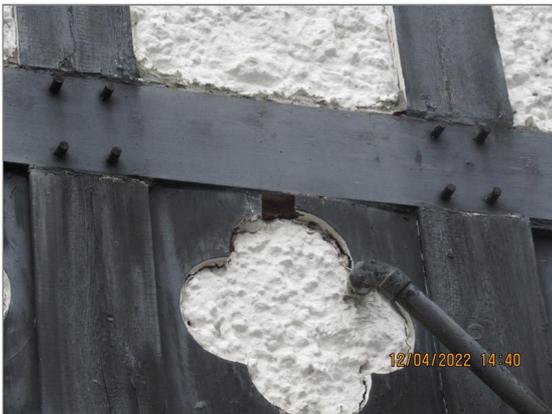
Timber repair needed to side elevation to prevent wood rot

Photo - 98 Timber repair needed to side elevation to prevent wood rot

Repair minor timber damage to side elevation to prevent wood rot and paint as necessary.

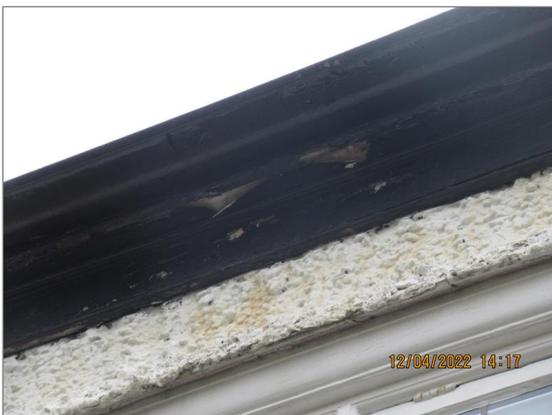
Timber bargeboard to the rear elevation is damaged where the gutters are leaking.

Photo - 100 Timber bargeboard to rear elevation damaged where gutters are leaking

Repaint timber bargeboard to rear elevation that has been damaged where the gutters are leaking. The bargeboard may need replacing if the water damage is found to be severe.

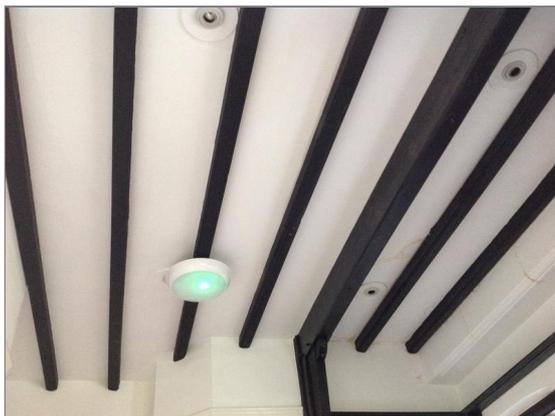
Water damage is apparent to the ceiling in the hallway. This has caused hairline cracking and staining of the ceiling surface (see photos below). This is not of structural concern and can be repaired by removing the plaster from the affected area and replastering/painting as necessary.

Photo - 101 Water damage to hallway ceiling

Repair of the laths underlying the plaster may be necessary prior to replastering.

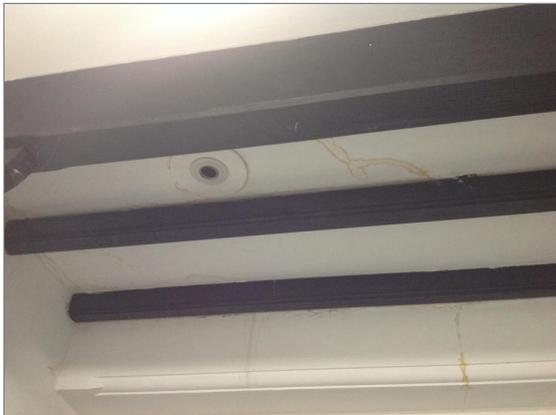
Photo - 103 Hairline cracks and staining to hallway ceiling caused by water damage

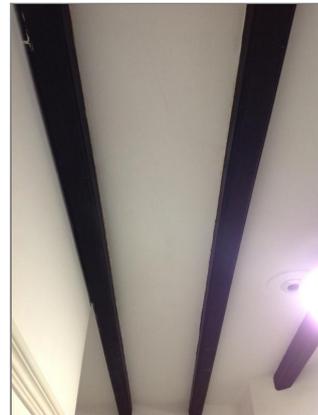
Photo - 104 Hairline cracks to hallway ceiling

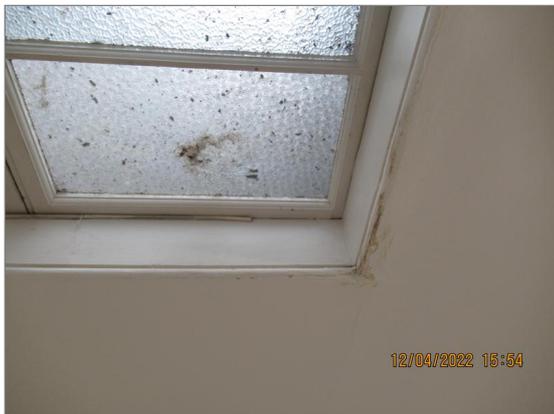
Photo - 127 Water ingress to skylight on 2nd floor

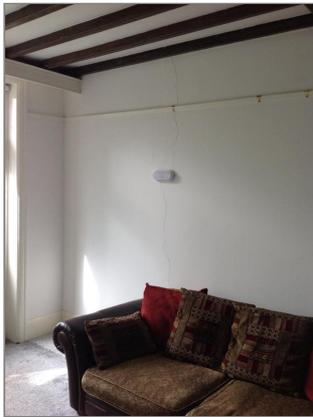
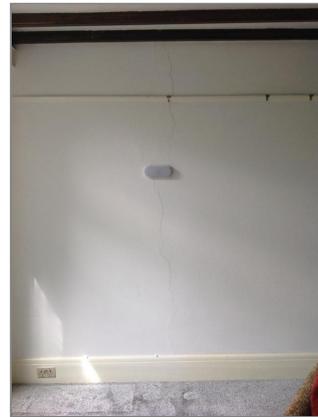
Photo - 128 Cracking to the wall in the living room

Photo - 129 Cracking to the wall in the living room

Normal maintenance is required, including filling and redecorating of cracks as necessary.

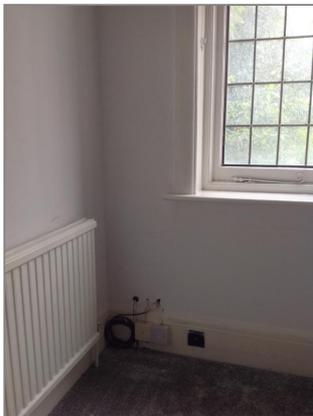
Photo - 130 Crack to bottom left-hand corner of window in living room

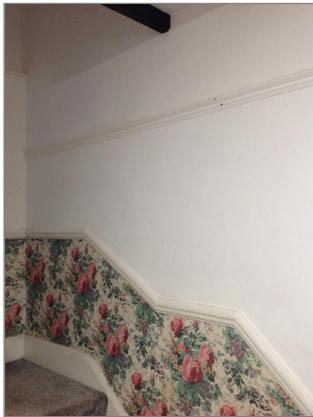
Photo - 134 Undulations to lath & plaster wall at bottom of stairs

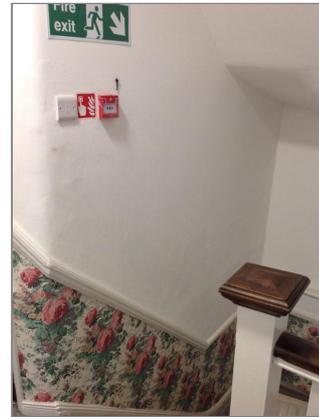
Photo - 135 Undulations to lath & plaster wall at bottom of stairs

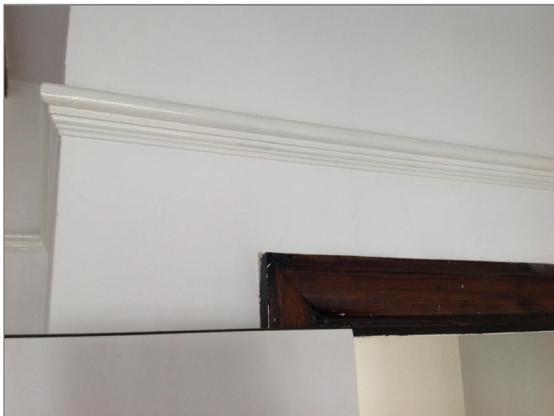
Photo - 136 Minor cracking to wall at corner of door frame in downstairs reception room

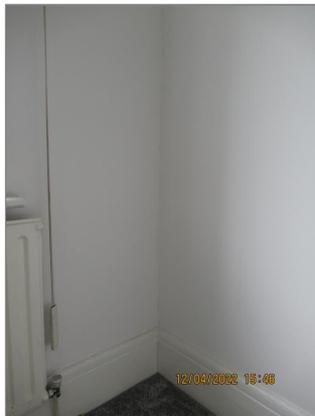
Photo - 142 Crack to corner of 1st floor rear bedroom

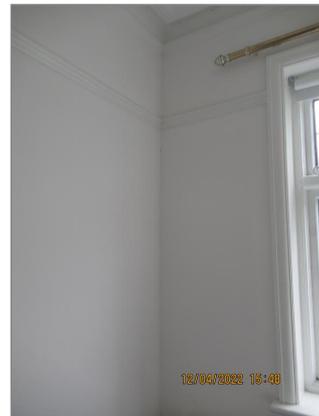
Photo - 143 Crack to corner of 1st floor rear bedroom

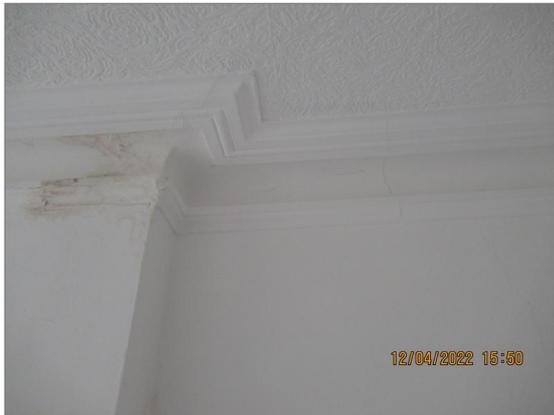
Photo - 146 Water damage to side wall in small rear bedroom

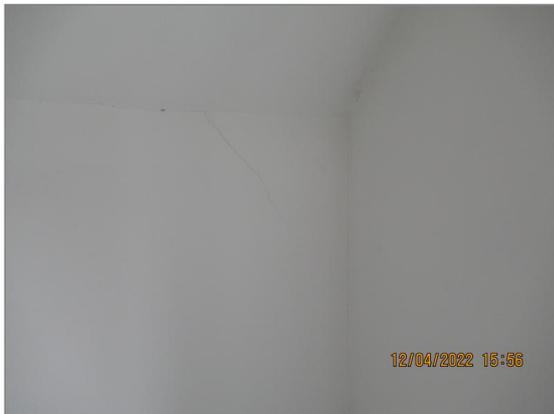
Photo - 148 Minor superficial cracking to wall in 2nd floor bedroom

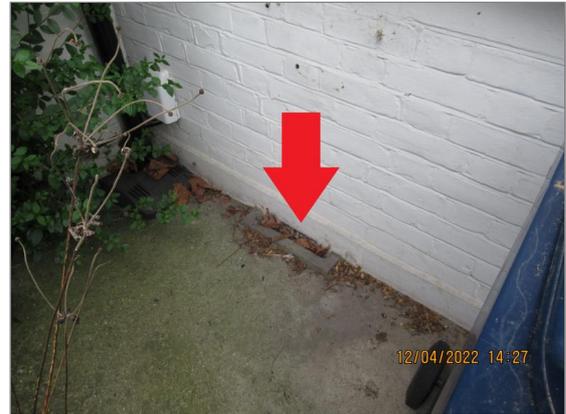
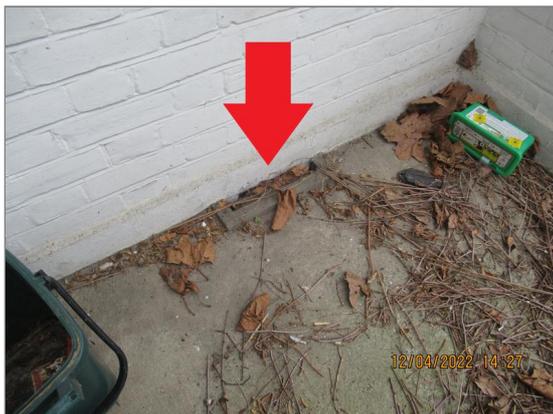
adequate ventilation to the underfloor voids, to minimise the build-up of moisture that can promote the development of rot and other defects in the timbers that support the floors. No evidence of any undue flexing of the ground floor structure was noted; this indicates that the ventilation levels in the past have been adequate. However at present the airbricks to the front of the property are blocked with debris (see photos below). It is essential that a free flow of air is maintained through the air bricks, hence the debris blocking the air bricks must be removed immediately.

Photo - 151 Air brick to front of property blocked with debris

Photo - 152 Air brick to front of property blocked with debris

Remove debris blocking the air bricks immediately. Ensure that the external air bricks, visible at the base of the external walls, are kept clear to maintain adequate ventilation in the underfloor void. External paving and soil levels should not be allowed to rise above the level of the air bricks. A lack of ventilation can allow moisture levels beneath the floor to become elevated, increasing the risk of the development of moisture related defects such as rot and infestations by wood boring insects (commonly known as woodworm).

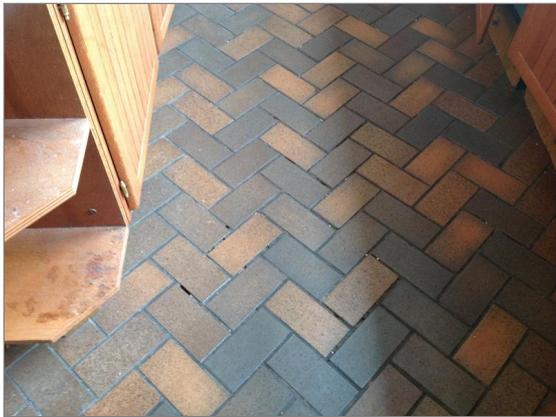
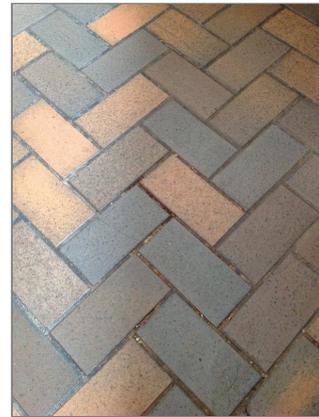
Being of solid concrete construction, specific checks were made for any drops to the floor in the kitchen and downstairs toilet area. Construction materials used for this type of floor can settle and cause distortion of the slab base. There were minor cracks noted to the clay brick sets that form the surface of the kitchen floor, where the underlying construction materials have compacted over time (see photos below). This is not of major concern and is normal in a property of this type and age. There were also gaps to the joints of the clay brick sets which need repairing with mortar (see photos below).

Photo - 155 Gaps to joints of clay brick sets in kitchen floor

Photo - 156 Gaps to joints of clay brick sets in kitchen floor

Photo - 157 Gaps to joints of clay brick sets in kitchen floor

Repair gaps to the joints in the clay brick sets in the kitchen.

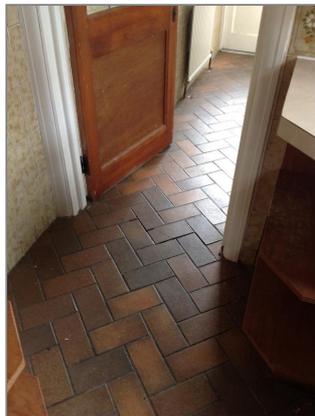
Photo - 158 Cracks to clay brick sets in kitchen floor

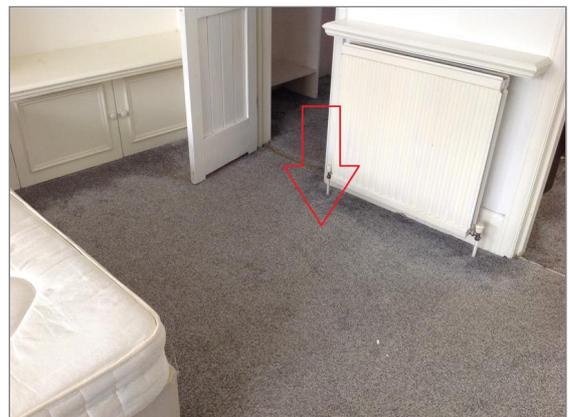
Floors in properties of this age can be uneven and out of level. This type of unevenness is commonly found in properties of this age and type and usually reflects settlement of the structure that has occurred over a long period of time. Where significant movement of the floor structure has occurred recently, it is most commonly identified by separation of the joints of the skirting's, door frames and other associated finishes, exposure of undecorated areas where one surface has moved away from another, and unusual amounts of spring in the floor surfaces. No undue levels of movement were noted at the time of the survey. However, two dips were noted to the suspended timber floor on the 1st floor. The first dip is located at the front bedroom door as you enter the front bedroom. The second is located in the front bedroom, in front of the walk-in wardrobe. There has been some slight movement to the floor structure in these locations, but this not of major concern and the floor is structurally sound. This movement in the floor structure also shows up in the misalignment of the door frame (see photos below).

Photo - 161 Dip to suspended timber floor located in the front bedroom, in front of the walk-in wardrobe

Floors should be monitored for any changes that occur in their level or springiness or noise, and further investigations carried out should any such changes become apparent.

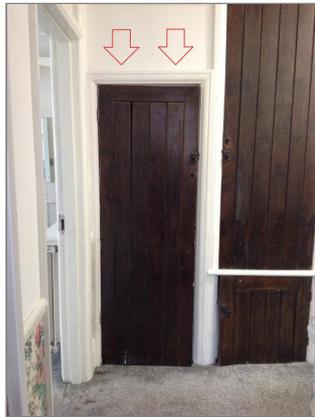
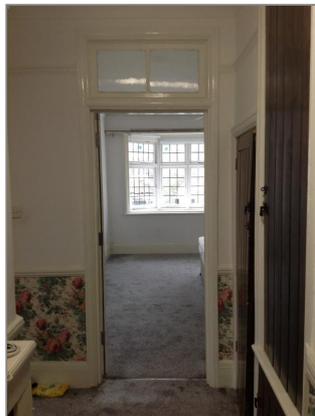
Photo - 162 Movement in floor structure shows up in misalignment of door frame

Photo - 163 Movement in floor structure shows up in misalignment of door frame

Photo - 164 Movement in floor structure shows up in misalignment of door frame

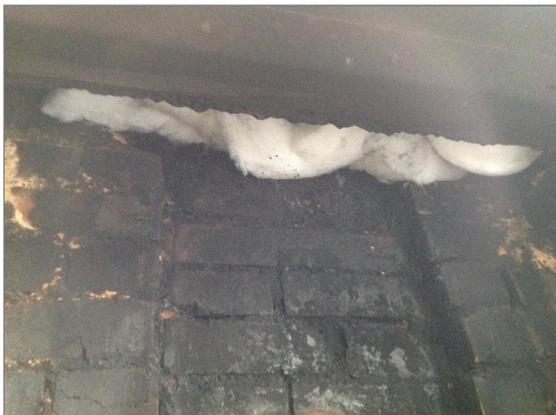
It is important to maintain an adequate airflow, by means of ventilation, through chimney flues to prevent the build-up of condensation within the chimney. It was noted during the survey, that ventilation to the fire place in the reception room had been blocked with what appeared to be a pillow (see photos below). The pillow should be removed to allow for adequate airflow through the

Photo - 167 Pillow blocking ventilation of flue in fire place

Remove pillow blocking ventilation of the flue in the reception room fire place.

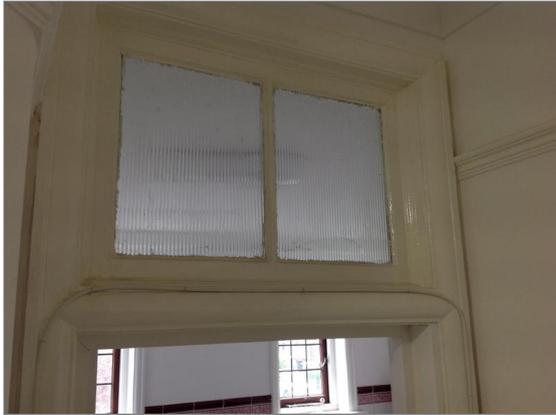
There are two cracked panes of glass above the main bathroom door on the 1st floor (see photos below).

Photo - 170 Two cracked panes of glass above main bathroom door on 1st floor

Replace the two cracked panes of glass above the main bathroom door on the 1st floor.

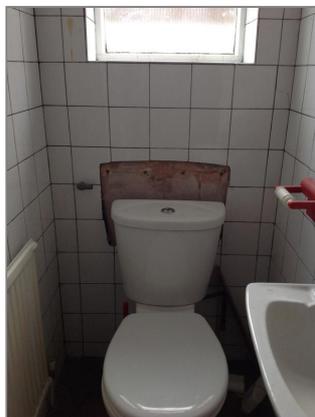
There is a section of wall tiles missing to the back wall of the WC. This is due to the old toilet being upgraded to a more modern toilet with a smaller cistern (see photo below).

Photo - 171 Missing wall tiles to downstairs WC

Retile back wall to downstairs WC as necessary.

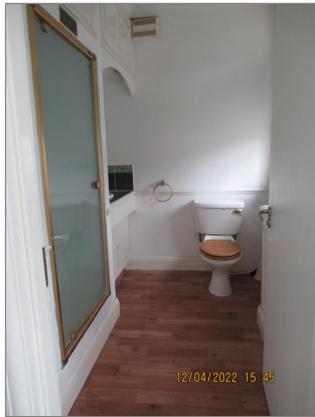
The fittings in the ensuite are of a dated style and it is anticipated that most new owners would replace them, in their entirety, upon occupation of the property (see photo below).

Photo - 173 Ensuite to front bedroom on 1st floor

Maintain, repair or replace units as necessary.

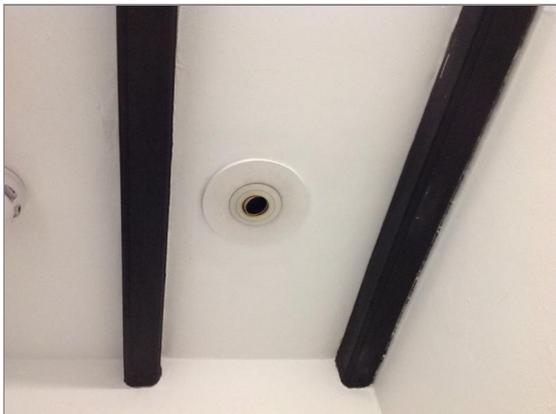
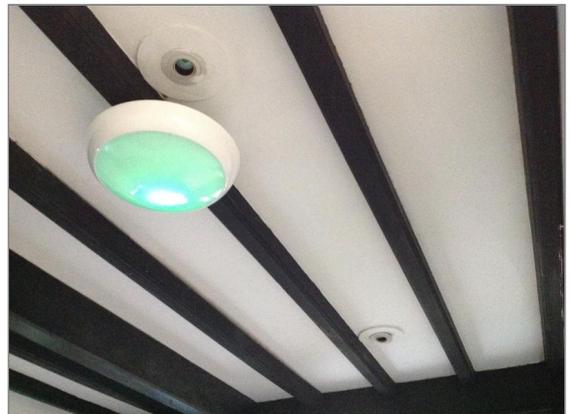
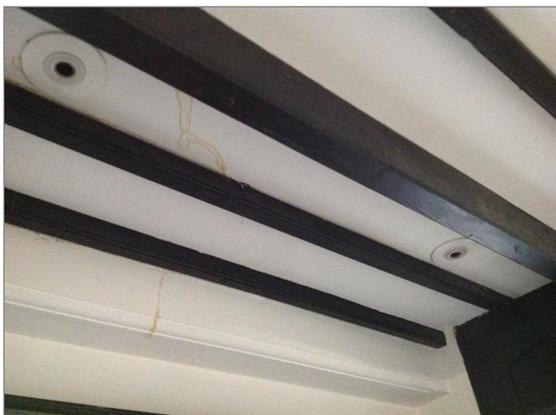
Photo - 177 Redundant spot light fittings to hallway ceiling

Photo - 178 Redundant spot light fittings to hallway ceiling

Photo - 179 Redundant spot light fittings to hallway ceiling

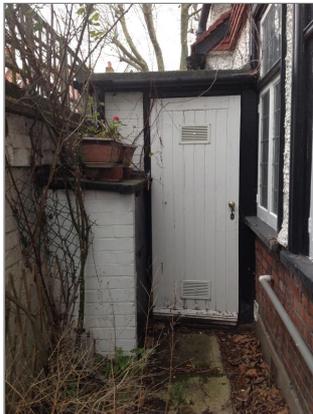
Photo - 184 Water damaged timber door to outbuilding

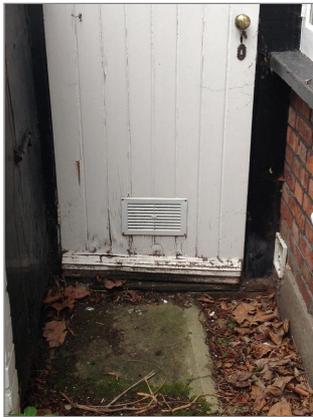
Photo - 186 Water damaged timber door to outbuilding

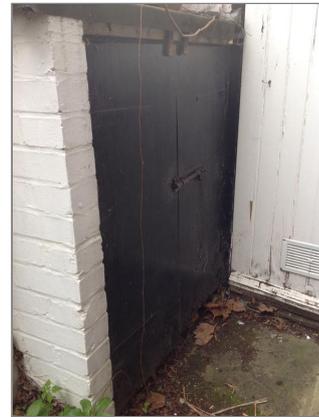
Photo - 187 Water damaged metal doors to store next to outbuilding

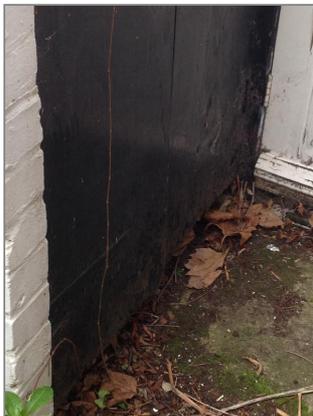
Photo - 188 Water damaged metal doors to store next to outbuilding

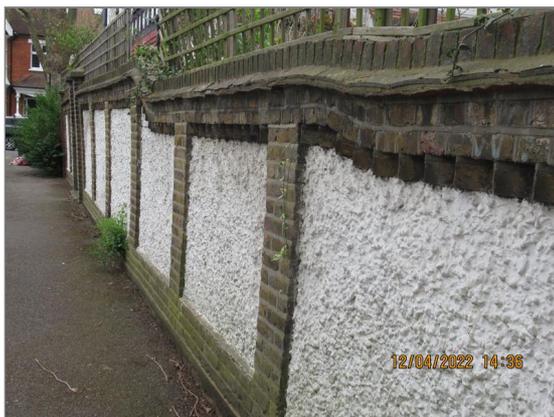
The brick boundary wall to the right-hand side of the garden is leaning to one side and there are cracks apparent to the base of the wall where movement has occurred (see photos below). The wall is structurally sound at present but should be monitored for any further movement.

Photo - 189 Boundary wall to the right-hand side of the garden is leaning to one side

Monitor condition of brick boundary wall to the rear garden and repair as necessary.
