Your survey report

52 Example Avenue,
London,
W9 7DF.

12th April 2022

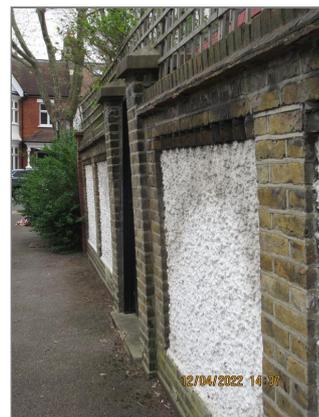
The brick boundary wall to the right-hand side of the garden is leaning to one side and there are cracks apparent to the base of the wall where movement has occurred (see photos below). The wall is structurally sound at present but should be monitored for any further movement.

Photo - 190 Boundary wall to the right-hand side of the garden is leaning to one side

Monitor condition of brick boundary wall to the rear garden and repair as necessary.

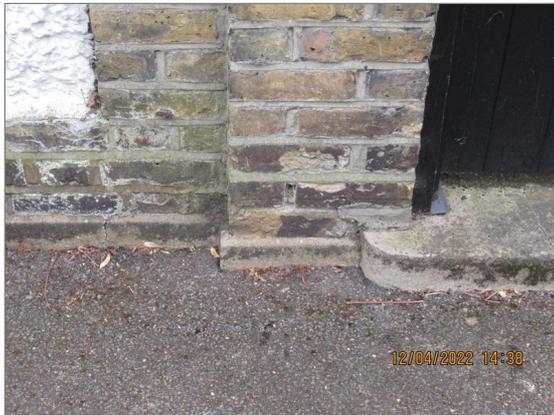
Photo - 191 Cracks apparent to base of wall where movement has occurred

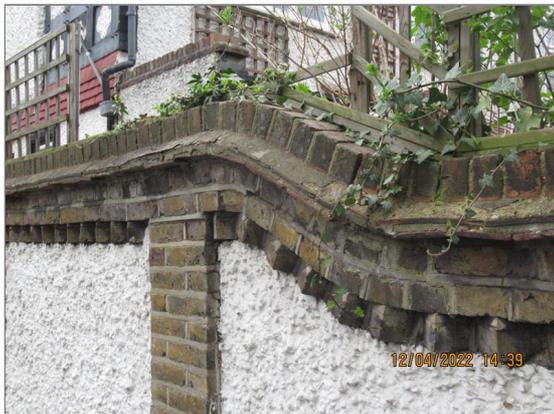
Photo - 193 Cracks apparent to wall where movement has occurred

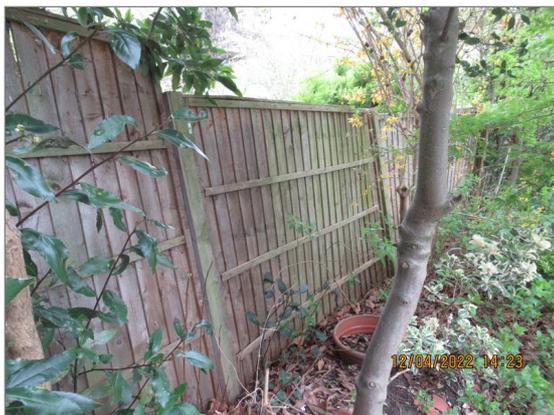
It was noted that the rear timber boundary to the left-hand side of the garden is leaning to one side (see photos below). Ownership of this boundary was unclear. Hence, you will need to seek clarification as to your responsibility with regards to this boundary.

Photo - 195 Rear timber boundary to the left-hand side of the rear garden is leaning to one side

Repair rear timber boundary to the left-hand side of the garden if this established to be your responsibility.

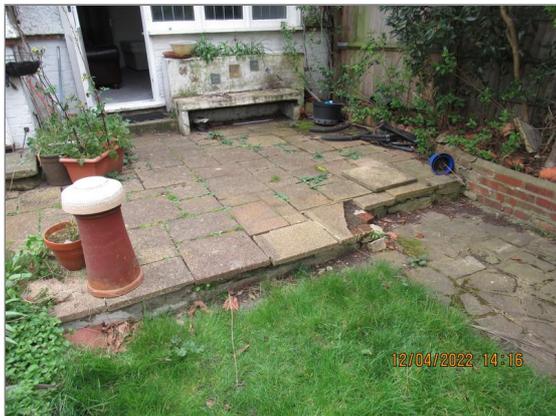
The paving in the rear garden and to the side of the property is in a serviceable condition. However, a section of paving located by the back door is in poor condition and in need of repair (see photo below).

Photo - 199 Section of paving located by back door is in poor condition

Replace section of concrete paving slabs in rear garden.
