Your survey report

6 Leicester Road,
London,
N2 8EB

20th October 2023

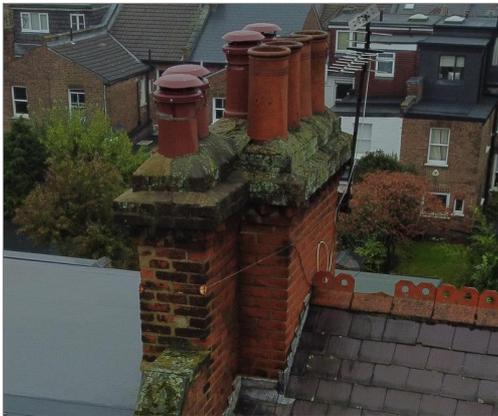
Photo - 2 Left-hand chimney stack

Minor cracking was noted to the flaunching of both chimney stacks. However, this cracking is minimal and is to be expected as the concrete flaunching ages and weathers.

Repair cracks to the concrete flaunching on both chimney stacks of the property.

Install chimney cowls to uncapped chimney pots.

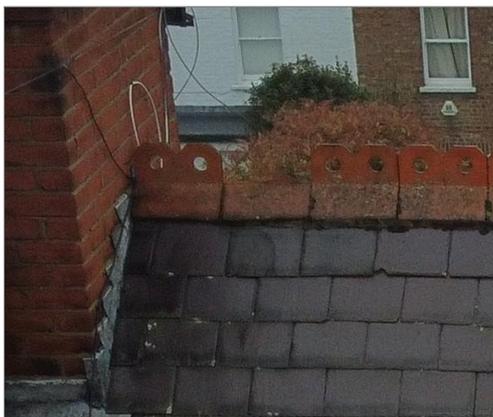
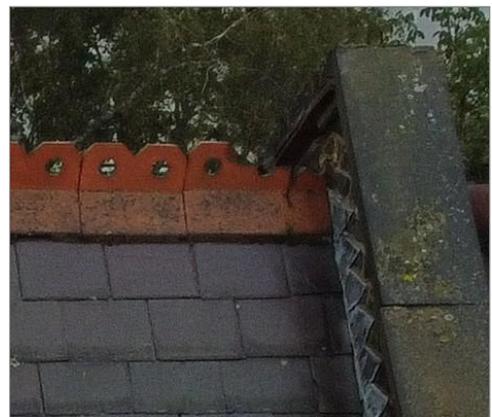
- Broken ridge tiles were noted to the front elevation of the main roof (see photo below).
- A broken tile was noted to the front elevation of the main roof (see photo below).

Photo - 12 Broken ridge tiles were noted to the front elevation of the main roof

Photo - 13 Broken ridge tiles were noted to the front elevation of the main roof

Replace the broken ridge tiles as required.

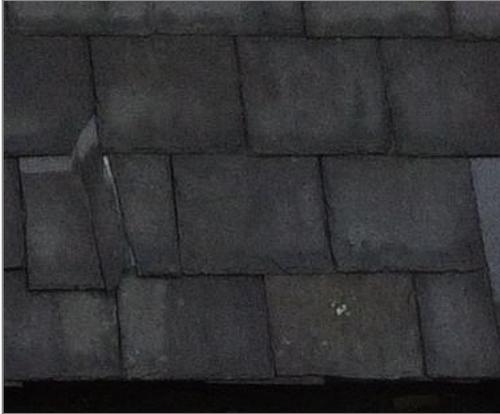
Photo - 14 A broken tile was noted to the front elevation of the main roof

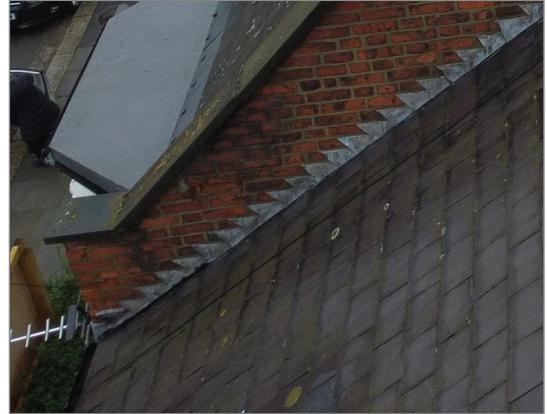
Photo - 15 Damp staining was noted to the front elevation left-hand parapet wall

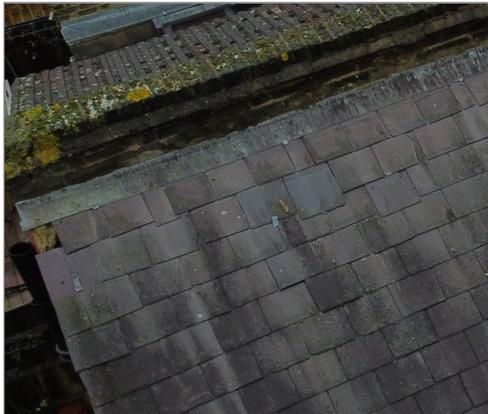
Photo - 16 Gaps were noted between the tiles on the rear elevation main roof

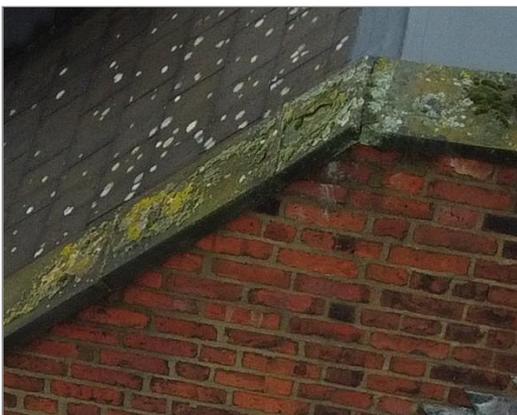
Photo - 18 Moss growth was noted to the joints of the coping stones of the parapet walls

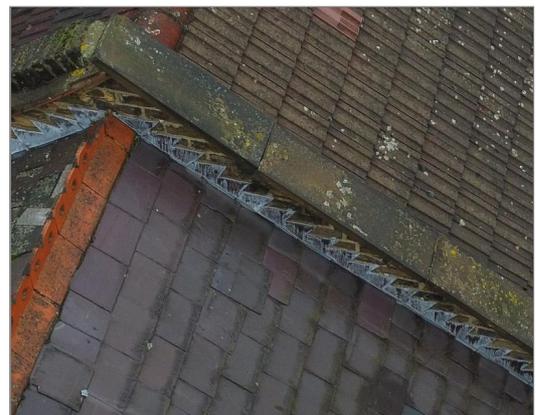
Photo - 19 Mortar was noted to be missing from the joints of the coping stones of the parapet walls

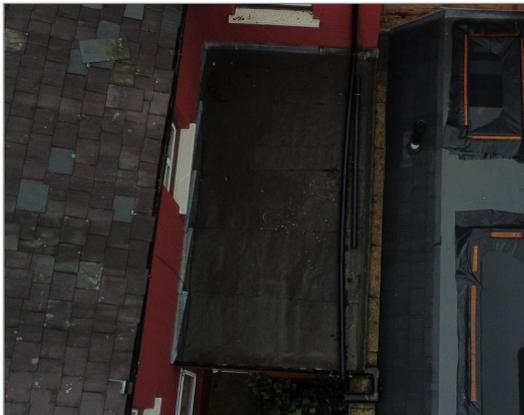
Photo - 20 Flat roof to the rear of the property

The flat roof to the rear of the property is in a serviceable condition.

Ideally you should anticipate that the flat roof will require normal maintenance for the short to medium term but you should allow for recovering in 5-10 years time. There is no evidence of failure at present.

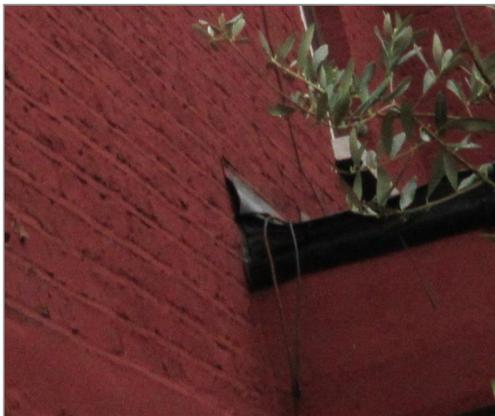
Photo - 22 Gaps were noted to the lead flashing seals of the flat roof

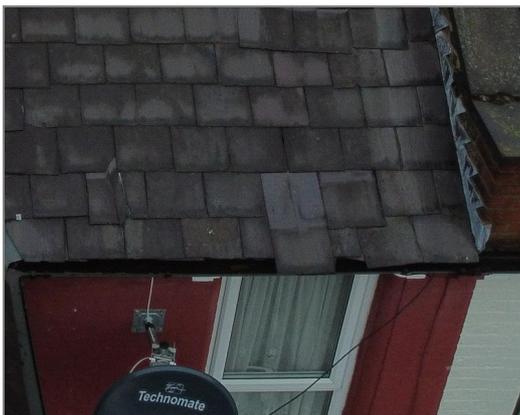
Photo - 23 A slipped tile was blocking the guttering on the front elevation

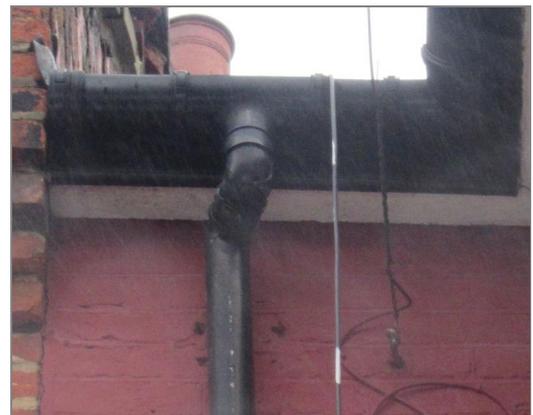
Photo - 24 Staining was noted to the joints of the down pipe on the front elevation

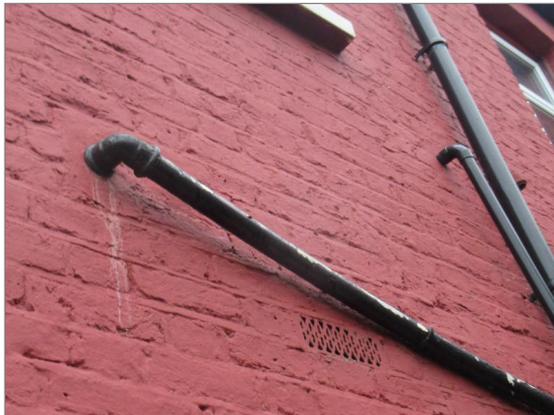
Photo - 25 Staining was noted to the bathroom waste pipe on the rear elevation

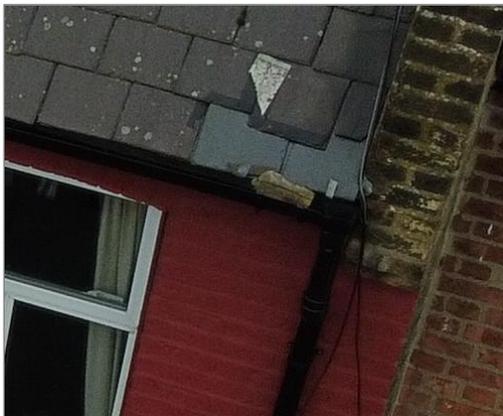
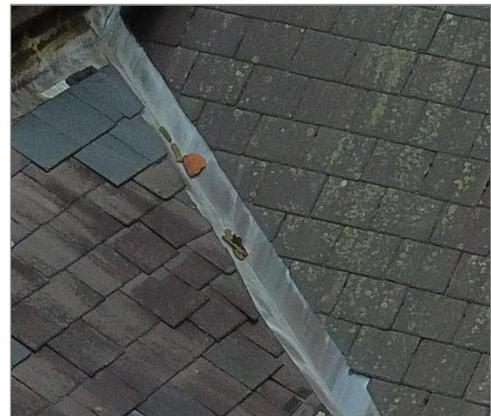
Photo - 27 Items were noted to be blocking the guttering on the rear elevation

Photo - 28 Items were noted to be blocking the guttering on the rear elevation

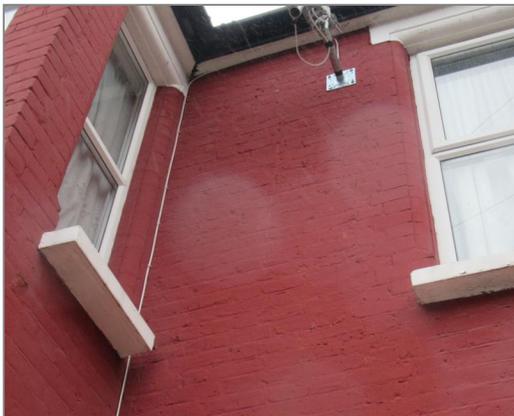
Photo - 31 Gaps were noted in the mortar pointing on the front elevation

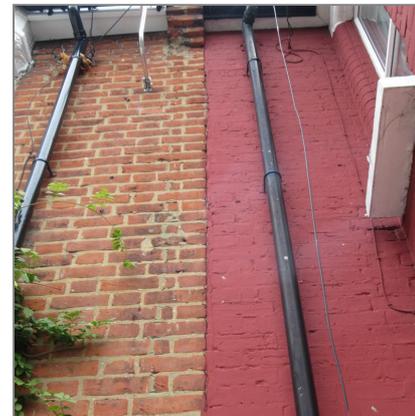
Photo - 32 Gaps were noted in the mortar pointing on the front elevation

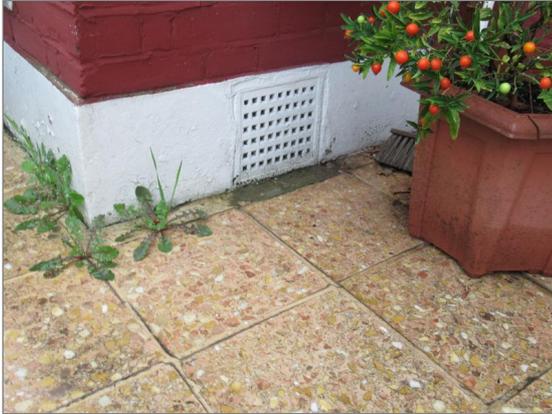
Suspected rising damp was identified to numerous walls throughout the property (refer to section 'E4 Walls and partitions' for further information). Further investigation will be required to ascertain the extent of the suspected rising damp noted and the cost of any remedial works.

Photo - 34 Damp was noted at the base of the walls on the front elevation

Photo - 35 Damp was noted at the base of the walls on the front elevation

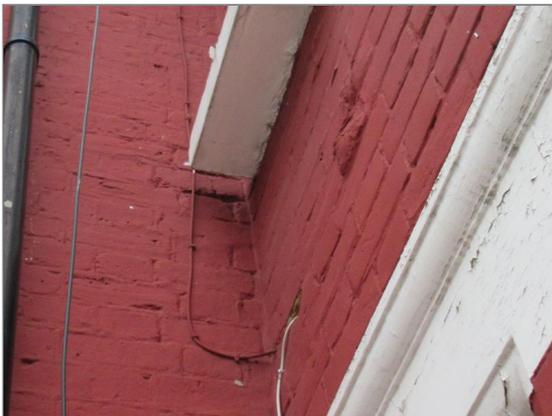
Photo - 37 Damp was noted to the brickwork on the front elevation

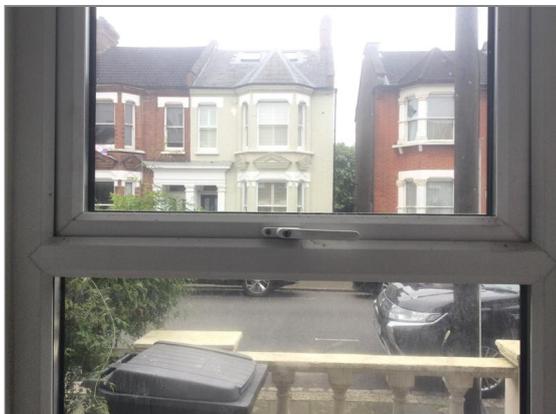
Photo - 41 The window in the front living room was noted to be stiff to operate

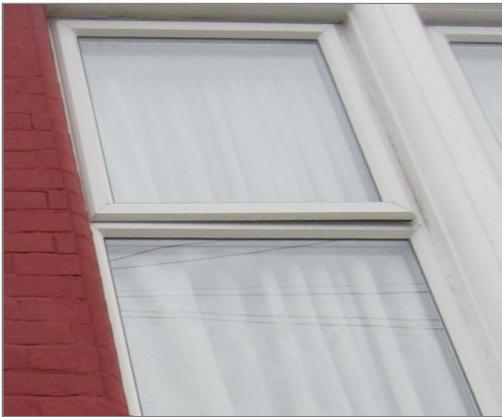
Photo - 43 The window in the front bedroom was noted to be defective and would not close sufficiently

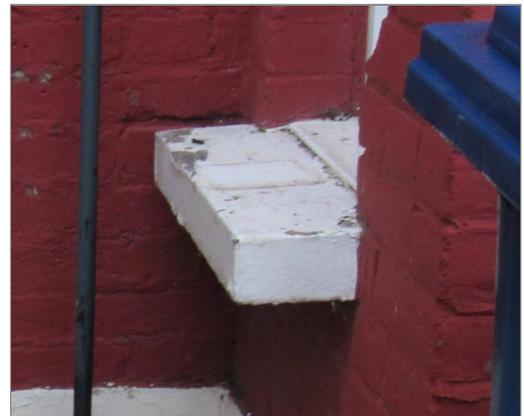
Photo - 46 Weathering was noted to the external concrete window cills on the front elevation

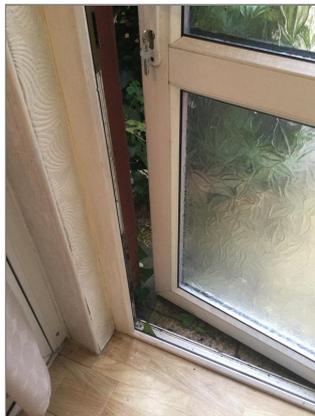
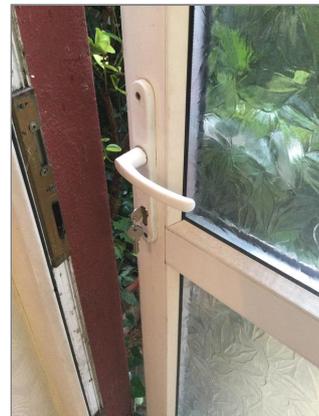
Photo - 53 The rear side door was noted to be defective when operated

Photo - 54 The rear side door was noted to be defective when operated

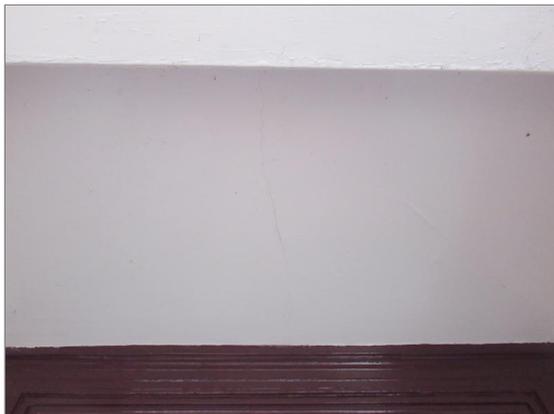
Photo - 56 Cracks were noted to the walls of the porch

Repair the cracks to the porch and redecorate as required.

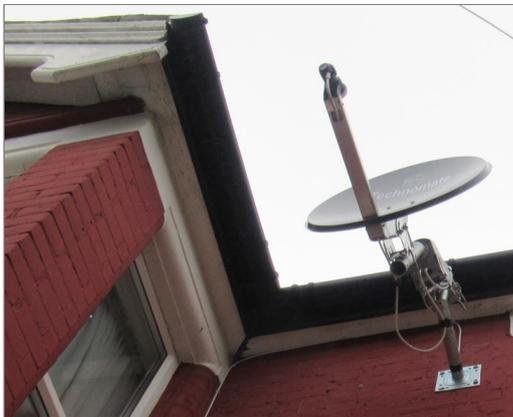
- Weathering was noted to the front elevation soffit and fascia boards (see photos below).

Photo - 59 Weathering was noted to the front elevation soffit and fascia boards

Redecorate the front elevation soffit and fascia boards with an exterior weatherproof paint as necessary.

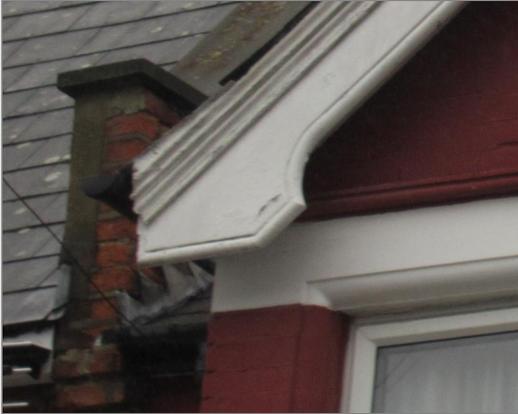
Photo - 61 Weathering was noted to the front elevation soffit and fascia boards

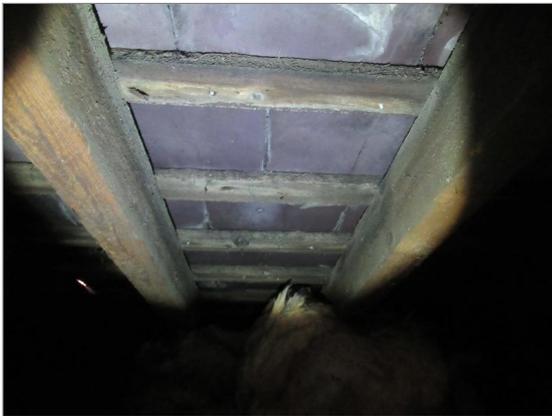
The sarking felt [undercovering] that is typically found as part of the roof construction is not present.

Photo - 62 No sarking present

Install sarking to prevent damage to the roof structure.

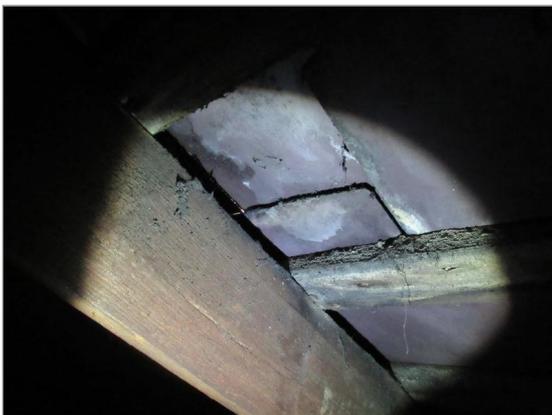
- Damp and mould was noted to the timber roof structure (see photo below). This is likely caused by the gaps to the roof tiles (refer to section 'D2 Roof coverings' for further information). The gaps are allowing rainwater ingress, causing damp to the timber framework of the roof.
- Gaps were noted to the roof covering (see photo below).
- A hole was noted to the wall in the roof space (see photo below).

Photo - 64 Damp and mould was noted to the timber roof structure

Once the issue with the roof coverings have been remedied, (refer to section 'D2 Roof coverings' for further information) allow for the timber roof structure to dry out naturally. The roof timbers should be monitored for further defects going forward.

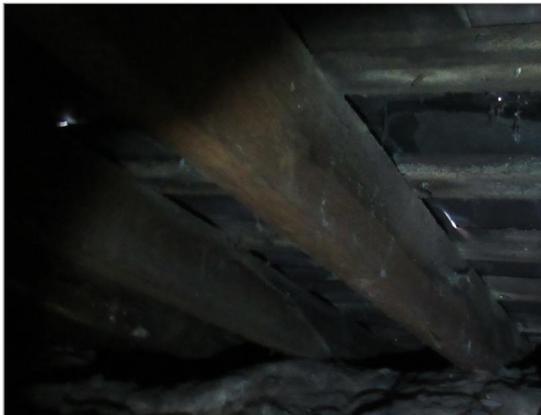
Photo - 66 Gaps were noted to the roof covering

Repair the gaps to the roof covering as necessary.

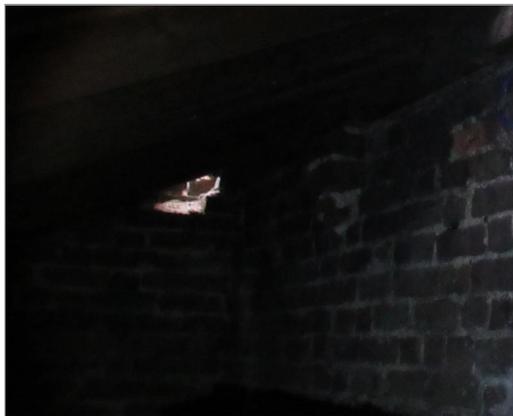
Photo - 68 A hole was noted to the wall in the roof space

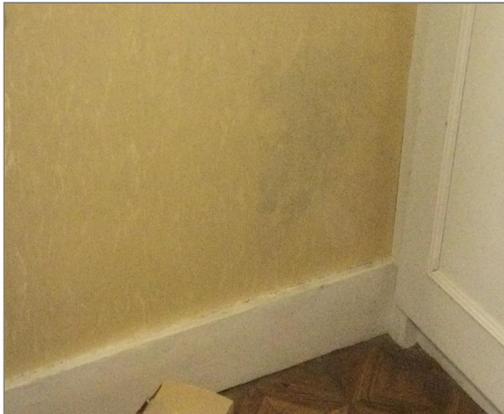
Photo - 83 Damp was noted to the wall in the second left-hand bedroom

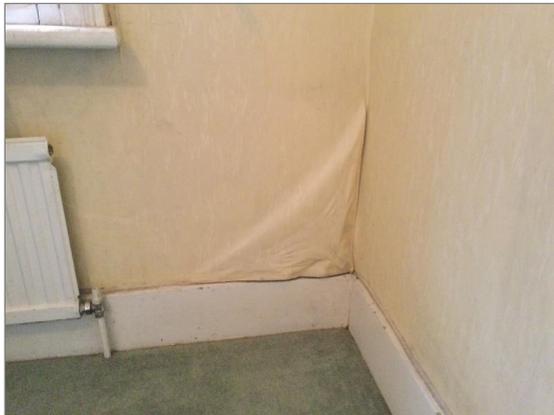
Photo - 93 High moisture meter readings were recorded on the wall in the third left-hand bedroom

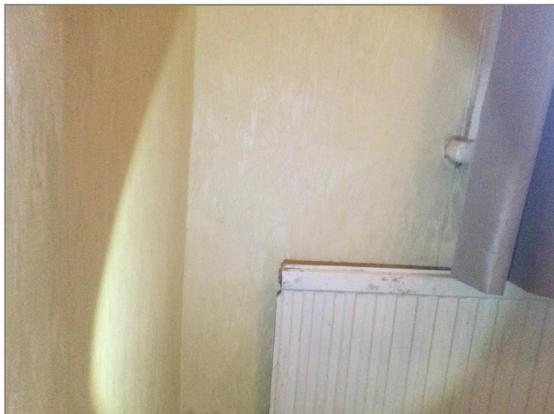
Photo - 95 High moisture meter readings were recorded on the wall in the third left-hand bedroom

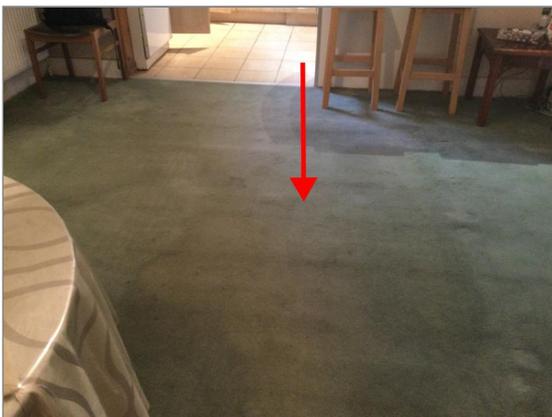
Photo - 99 The flooring was noted to be raised in the dining room

Floors should be monitored for any changes that occur in their level or springiness or noise, and further investigations carried out should any such changes become apparent.

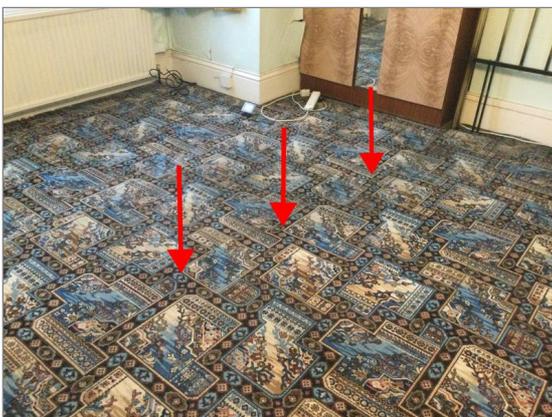
Photo - 101 The flooring was noted to be raised in the front bedroom

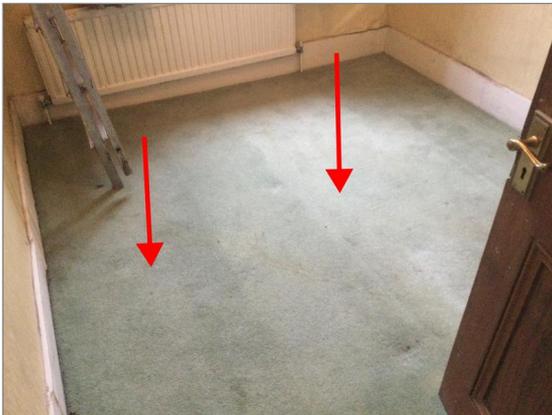
Photo - 103 Floorboards were noted to deflect when traversed in the third left hand bedroom

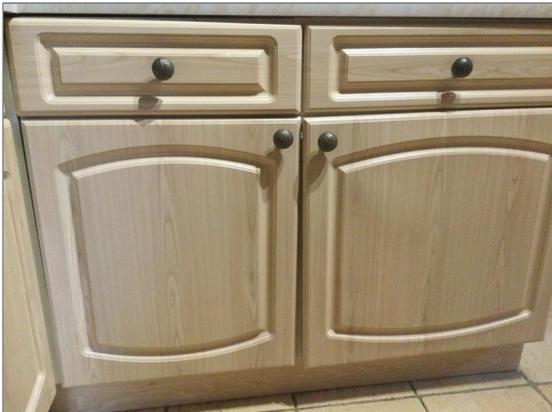
Photo - 111 The cupboard doors were noted to have dropped on their hinges

Maintain kitchen units and cupboard doors as necessary.

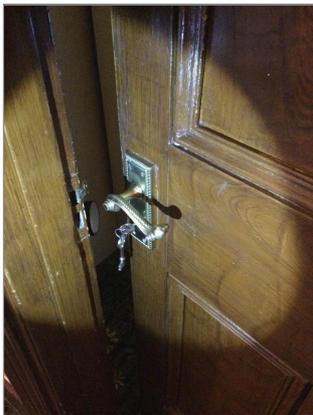
Photo - 113 The second living room door does not engage with latch when closed

All door hinges and locks should be regularly lubricated. Internal timbers should be inspected regularly for evidence of bowing or distortion, woodworm and other defects.

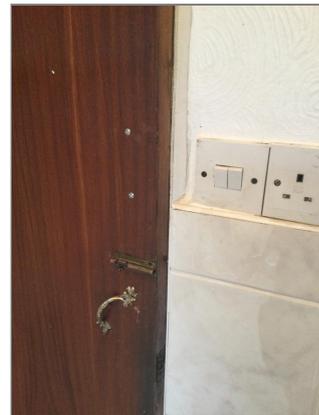
Photo - 114 The rear shower room door does not shut and scuffs the frame when operated

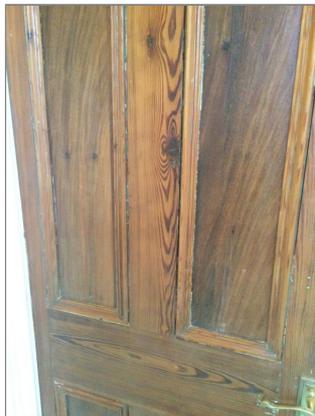
Photo - 117 Shrinkage cracking was noted to the timber door of the third left hand bedroom

Fill and redecorate shrinkage cracks as necessary

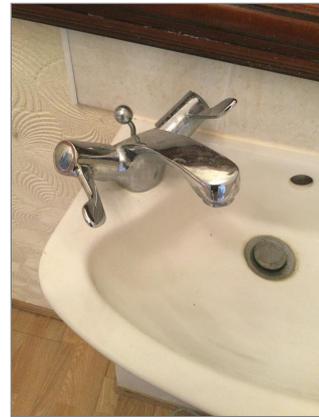
Photo - 121 The tap on the rear left shower room sink was noted to be loose

Maintain, repair or replace units as necessary.

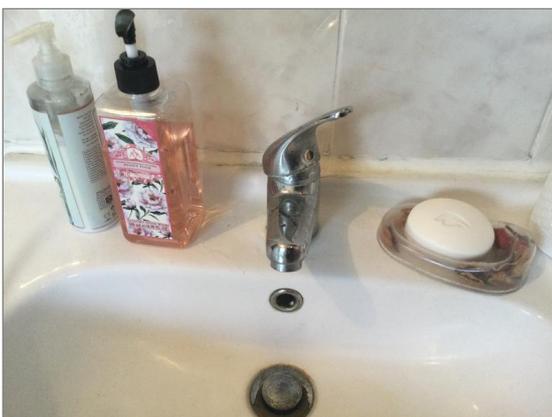
Photo - 124 Cold water was unavailable from the rear shower room tap when operated

Investigate the issue with the flow of cold water to the tap in the rear shower room and repair as necessary.

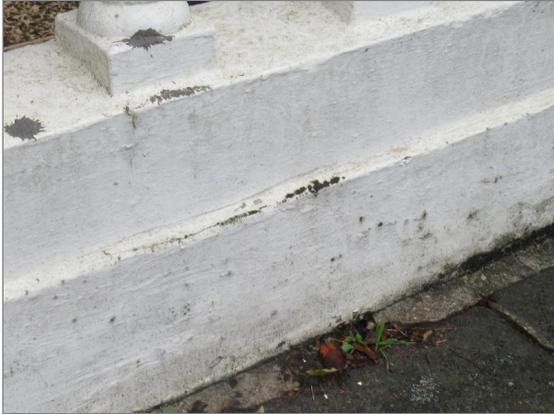
Photo - 136 Cracks were noted to the front boundary wall

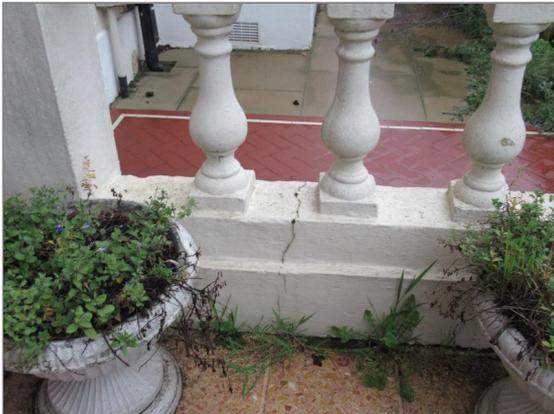
Photo - 138 Cracks were noted to the front right-hand boundary wall

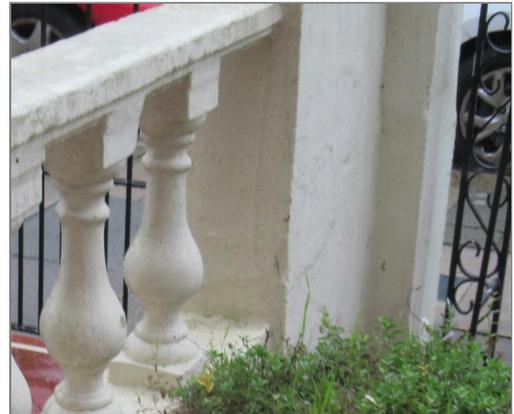
Photo - 139 Cracks were noted to the front right-hand boundary wall

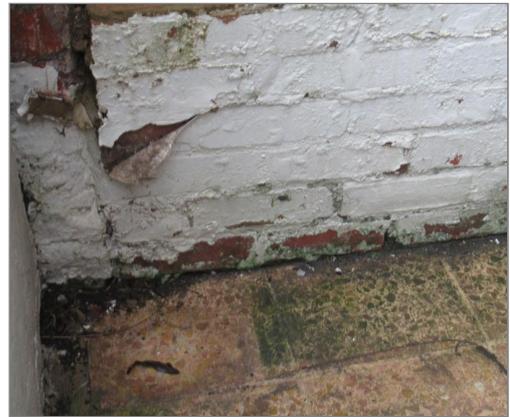
Photo - 143 Damp was noted to the front left-hand boundary wall

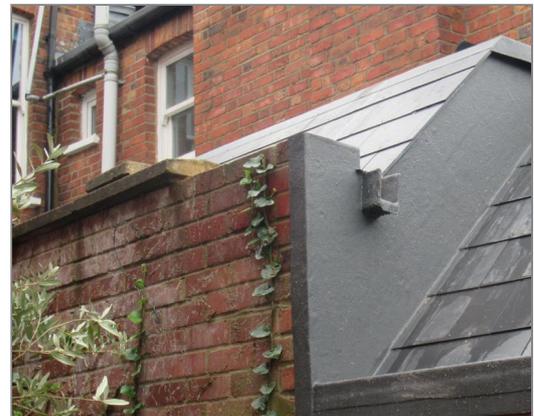
Photo - 151 A coping stone was noted to be removed from the rear right-hand boundary wall

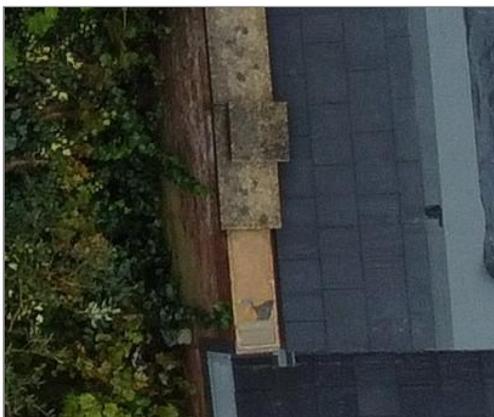
Photo - 152 A coping stone was noted to be removed from the rear right-hand boundary wall
