# Your survey report

6 Leicester Road,  
London,  
N2 8EB

20th October 2023

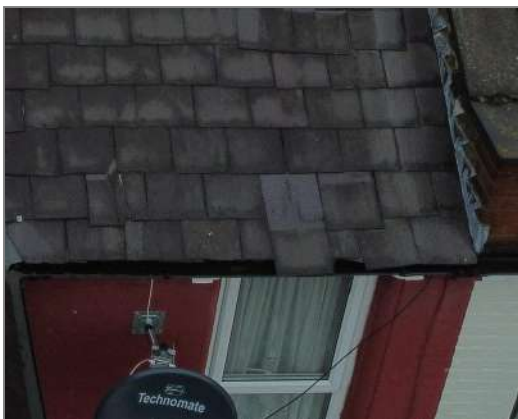
*Photo - 23 A slipped tile was blocking the guttering on the front elevation*

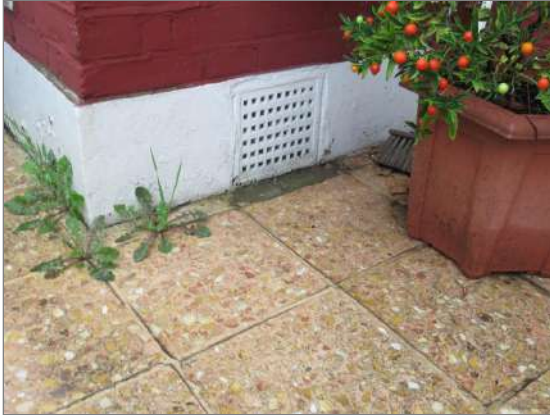
*Photo - 97 Air brick*

Air bricks are visible at the base of the external walls. These air bricks are present to ensure adequate ventilation to the underfloor voids, to minimise the build-up of moisture that can promote the development of rot and other defects in the timbers that support the floors. No evidence of any undue flexing of the ground floor structure was noted; this indicates that the ventilation levels are adequate. It is however, essential that a free flow of air is maintained through the air bricks (see photo below of external air bricks).

Ensure that the external air bricks, visible at the base of the external walls, are kept clear to maintain adequate ventilation in the underfloor void. External paving and soil levels should not be allowed to rise above the level of the air bricks. A lack of ventilation can allow moisture levels beneath the floor to become elevated, increasing the risk of the development of moisture related defects such as rot and infestations by wood boring insects (commonly known as woodworm).
